14.1.10 Data Recorder Tape Deterioration

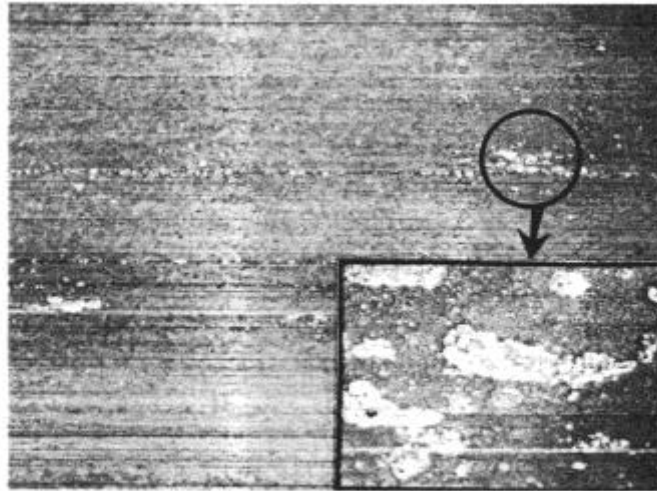
An electrical and physical examination of the flight tape was conducted. Observation of the bi-phase output of the 51.2 kilobit pulse code modulated output from the playback showed a complete deterioration of the waveform for the first 20 seconds (12-1/2 feet), together with numerous complete dropouts. After 20 seconds, the bi-phase signal gradually improved to the point where, at 30 seconds, the signal appeared normal. The 64 kilobit pulse code modulated output was similarly affected to a lesser degree.

The first 30 feet of tape was scanned under magnifications ranging from 50X to 400X. Under 50X magnification, a distinct pattern of embedded particles could be observed (**Fig. 14-14**). The deposits were quite heavy over the first 12 feet of tape, and gradually tapered out so that, at 20 feet, very few particles could be observed. Under 400X magnification, individual flakes of deposited material were observed. The portion of **Fig. 14-14** at 400X magnification shows a typical cluster of particles on the beginning portions of the tape.

Figure 14-14.- Recording tape photographed under 50 power and 400 power magnification showing silver oxide deposits.

A 10-foot leader coated with a silver oxide compound is spliced to the beginning and end of the magnetic tape roll to activate the end-of-reel sensors on the tape transport. There has been a history of this material flaking off and affecting tape performance. Tape screening procedures were implemented by the manufacturer in 1968 to eliminate this problem. No further problems were encountered until Apollo 15. The recording method for Apollo 14 and previous missions was considerably different than that for the Apollo 15 mission. Bit packing densities for the Apollo 15 mission tape approach 9000 bits per inch while those for the previous missions were only 800 bits per inch. Abnormalities in the tape would have considerably more effect with the higher packing density. The utilization of the Apollo 15 mission recorder is also considerably higher, allowing more time for deposits to build up.

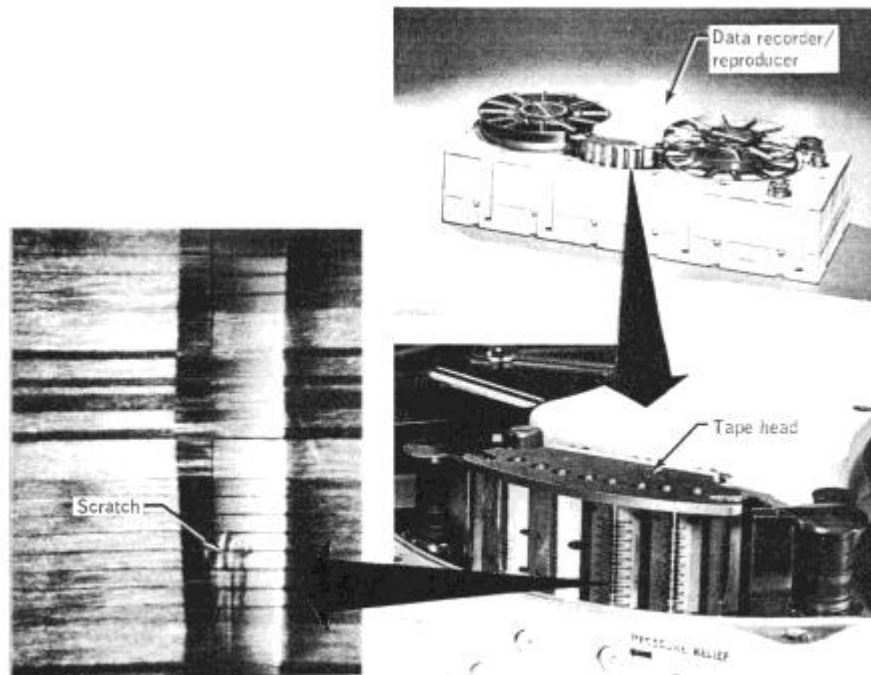
Inspection on the magnetic heads under 20X magnification disclosed four scratches, one of which is shown in **Fig. 14-15**. An overlay was made of the scratches with respect to the accumulation of silver oxide on the tape; two of the four scratches aligned perfectly with the silver oxide accumulation. The scratches must have scraped loose the silver oxide on the leader. Operation of the recorder would then distribute the silver oxide particles along the tape. During the manufacture of the Apollo 16 recorder, it was discovered that the heads were being scratched by handling. The Apollo 15 recorder heads were probably also scratched during manufacture. The scratches would not have been detected during acceptance inspection since they are not visible at the 7X magnification used during that inspection.

Figure 14-15.- Data recorder/reproducer and scratches on head.

Removable head covers have been provided to protect the heads from handling damage when the recorder covers are not installed. These covers have been used since early in the buildup cycle of the Apollo 16 and 17 data recorders. The recorder heads have been examined under 20X magnification and no scratches were found.

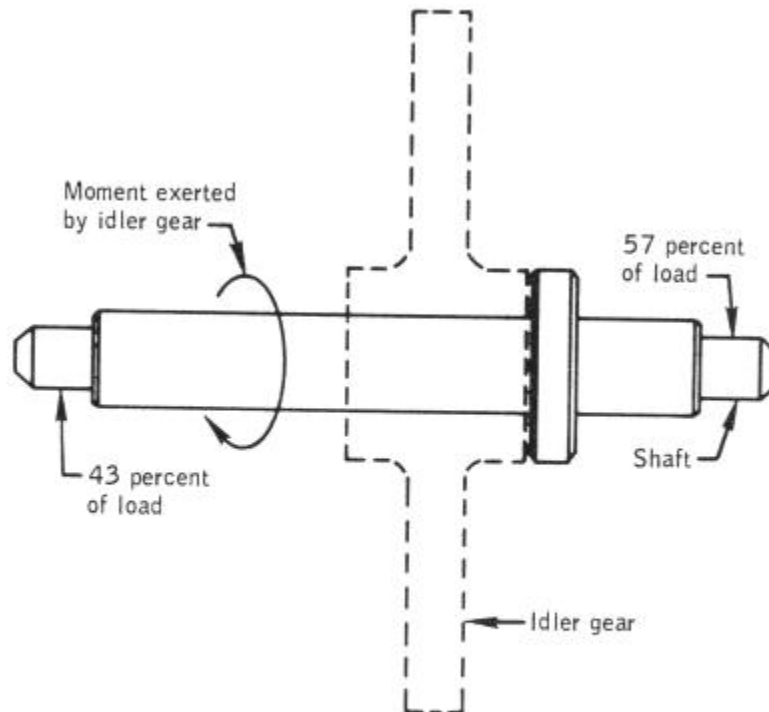
Figure 14-16.- Forces on idler gear shaft in countdown mode.

The seconds digit of the digital event timer, located on panel 1, became obscured by a powder-like substance that formed on the inside of the glass. Postflight analysis of the unit disclosed that the substance on the window was paint which had been scraped from the number wheel by the idler gear. The idler gear is free to rotate on the shaft (**Fig. 14-16**); however, the design allows the stainless-steel shaft to also rotate. The stainless steel shaft bearing points are in the magnesium motor plate and the shaft rotation wears away the softer magnesium material.

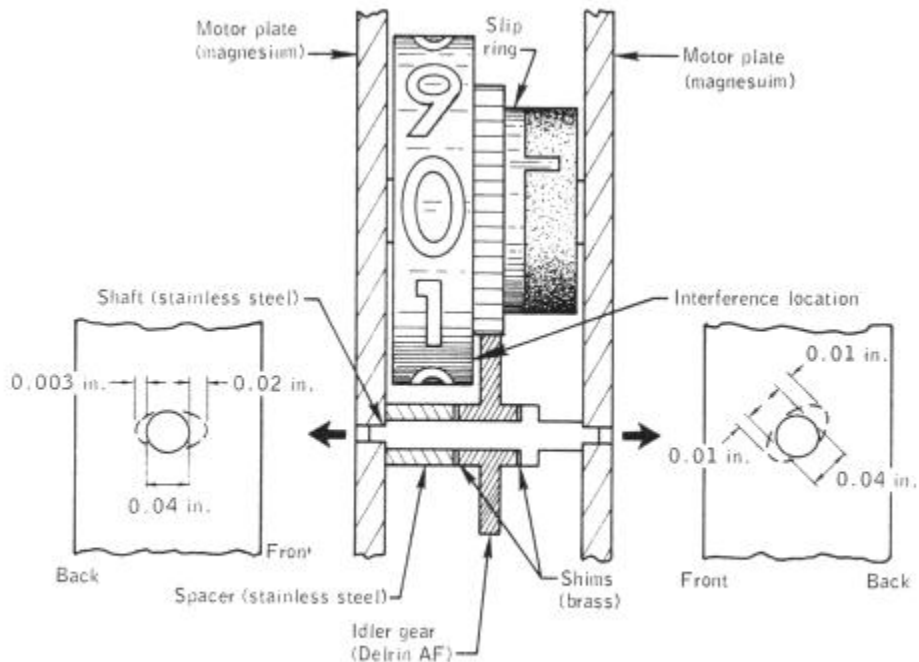
Inspection of the unit showed that the magnesium bearing points had been elongated as shown in **Fig. 14-17**. Torque from the stepping motor applied to the idler gear not only resulted in rotation of the shaft but also caused the shaft to tilt (**Fig. 14-17**). The wearing eventually allowed the shaft to tilt sufficiently to cause the gear to rub against the number wheel. When the timer counted down, the motor torque threw the gear teeth into the front edge of the counter wheel. Testing indicates that this bearing hole elongation occurs after approximately 500 hours running time (specification life is 1400 hours).

Figure 14-17.- Digital event timer mechanism.

The analysis of those failures revealed that the idler gear was rubbing paint off the number wheel and paint particles prevented the slip rings and brushes from making good contact. A review of drawing tolerances showed that an interference could occur and the addition of the shims appeared to be adequate corrective action. These failure analyses did not reveal the problem of the elongation of the bearing points since it is not obvious until the timers are disassembled.

Units for future flights will be visually inspected by looking through the window for paint flakes and signs of wear.

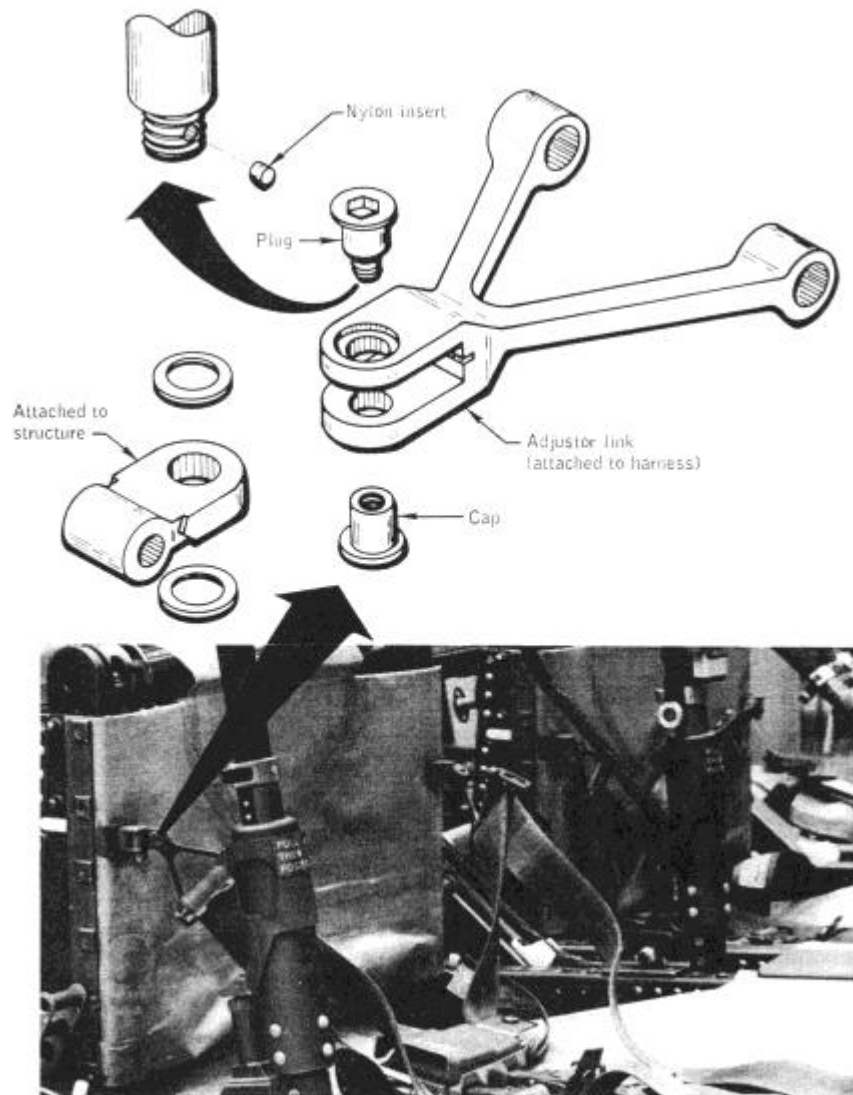
Figure 14-18.- Crew restraint harness connector.

The restraint harness on the right side of both the center and right crew couches came apart during lunar orbit. The assemblies had become unscrewed, but the crew was able to retrieve all the parts except one cap and reassemble the harnesses satisfactorily for landing. The mating plug for the missing cap was held in place with tape.

The plug-and-cap assembly (**Fig. 14-18**), which is part of the universal assembly that attaches the restraint harness to the couch seatpan, separated. (There are a total of six plug-and-cap assemblies on the crew couch, two per man.) The plug component (bolt) has a nylon insert in the threaded portion that acts as a locking device. Back-and-forth rotation of the adjuster link can cause the plug-and-cap assembly to unscrew from each other. Checks on the four other Apollo 15 assemblies showed zero torque on two of the units and minimum specification value (2.0 in-lb) on the others. The loss of torque is apparently due to cold flow of the plastic self-locking pellet, causing a loss of friction against the mating threads.

A thread locking sealant will be used to prevent the problem on future missions.

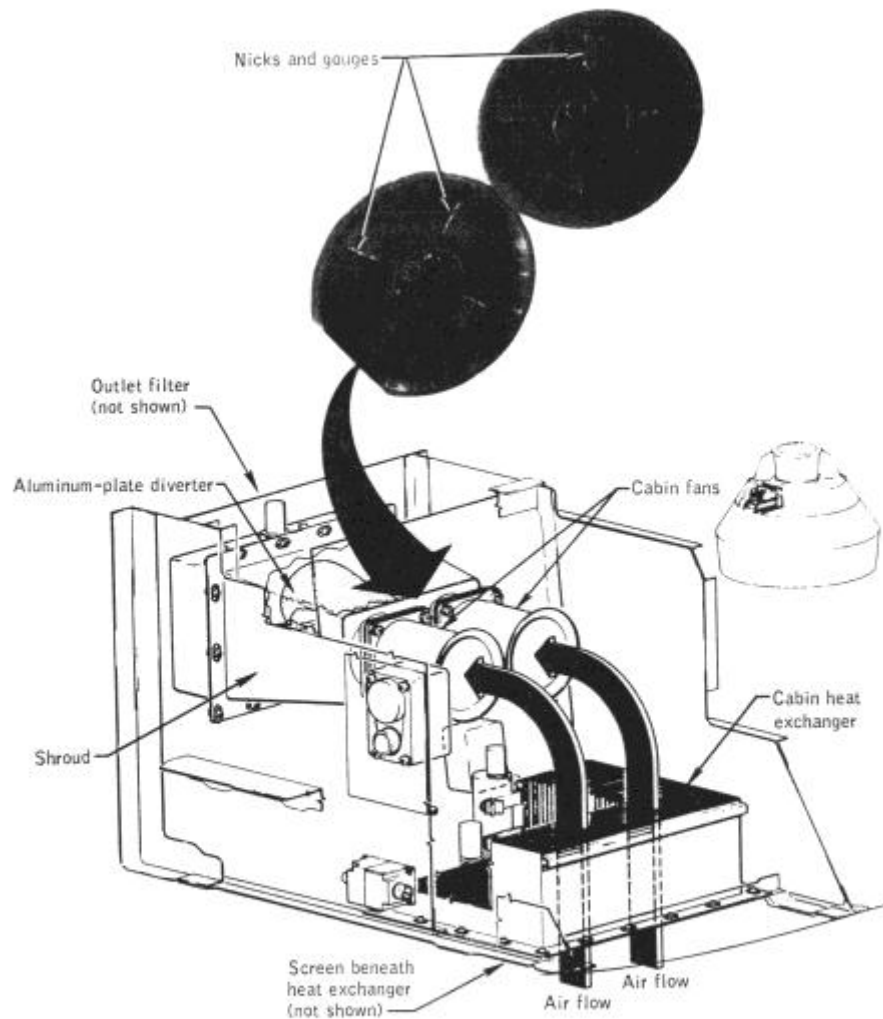
Figure 14-19.- Cabin fan installation.

During portions of the flight when the cabin fans (**Fig. 14-19**) were activated, the crew heard sounds like an object striking the blades. Cycling the fans several times allowed the object to be retained in a position that precluded it from interfering with fan operation.

Inspection of the fans revealed considerable gouging on the leading edges of the blades of both fans (**Fig. 14-19**). No marks were found on the outlet de-swirl vanes of either fan. After extensive examination, including the lunar dust filter, a 1/4-inch washer was found in the ducting.

Although the fan inlet is protected by screens in addition to the heat exchanger core, the outlet is relatively open and the washer could have drifted in and out when the fans were not operating. The outlet was protected only during the limited time when the lunar dust filter was installed. The washer could also have been left in the duct during assembly.

No hardware changes are contemplated. Should the anomaly occur on a subsequent flight, no detrimental effects would result.

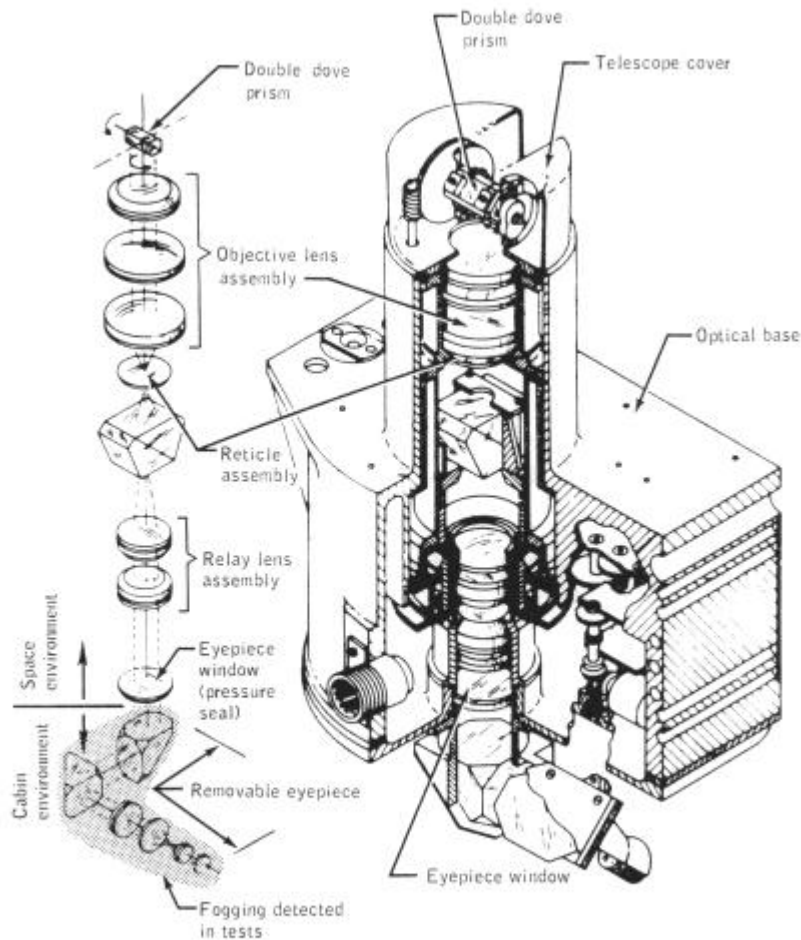
Figure 14-20.- Scanning telescope assembly.

The crew reported that excessive attenuation of light through the scanning telescope existed throughout the flight. The telescope was adequate to perform landmark tracking while in lunar orbit, but the crew was unable to identify constellations, even though large numbers of stars could be seen by looking out the spacecraft window.

Visual observations through the telescope (**Fig. 14-20**) were made at the spacecraft manufacturer's facility, and no degradation could be observed. A luminescent transmittance test was performed on the telescope before removal from the spacecraft and transmittance was calculated to be 25 percent. This compares with an acceptance test value of 55 percent. The decrease is due to the entry environment and sea water contamination. The 30-percent decrease agrees well with the expected results and is not significant as far as being able to see and recognize constellations is concerned. For comparison, the earth's atmosphere normally causes a 50 percent loss in star intensity; therefore, observing stars from earth with a telescope with a 50-percent transmittance would be equivalent to observing stars from a spacecraft in flight using a telescope with a 25- percent transmittance.

The flight anomaly was reproduced in the laboratory by placing the optical unit assembly, the removable eye piece, and the optics panel in a chamber wherein the environmental conditions that existed in the cabin during flight were duplicated. Condensation on the eyepiece window and, to a lesser extent, on the prisms in the removable eyepiece caused the transmittance to decrease to about 4 percent.

A heater will be added to the removable eyepiece to prevent fogging in the eyepiece assembly and on the eyepiece window.

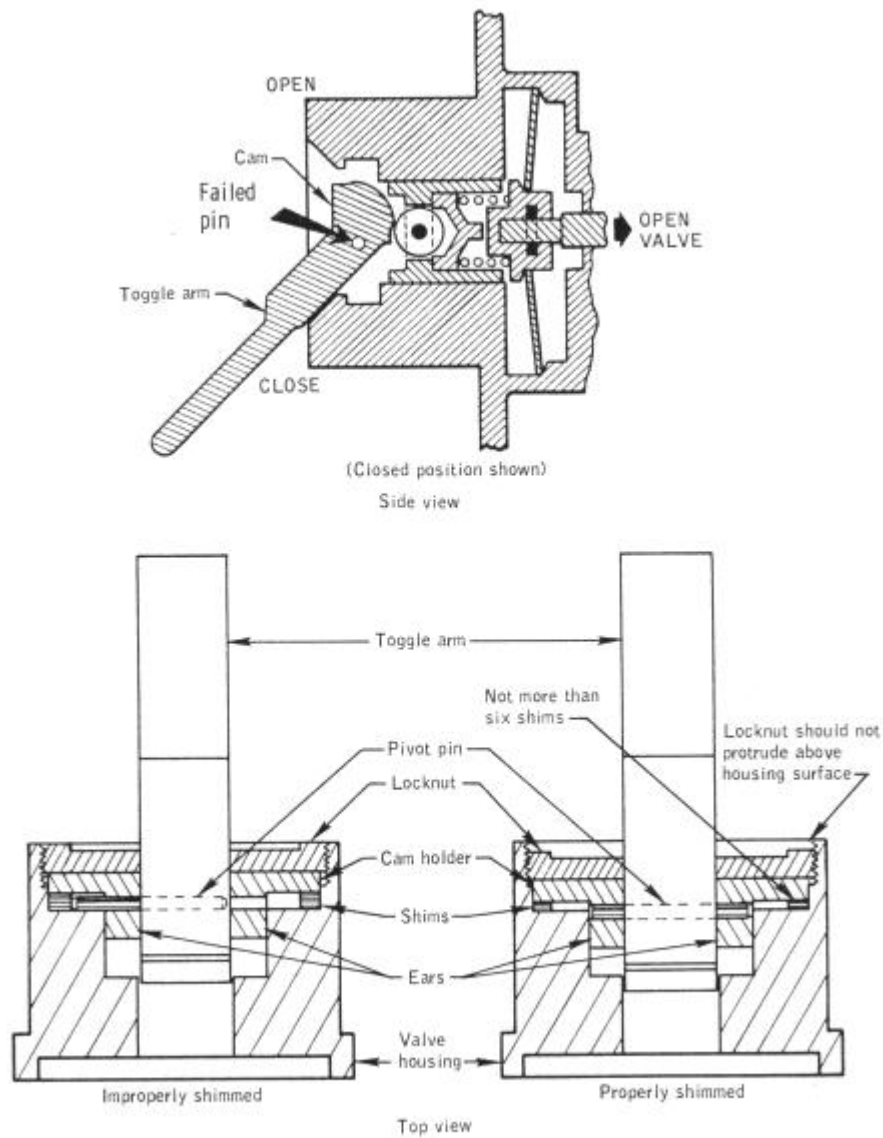
Figure 14-22.- Oxygen regulator shutoff valve.

The pivot pin attaches the toggle arm to the cam holder and is retained in place by the valve housing when properly assembled (**Fig. 14-22**).

Failure analysis showed that the pivot pin failed in single shear and bending. This failure resulted from improper shimming which allowed the pivot pin to come out of one side of the cam holder as shown in **Fig. 14-22**. Analysis and testing has shown that the pin strength is adequate in double shear, but will fail in single shear and bending with a force of about 70 pounds applied at the tip of the toggle arm when it is in the closed position. No marks were found on the toggle arm to indicate that it had been struck by some object.

Inspection criteria to assure that valves now installed in other spacecraft are properly assembled have been developed from a study of adverse tolerance buildups associated

with the valve components. These criteria are that the lock nut does not protrude and the number of shims does not exceed six (fig. 14-22).

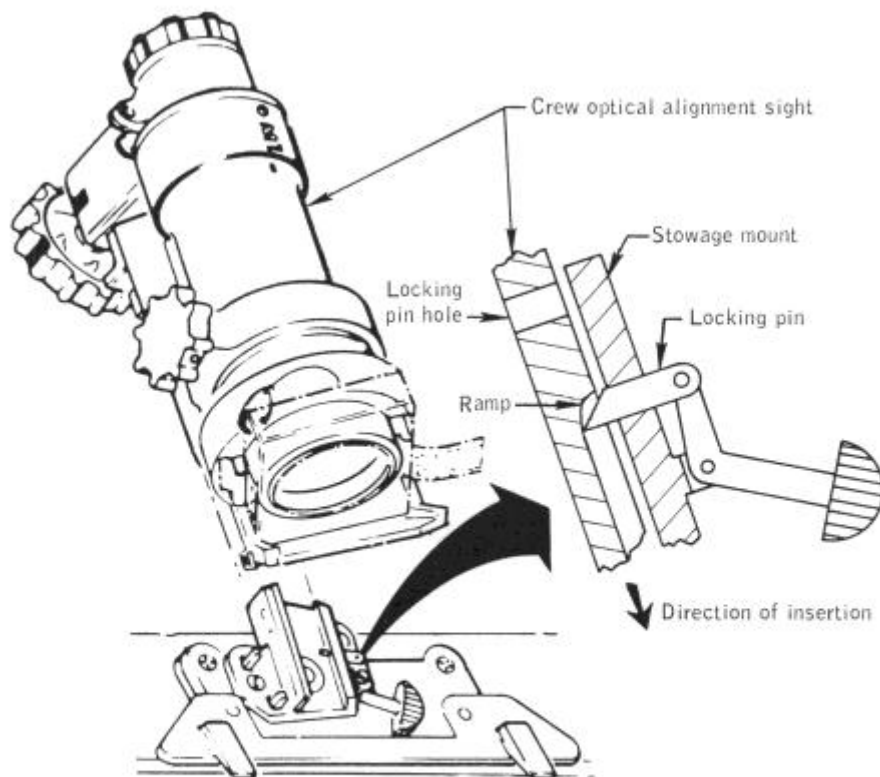
Figure 14-23.- Crew optical alignment sight stowage.

The crew optical alignment sight fell from its stowage mount during landing because the locking pin which secures it was not engaged. Normally, when the sight is placed into the mount, the locking pin is raised automatically by a ramp and the pin is moved into the locking pin hole by spring action (**Fig. 14-23**). Postflight examination showed that the ramp had been gouged preventing raising of the pin by the ramp. The cause of the gouge is not known.

The crew optical alignment sights for Apollo 16 and future spacecraft will be fit-checked to insure proper operation of the latching mechanism. Also, the Apollo Operations Handbook and crew checklist are being revised to include verification of the latching pin engagement prior to entry.

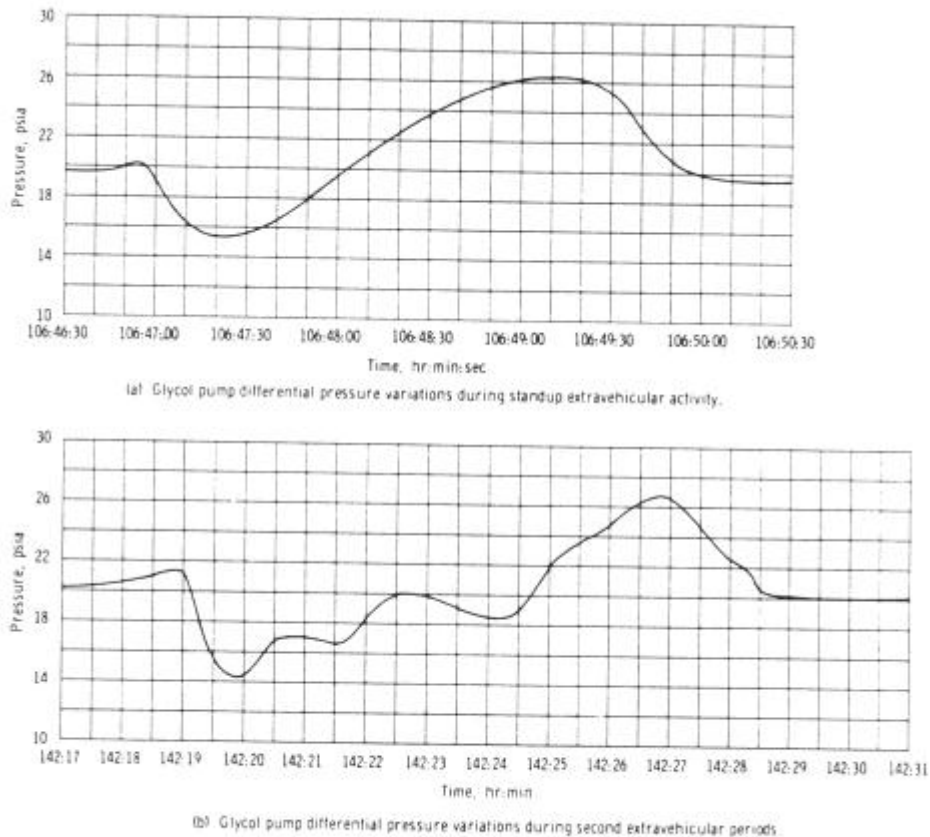
Figure 14-24.- Glycol pump differential pressure variations during extravehicular periods.

Variations were noted in the water/glycol pump differential pressure shortly after the cabin depressurizations for the standup extravehicular activity and the second extravehicular activity. The variations were similar on both occasions. The pressure differential decreased from about 20 psid (normal) to about 15 psid, then increased to about 27 psid and returned to normal (**Fig. 14-24**).

The total times for the cycles were 3 minutes during the standup extravehicular activity and 10 minutes during the second extravehicular activity. The pump discharge pressure remained relatively stable throughout both periods. If pressure fluctuations had taken place in the heat transport system, both the pump discharge pressure and differential pressure should have varied together.

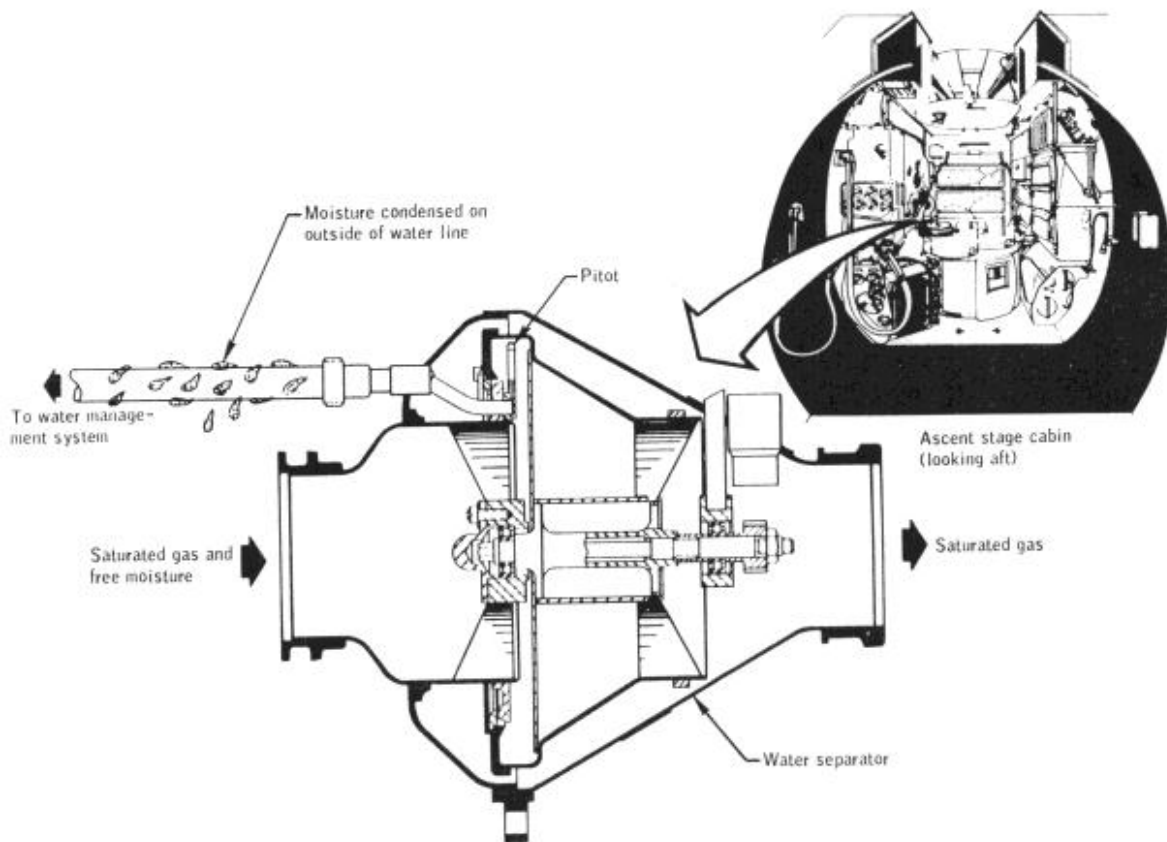
Figure 14-27.- Cross section of water separator.

Cabin atmosphere is cooled and passed through one of the water separators (fig. 14-27) where condensed water is separated by centrifugal force and picked up by a pitot tube. The water is then piped from the pitot tube, through a check valve, to the water management system where it is used in the sublimator.

Cabin humidity was high before the standup extravehicular activity and, because the water and structure were cold, the line between the water separator pitot tube and the water management system was cold. Under these conditions, water would condense on the outside of the line (**Fig. 14-27**), and when the cabin was depressurized for the standup extravehicular activity, the water on the outside of the line would boil, freeze, and sublime, thereby freezing the water in the line.

Analysis shows that as little as a 0.01-inch film of water on the outside of the line will freeze the line at cabin depressurization. Freezing within the line will cause the separator to slow down and stall because of excessive water. Separator 2 had not been used. Therefore, no water was in its outlet line to freeze. Consequently, it operated successfully when activated.

Analysis and tests have shown that freezing of the line will not damage any spacecraft hardware. If such freezing occurs, the other separator would be used. Therefore, no corrective action is required.

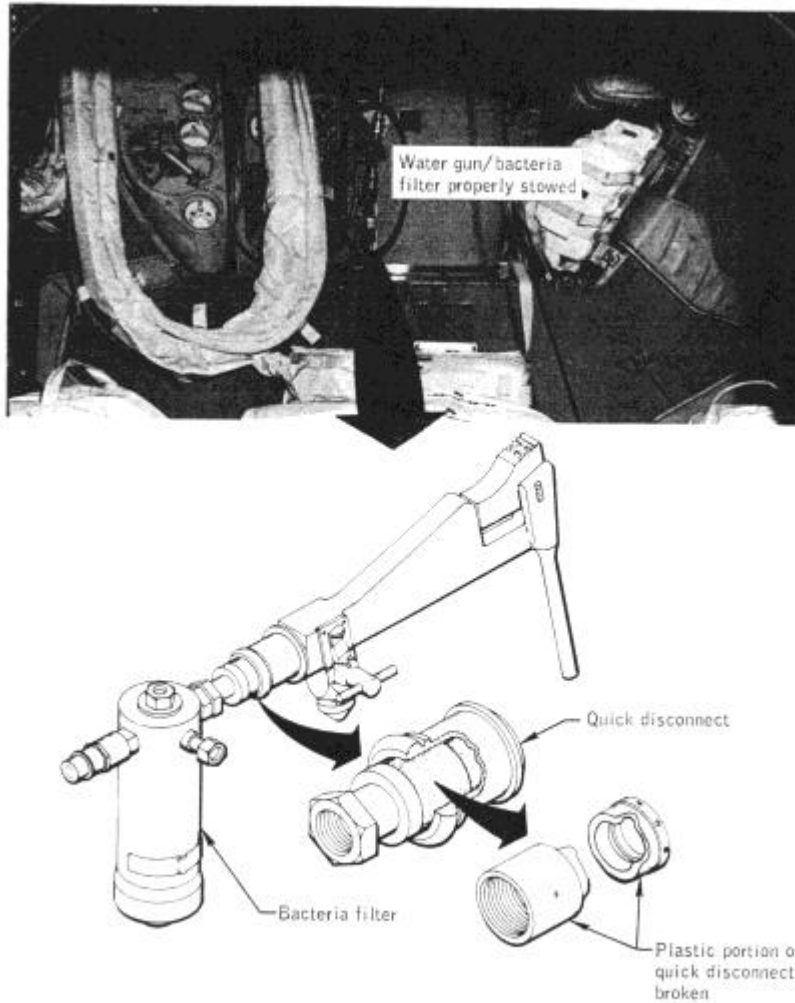
Figure 14-28.- Water gun/bacteria filter.

A water leak occurred at the quick disconnect between the bacteria filter and the water gun (fig. 14-28) shortly after the first extravehicular activity. The leak was caused by the plastic portion of the disconnect being broken and was stopped by removing the filter.

U-shaped boot (**Fig. 14-28**). Both the gun and filter are held in place by straps with the hose protruding above the liquid cooling assembly. Bending the hose can easily exceed the force required to break the quick disconnect between the bacteria filter and the water gun if the filter is not strapped down. A test showed that a torque of 204.6 inch-pounds caused a similar quick disconnect to break in half.

Based on the torque value of 204.6 inch-pounds, a force of approximately 27 pounds applied at the hose quick disconnect interface would break the disconnect between the filter and the water gun.

The plastic parts will be replaced by steel inserts in all locations where the quick disconnects are used in the lunar module and command module.

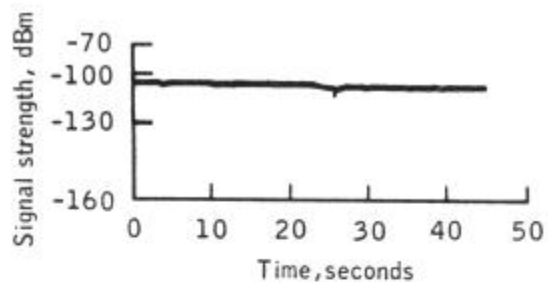
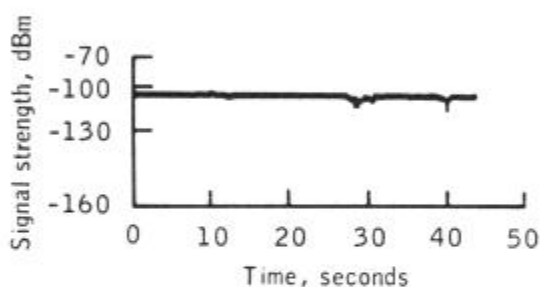
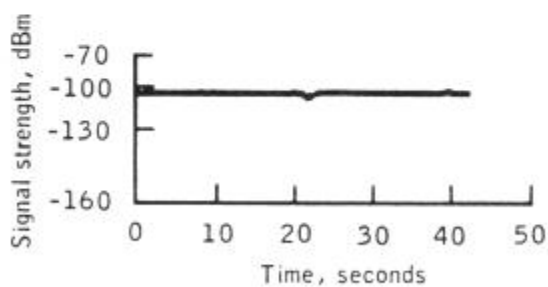
Figure 14-29.- Damped antenna oscillations at random times.

Random oscillations occurred while the steerable antenna was in the auto-track mode. The oscillations were small, and damped without losing auto-track capability (**Fig. 14-29**). The three times when the oscillations became divergent are shown in **Fig. 14-30**.

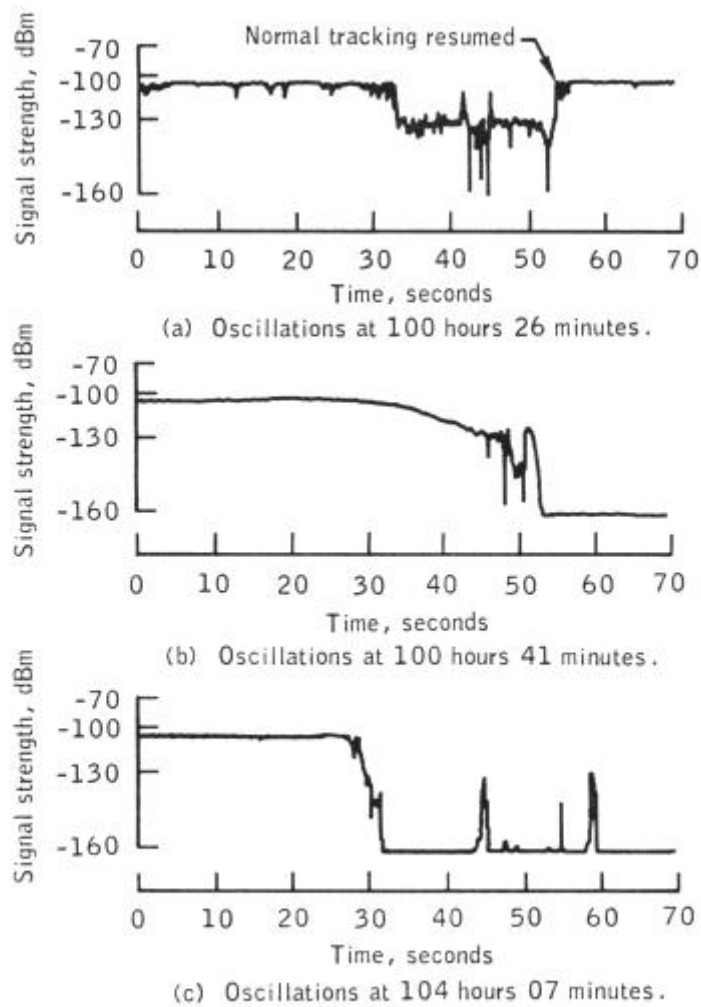
Figure 14-30.- Received signal strength plots associated with divergent antenna oscillations.

100:26 (revolution 12): This divergence occurred prior to separation and was not caused by vehicle blockage or reflections from the command and service module structure.

100:41 (revolution 12): The lunar module maneuver, performed approximately 2 minutes after separation, caused the antenna to track into vehicle blockage, which resulted in the antenna oscillation and loss of lock.

104:07 (revolution 14): Earth look angles for this time period indicate that the antenna was clear of any vehicle blockage.

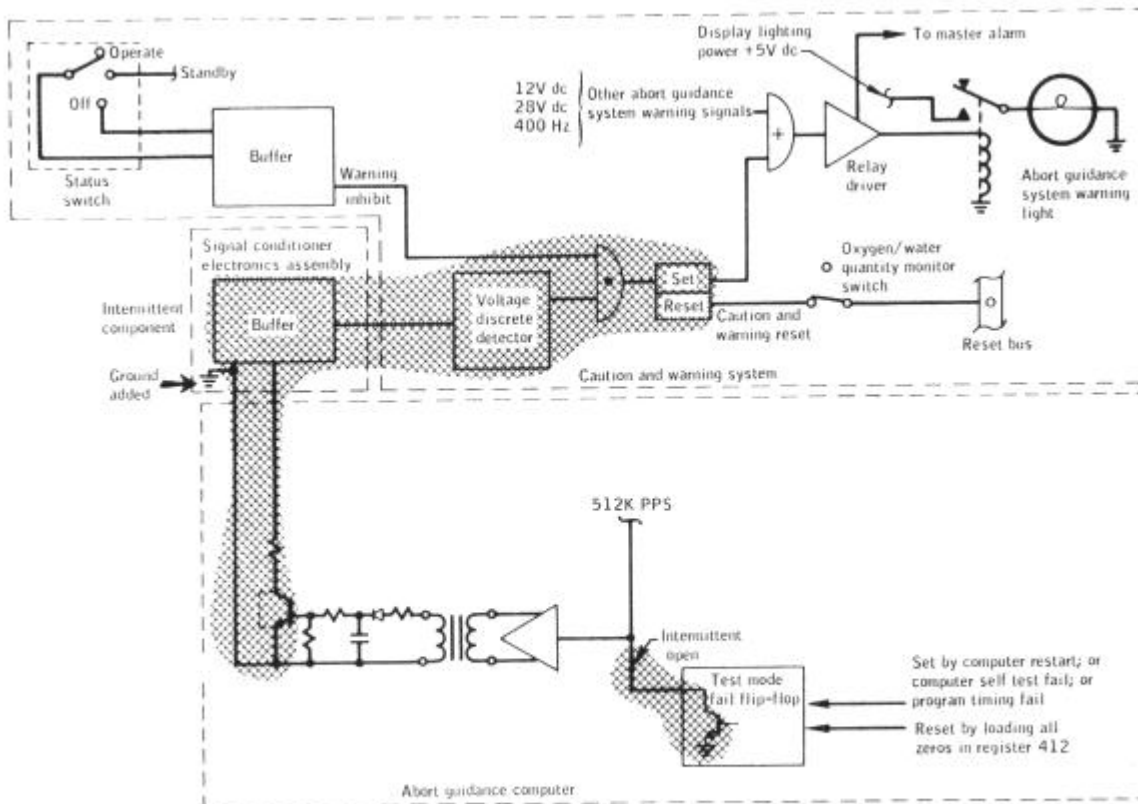
Figure 14-32.- Abort guidance system test mode fail circuitry.

The abort electronics assembly test mode fail output drives a buffer (**Fig. 14-32**) in the signal conditioner electronics assembly which, in turn supplies the test mode fail signal to the caution and warning system. The test mode fail buffer is the only application in the lunar module where a transistor supplies the input signal to the buffer and where the low side of the input to the buffer is not grounded. Tests have shown that some buffers feed back 10-kHz and 600-kHz signals to the buffer input lines. These signals are completely suppressed when the low side of the buffer input is grounded.

With the noise signal voltages present, the test mode fail driver is more susceptible to electromagnetic interference. An analysis indicates that, with worst-case noise signals present, an induced voltage spike of only about 3.5 volts will cause the test mode fail driver to momentarily turn on and latch the caution and warning system master alarm and abort guidance system warning light on.

For future spacecraft, the low side of the input to the buffer will be grounded.

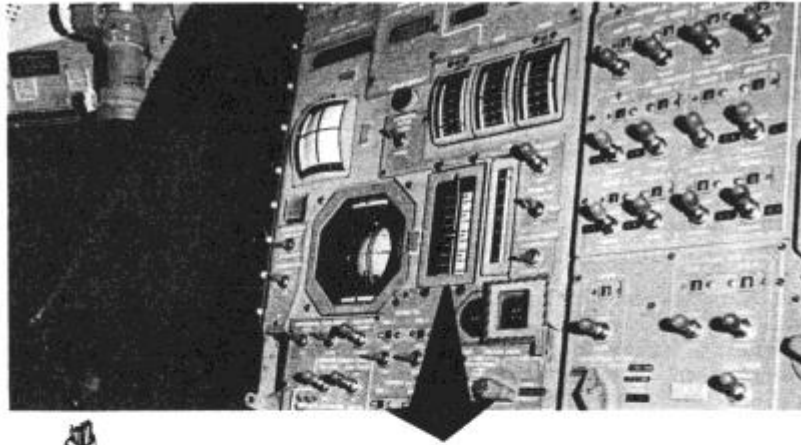
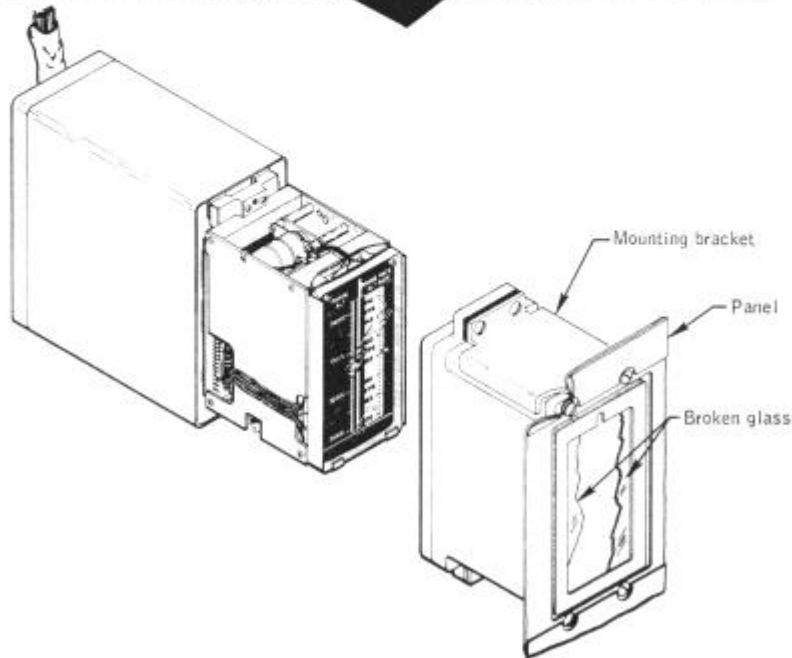
Figure 14-34.- Range/range rate meter mounting.

Sometime prior to ingress into the lunar module, the window of the range/range-rate meter broke (Fig. 14-34). Upon ingress, the crew saw many glass particles floating in the spacecraft, presenting a hazardous situation.

The window is an integral part of the meter case and is made of annealed soda-lime glass 0.085-inch thick. The meter case is hermetically sealed and pressurized with helium to 14.7 psia at ambient temperature. At the maximum meter operating temperature and with the cabin at vacuum, the pressure differential can be as high as 16.1 psi. This pressure differential is equivalent to a stress level of 6680 psi in the glass.

Glass will break when there is a surface flaw large enough to grow at the stress levels present. The threshold flaw size in a dry environment is about the same as the critical flaw size and immediate breakage occurs. The critical flaw size remains the same in a humid environment, but the threshold flaw is much smaller. For annealed soda-lime glass at a stress level of 6680 psi, the critical flaw depth is 0.0036 inch, and for a humid

For future missions, an exterior glass doubler will be added to the flaw depth to 0.0036 inch and the critical flaw depth to 0.032 inch. This should prevent future fatigue failures since there are no reported fatigue failures in soda-lime glass at stresses below 2000 psi. In addition, all similar glass applications in the lunar module and command module were reviewed and changes are being made. In the command module, transparent Teflon shields will be installed on the:

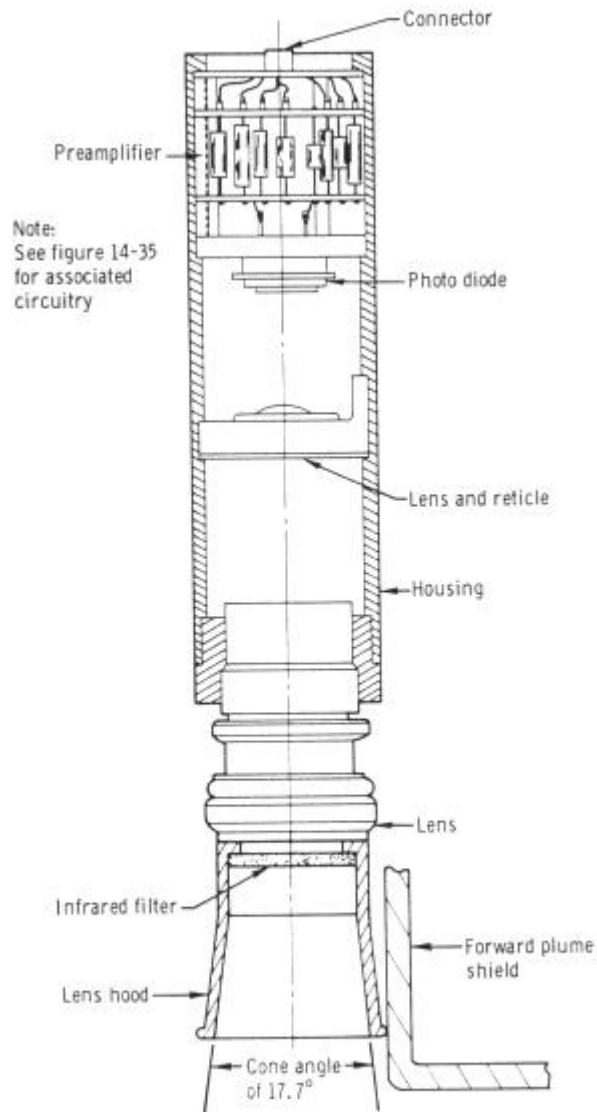
Figure 14-35.- Velocity/altitude sensor assembly.

Telemetry received from the first panoramic camera pass on revolution 4 indicated that the velocity/altitude sensor (**Fig. 14-35**) was not operating correctly.

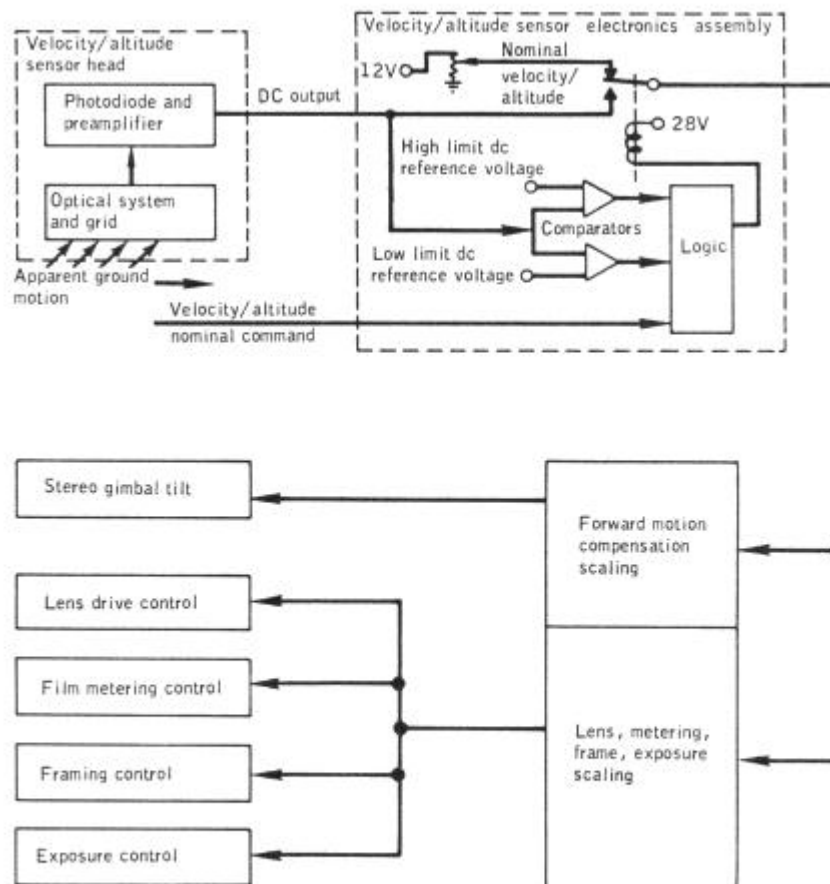
Figure 14-36.- Velocity/altitude output circuitry.

Breadboard tests and circuit analyses of the velocity/altitude electronics (**Fig. 14-36**) did not indicate failure. Tests were conducted in which endless belts of lunar scene photography from Apollo 8 and 15 were passed in front of velocity/altitude sensors. Sensors from the prototype and qualification units, and flight unit number 1 were used. By varying the illumination level, sensor performance somewhat similar to the Apollo 15 anomaly could be obtained.

The results of the tests, coupled with analyses of the basic sensor design, indicate that the problem is related to the optical signal-to-noise ratio. The remaining flight hardware will be modified to improve this ratio. The optical signal will be enhanced by increasing the lens aperture from $f/4.0$ to $f/3-5$ and by deleting the infrared filter. The optical noise (reflections) will be reduced by increasing the length of the lens hood and by repositioning the sensor so that the camera's forward plume shield will not be in the field of view of the sensor. In addition, a manual override of the velocity/altitude sensor will be provided on the remaining flight units. By using a three-position switch, two preselected velocity/altitude ratios will be provided, as well as the automatic function.
