HETA 2000-0339-2852
Group Health Associates
Cincinnati, Ohio

Evaluation of Indoor Air Quality at Group Health Associates

**Health Hazard Evaluation Report 2000-0339-2852
Group Health Associates
Cincinnati, Ohio
June 2001**

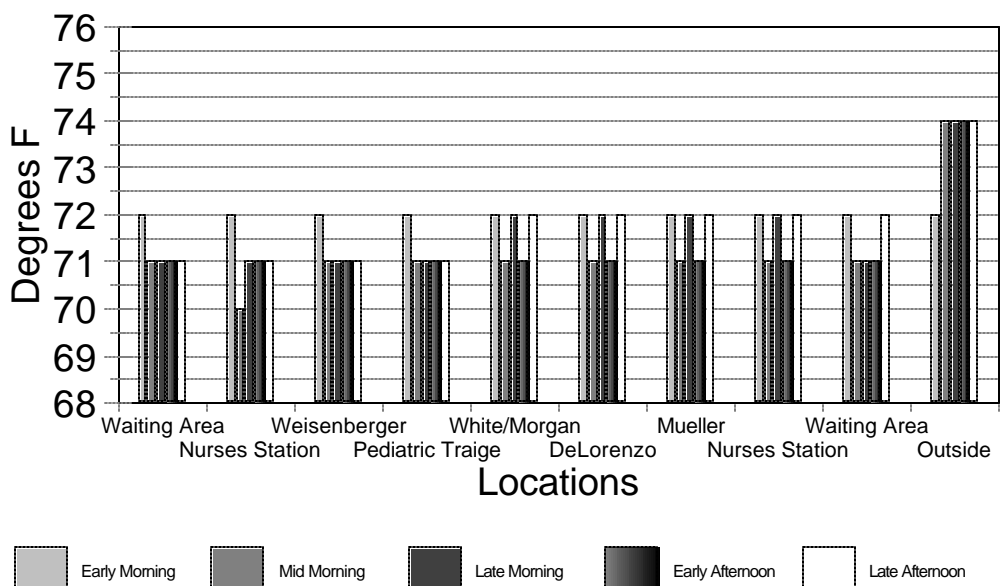
**Figure 1 - Temperature Measurements
HETA 2000-0339**

Figures 1 to 3 show the spot measurements (rounded to the nearest whole number) of temperature, RH, and CO₂. The measurements were collected between 8:00 a.m. and 4:30 p.m. As shown in Figure 1, temperatures ranged from 71 to 72°F inside and 72 to 74°F outside. It was cloudy all day. The temperatures were below the ASHRAE guidelines for the summer season. The relative humidities, presented in Figure 2, varied from 44 to 70% inside. The relative humidity outdoors was 86% in the morning and 76% in the late afternoon. The relative humidity was higher in the new area, exceeding the recommended ASHRAE guideline of 30 to 60%. The CO₂ levels are shown in Figure 3. The levels ranged from 470 to 1260 ppm inside, and 350 to 390 ppm outside. The highest concentrations of CO₂ were measured in the new addition, exceeding the NIOSH 800 ppm guideline in the pediatric waiting

The temperature measurements in both sections were cooler than the ASHRAE guideline of 73 to 79°F recommended for the summer season. This can result in individuals feeling uncomfortable.

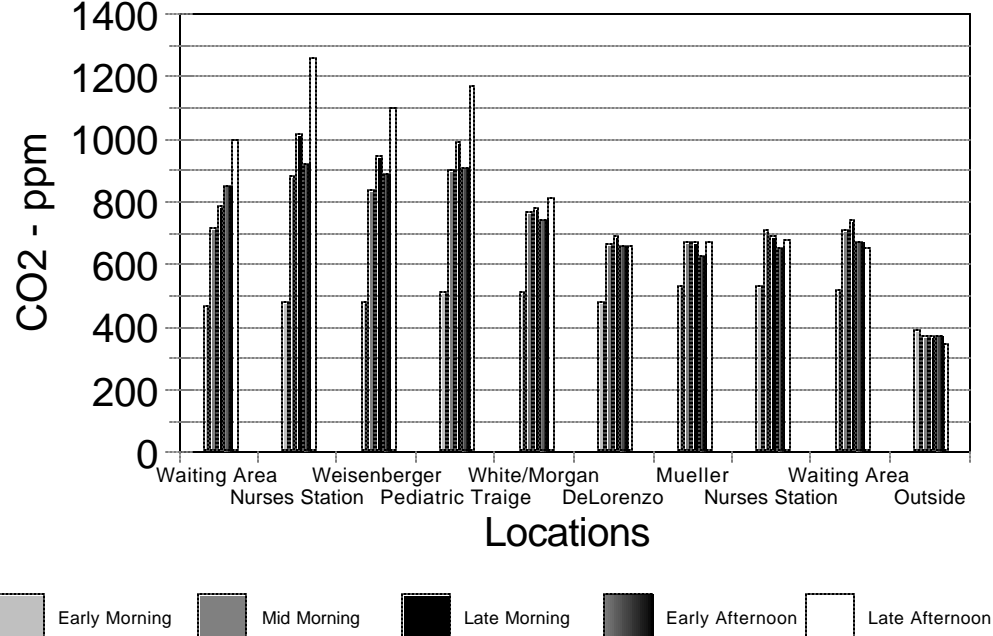
**Figure 3 - Carbon Dioxide
HETA 2000-0339**

area, the pediatric nursing station, one of the pediatrician's offices, and the Pediatric Triage area.

Spot measurements collected for CO₂ indicate that 4 of the 10 area locations had concentrations above the NIOSH guideline of 800 ppm indicating that further evaluation of the ventilation system is warranted. These locations are in the new addition and include the waiting area, the nurses' station, the pediatrician's office, and Pediatric Triage. The highest concentrations were found in the nurses' station and Pediatric Triage. Each location, except the pediatrician's office, is a patient servicing area and has the potential to be occupied by numerous visitors. The elevated CO₂

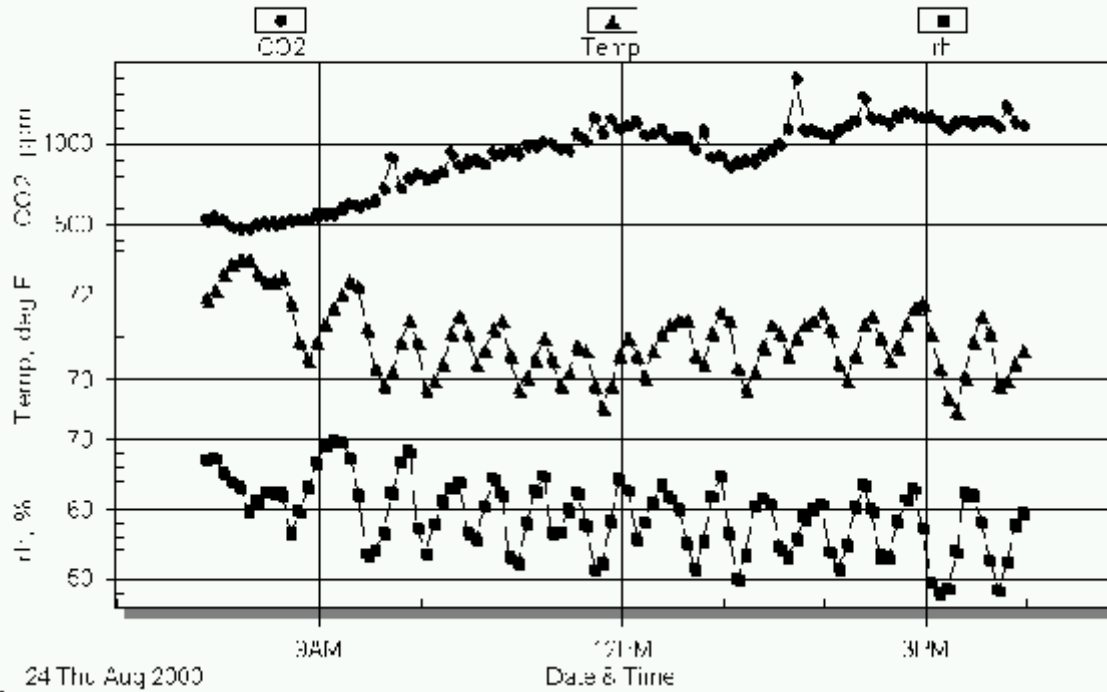
Figure 4 - Indoor Environmental Quality Measurements

The pediatric waiting area is part of the new addition. The pattern of CO₂, temperature, and RH results shown in Figure 4 is consistent with the HVAC unit cycling on and off. The CO₂ levels rose throughout the day and exceeded the NIOSH 800 ppm guideline from mid-morning through the end of the day. The temperatures were between 69 and 73°F and were outside the recommended ASHRAE temperature guidelines for summer of 73 to 79°F, for most of the day. The relative humidity levels ranged from 48 to 70%, frequently exceeding the 30 to 60 % ASHRAE guideline.

The peak relative humidity levels in the pediatric waiting area and Pediatrics Room D were above the ASHRAE recommended maximum of 60%. The RH levels in the medical records area were within the ASHRAE guidelines. Measurements collected in the adult reception area, Internal Medicine Room A, and Podiatry Room D reveal relatively stable temperature and RH values throughout the work day.

3. The thermostats controlling the HVAC units for the new addition should remain in the "on" fan mode whenever the building is occupied so that there is a constant supply of air to the offices and examination rooms. ASHRAE standard 62-1999 recommends outdoor air ventilation rates for patient rooms of 25 cfm outdoor air/person.¹⁰

4. Working with a certified ventilation engineer, changes should be undertaken for the new building addition ventilation system to correct the humidity problems. There are commercially available hybrid fan-coil units that continuously dehumidify outdoor air even when the room temperature is less than the thermostat setting.³²

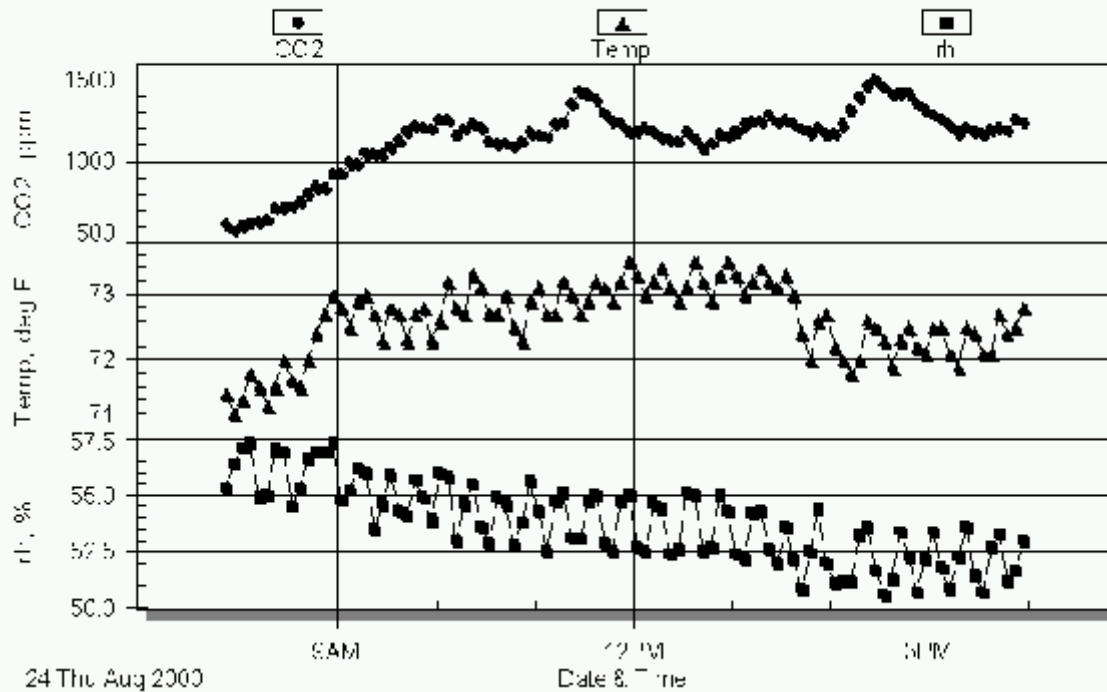
Figure 5 - Indoor Environmental Quality Measurements

Figure 5 shows the CO₂, temperature, and relative humidity measurements for the medical records area in the basement. The CO₂ levels rose throughout the day and exceeded the NIOSH 800 ppm guideline by 9:00 a.m. Temperatures and relative humidities ranged from 71 to 73.3°F and from 50 to 57.5%, respectively. It was colder than the recommended ASHRAE guideline, but the relative humidity readings were within acceptable limits.

Two small package ventilation systems were observed in a small room in the basement. These units serve all areas in the basement. Upon inspection, neither system appeared to have the capacity to introduce outside air. This offers a plausible explanation for the elevated CO₂ concentrations in the medical records room after 9:00 a.m. Visual inspection of the large HVAC unit serving the old section showed that the outside air damper was closed, preventing the introduction of outside air to that portion of the building. The small HVAC units had the capacity to bring in outside air, but we were not able to get information on outside air flow rates for comparison with ASHRAE guidelines.

2. Outside air provisions need to be made for the basement area. ASHRAE standard 62-1999 recommends outdoor air ventilation rates for offices of 20 cfm outdoor air/person.¹⁰

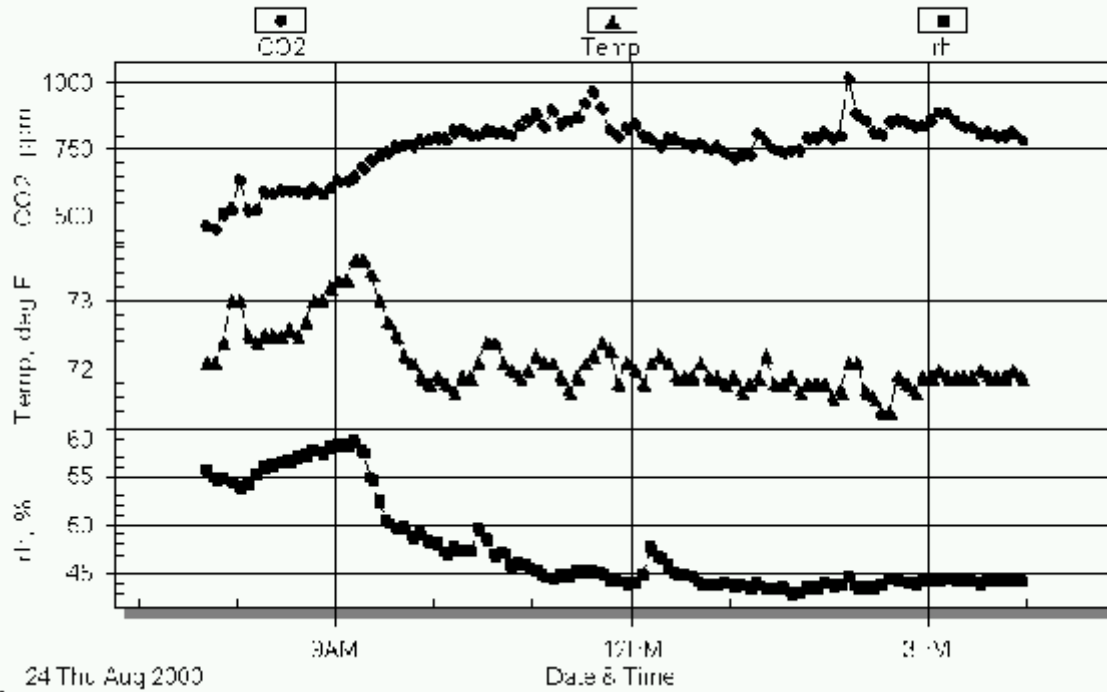
Figure 6 - Indoor Environmental Quality Measurements

Figure 6 presents the measurements for the adult medicine reception area in the original building. The CO₂ measurements ranged from 480 to 1000 ppm which exceeded the NIOSH 800 ppm guideline. The temperature ranged from 71.2 to 73.5°F, and the relative humidity ranged from 44 to 58%. Temperature readings were on the low end of the recommended ASHRAE guideline and the relative humidity readings were within acceptable limits.

1. The outside air intake for the large HVAC unit for the original building should be opened. The ASHRAE Applications Handbook recommends at least 2 air changes of outdoor air per hour for examination rooms (6 total air changes per hour [ACH] for a ventilation rate) and 5 air changes of outdoor air per hour for operating rooms on a recirculating system (25 ACH for a total ventilation rate).³¹

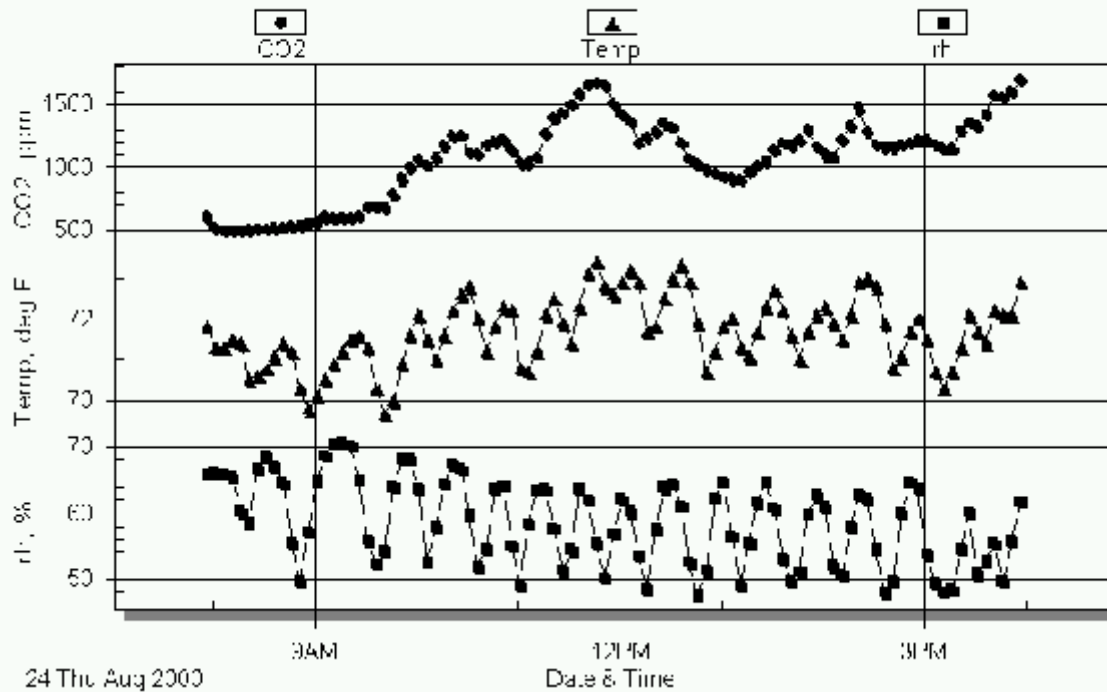
Figure 7 - Indoor Environmental Quality Measurements

Figures 7 to 9 show the data collected in pediatric, internal medicine, and podiatry/dermatology examination rooms. During the day, 7 patients were seen in the pediatrics examination room, 11 were seen in the internal medicine examination room, and 33 were seen in the podiatry/dermatology examination room. The pediatrics area is located in the new addition. The CO₂ levels ranged from 600 to 1540 ppm, the temperature ranged from 69.8 to 70°F, and the relative humidity was between 49.8 and 70%. The other two examination rooms were in the

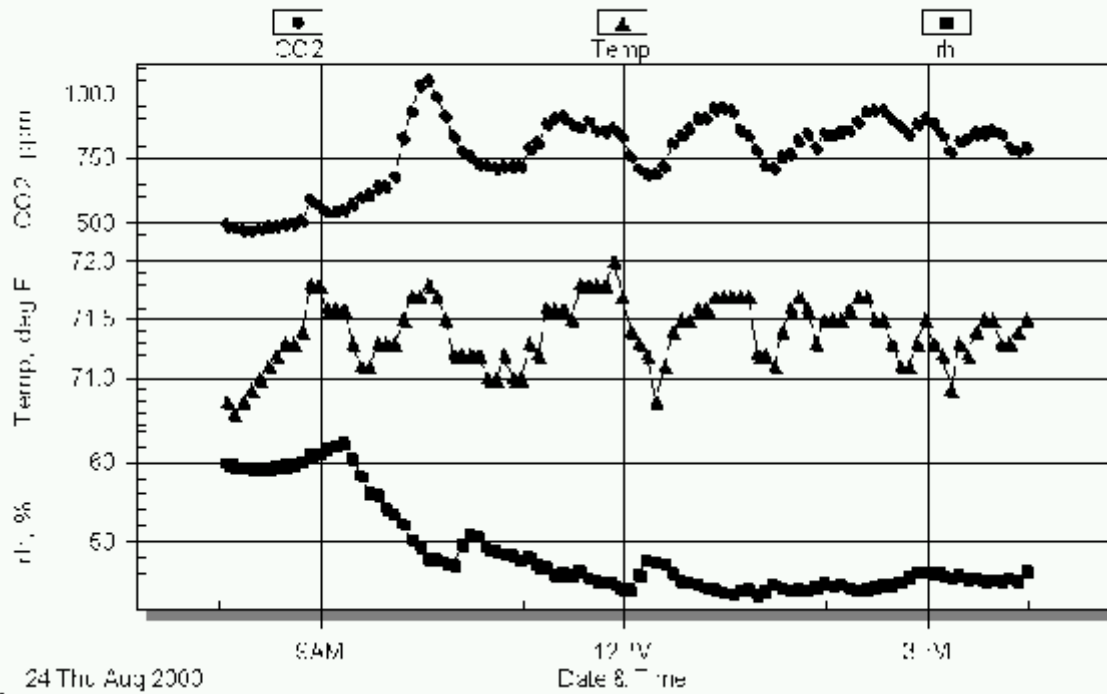
Figure 8 - Indoor Environmental Quality Measurements
Internal Medicine/Seltzer/Room A

original building. Temperature and relative humidity were better controlled in the original building; however, the internal medicine examination room was still colder than recommended for this time of year. The CO₂ levels in both rooms did exceed the current NIOSH guideline of 800 ppm. The podiatry/dermatology examination room showed a steady increase in CO₂ and temperature throughout the day.
