## **NIOSH HEALTH HAZARD EVALUATION REPORT**

**HETA #2005-0033-2984 and 2005-0234-2984  
Liberty Central School District  
Liberty, New York**

**November 2005**

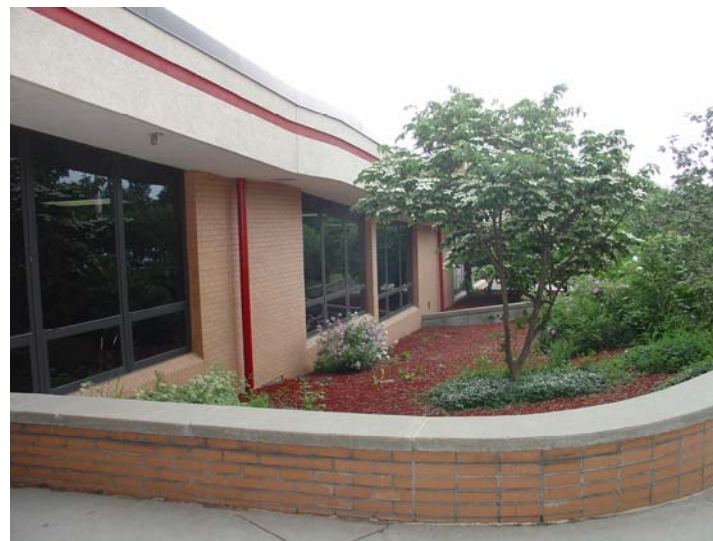
The connecting hallway between the Middle and High Schools had indications of water damage. The landscaping outside this area was graded toward the building and had no French drains or other drainage systems, according to the head custodian (Figure 4). This may allow water to flow into the building, causing water damage.

Figure 4. Corridor connecting Liberty Middle and High Schools.

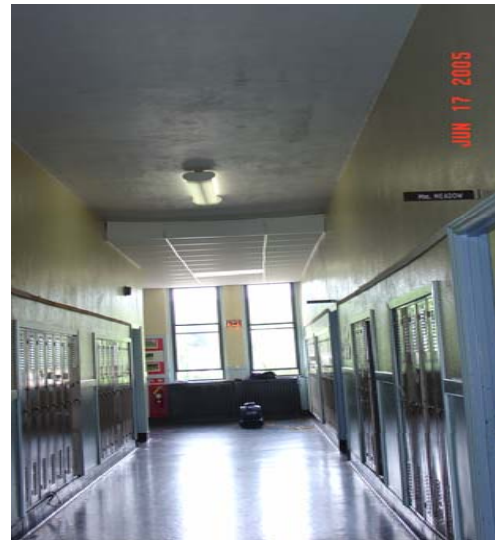
Figure 6. Bowed ceiling in Elementary School.

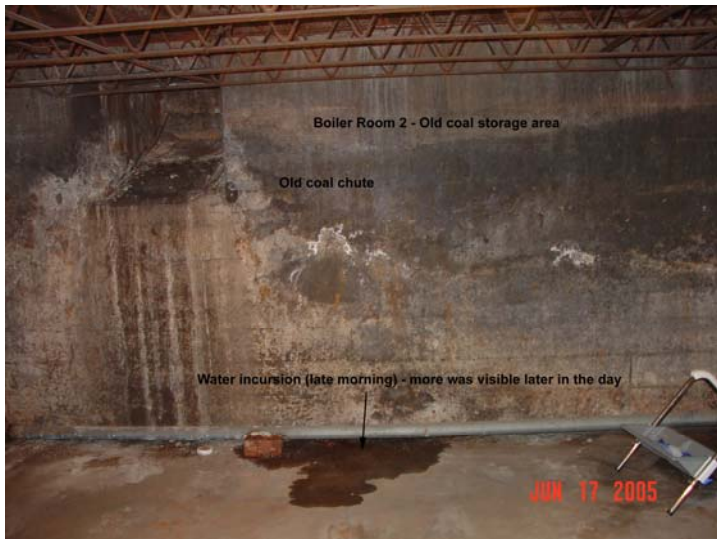
Some water stains and possible mold were found in the third floor hallway. Classrooms 33 and 37 had water stains greater than 2 ft<sup>2</sup>. Many teachers reported musty odors in their classrooms especially when entering in the morning. Steam pipe leaks were reported to have occurred in several areas of the building. Additionally, water incursion was found in Boiler Room 2, in the former coal storage area (Figure 7).

Figure 7. Water incursion in Liberty Elementary School's Boiler Room 2, old coal storage area.

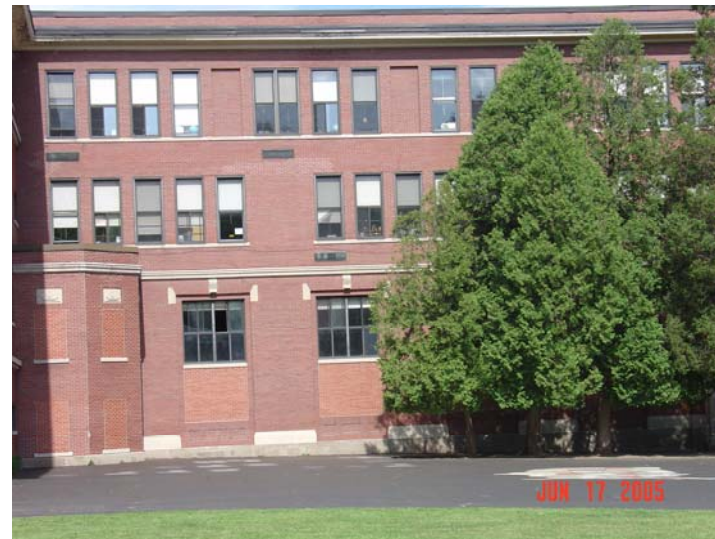
Figure 8. Liberty Elementary School's partially bricked windows in the gymnasium.

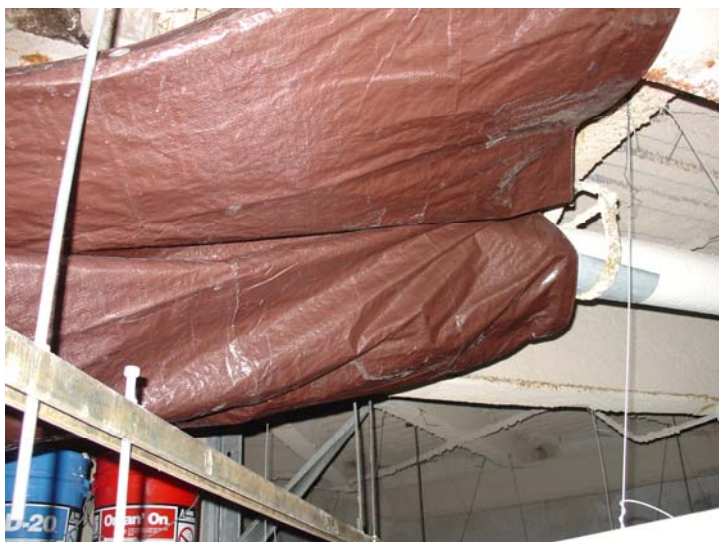
Figure 9. Tarps and buckets above the Middle School library's ceiling.

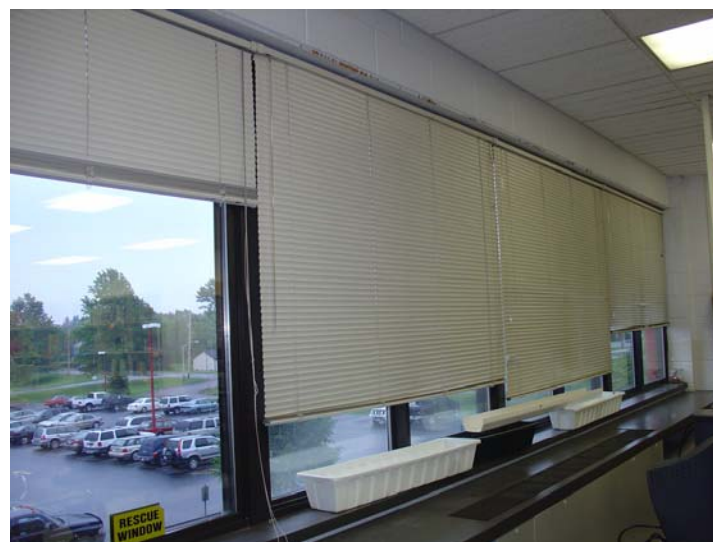
Figure 10. Containers used to collect rainwater entering the Middle School library.

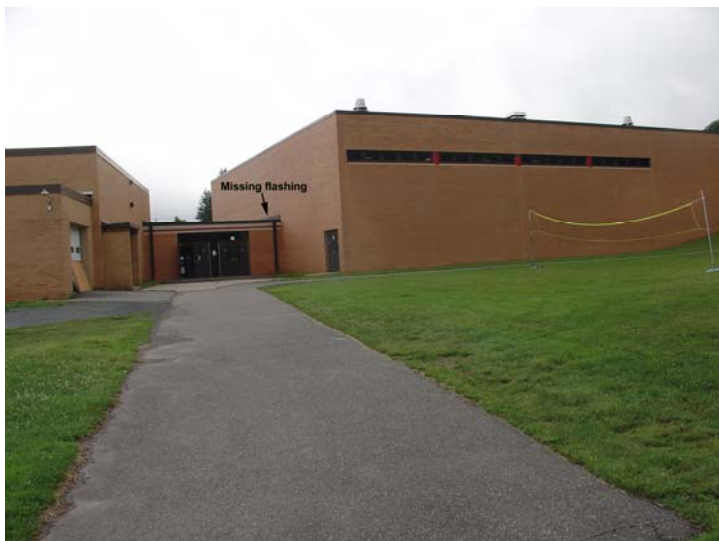
The Liberty Central School District has conducted many repairs to address the known water leaks. Improper roof flashing has been removed and re-installed. Caulking around the windows of the greenhouse was repaired on numerous occasions and sealer was applied to exterior brick in several areas to prevent leaks. Evidence of previous leaks was still in place above the drop ceiling in the library, including tarps and buckets that were used to channel and collect water from the leaking roof (Figure 9). Other signs of water incursion included a light fixture in the hallway outside the gymnasium with a hole drilled in the plastic cover to allow water to flow out of the fixture and containers on some windowsills to capture water coming in through the windows (Figure 10). Water incursion in this area may be from missing flashing above the rear entrance, near the gymnasium (Figure 11). The administrative offices in the front of the building showed

Figure 11. Missing flashing above corridor in Middle School.

- Replace flashing that was missing between the gymnasium (two-story) and hallway (one-story).
- Remove and discard the mural in the Middle School lobby. Also, remove the mold found in the stairwell near exit 6. Follow the Environmental Protection Agency or New York City Department of Health and Mental Hygiene guidelines when removing or cleaning mold-contaminated building materials or furnishings.<sup>2,3</sup>

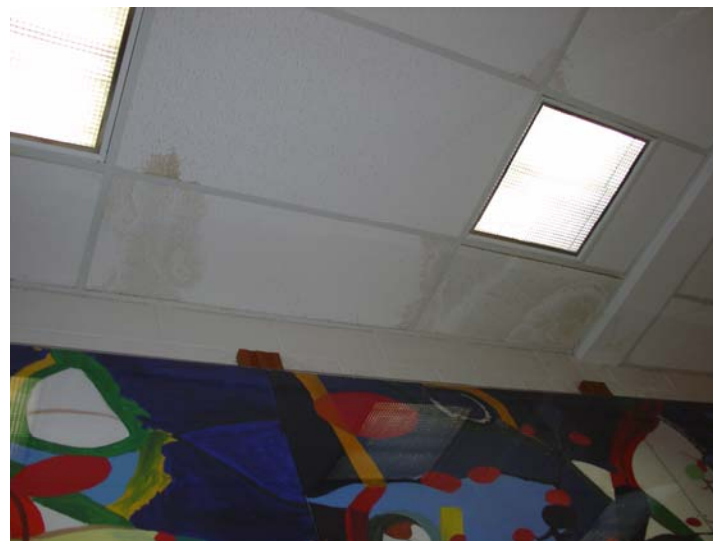
Figure 12. Water-stained ceiling tiles in the Middle School lobby.

- Replace all water-stained ceiling tiles. Teachers and maintenance staff should be instructed to watch for new stains and to report them immediately.

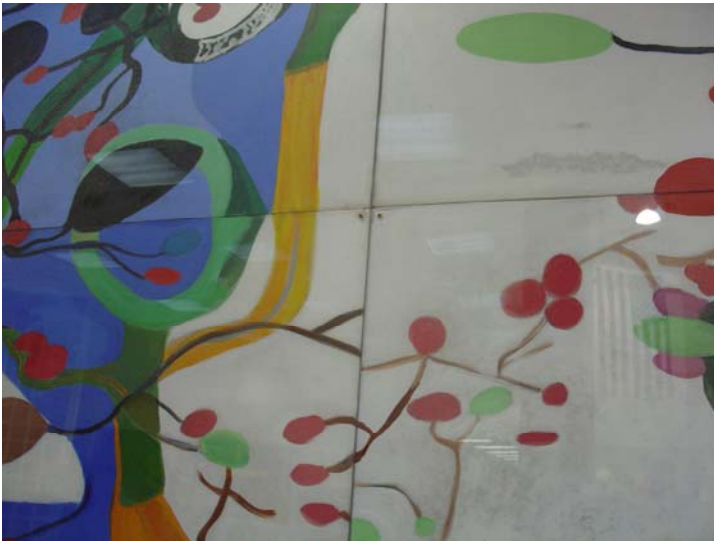
Figure 13. Likely mold growing on the mural in the Middle School lobby.

ceiling tiles in the lobby have been removed and the wall was cleaned, bleached, primed, and painted on August 19, 2005. Additionally, the mold found in the stairwell near exit 6 had been removed and the area has been cleaned. This area is reportedly prone to mold growth and should be monitored closely. A dehumidifier was purchased for the teachers' lounge, which will be emptied nightly and cleaned according to manufacturer's instructions. The head custodian also verified that the water stained ceiling tiles located next to the window in each room were likely due to leaking valves or condensation from pipes in the unit ventilators. Finally, a moldy or musty odor is still apparent in the assistant principal's office. The custodial staff was working to find the cause and is running the ventilation system in this area 24 hours a day.

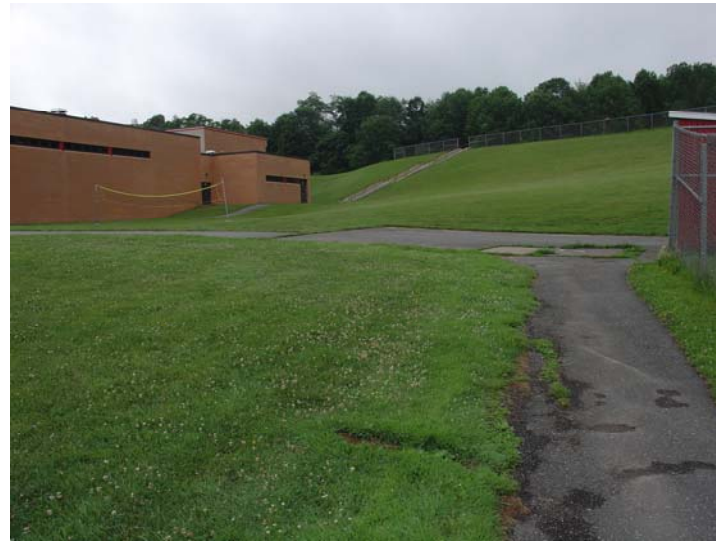
Figure 14. View of the grounds toward the back of the Middle School classroom building.

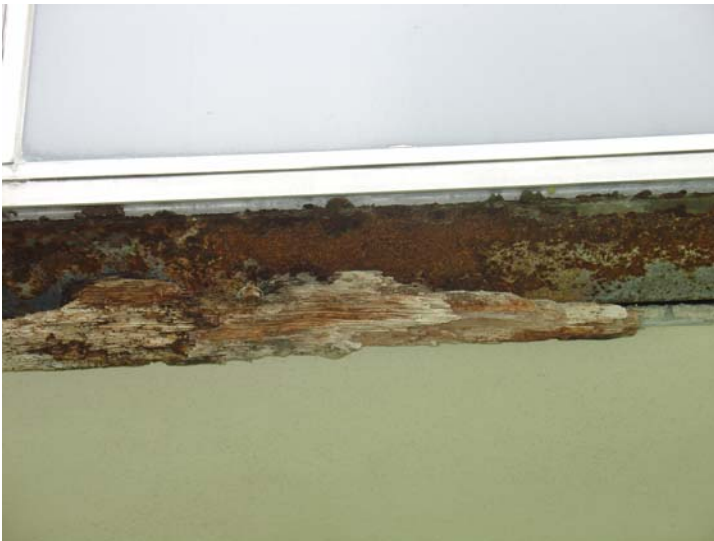
The floor and supports of the covered walkway connecting the two High School buildings had some damage (Figure 15). The walls of the walkway were curtain walls. Pieces of the aluminum bottom cap were missing and the wood support had been exposed to the elements and was rotted. We observed a hole on the underside of the walkway floor and broken glass in one window. The Facilities Director was aware of the window, which had been broken the day before our site visit.

Figure 15. Rotten wood and rust on the bottom of the High School bridge.

- Inspect and repair the bridges connecting the two High School buildings. Replace rotted wood and other damaged materials.
- Clean or replace moldy window blinds.

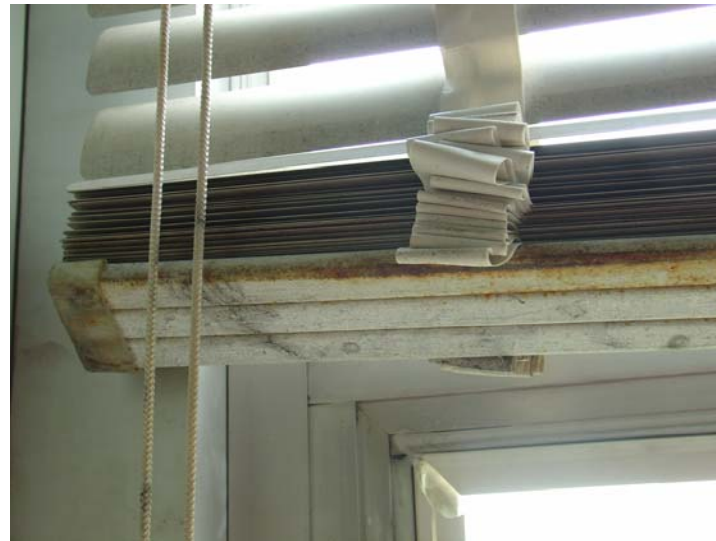
The library had rusty, and possibly moldy, window blinds (Figure 16). The rust appeared to be caused by the blinds sitting in water or staying wet for long periods. We noticed other blinds in various rooms with rust and possible mold, although not to the extent of the library's blinds.

Figure 16. Rust, dirt, and possible mold on an aluminum blind in the High School library.
