MERCURY CONTROL TECHNOLOGY ASSESSMENT STUDY

North American Philips Lighting Company  
Lynn, Massachusetts

Indepth Survey Report  
for the Site Visit of  
April 13-15, 1982

September 1982

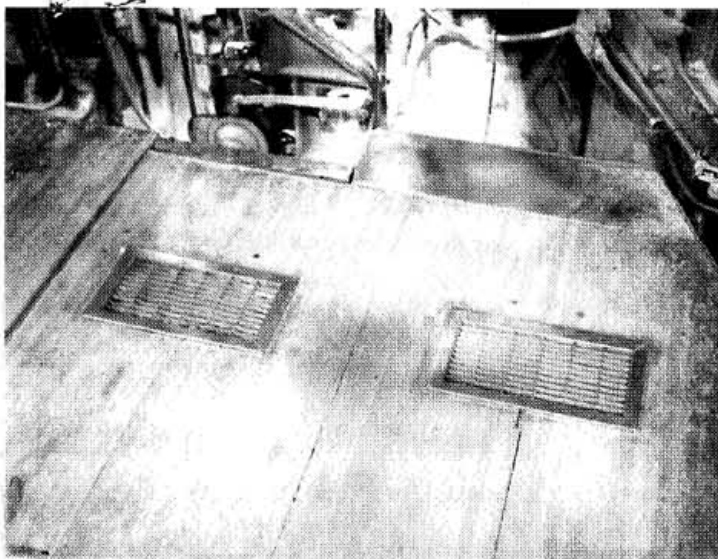
vents situated at worker breathing zones and underneath working platforms (Figure 2).

Figure 2. Supply Air Vent from Underneath Working Platform

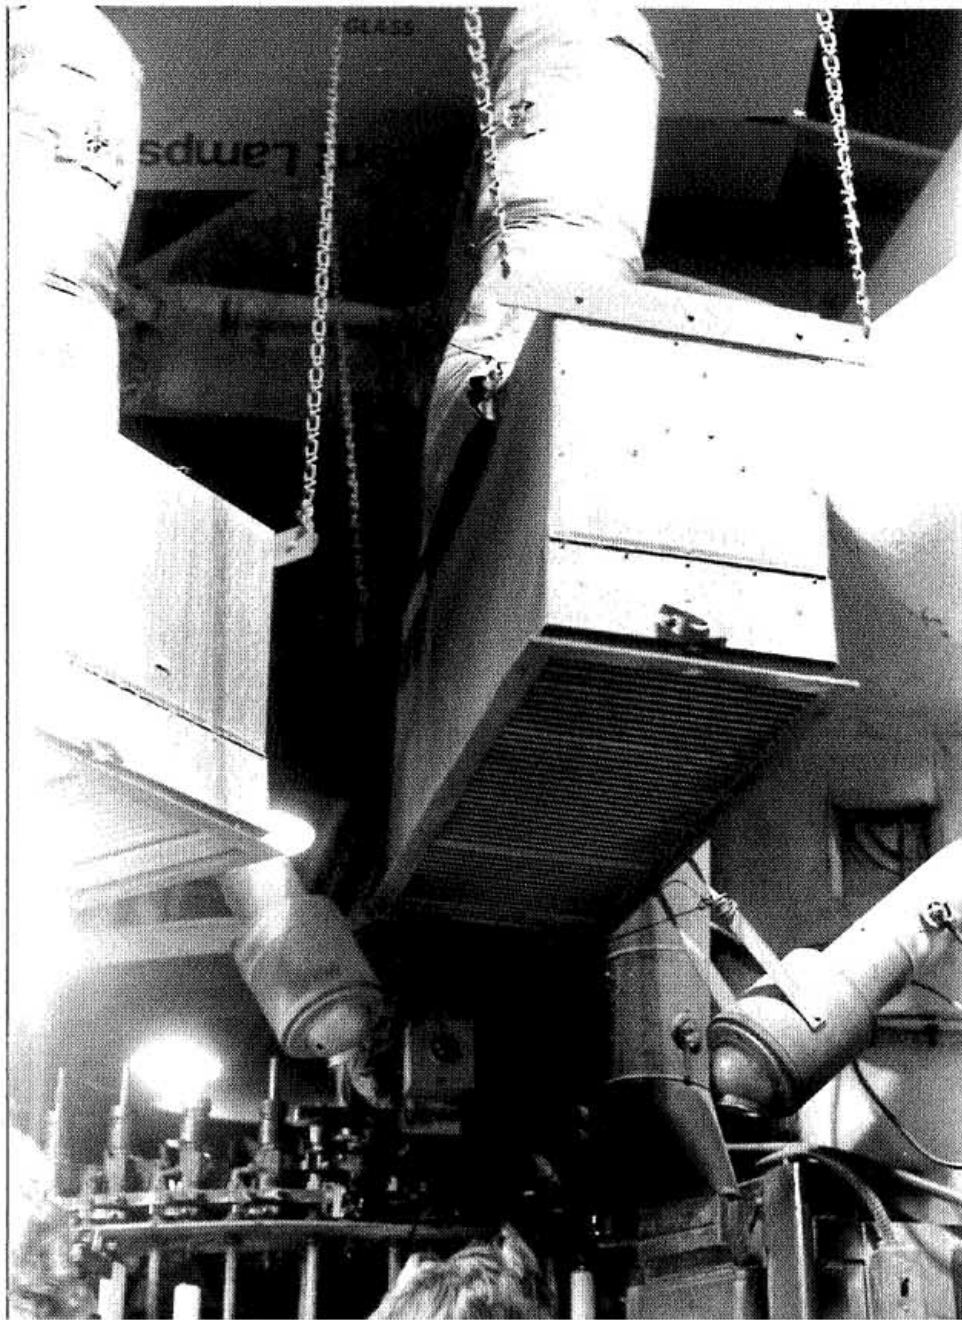
Velocity readings taken at the adjustable 2-inch circular supply vents on the personnel cooling air system using a thermoanemometer averaged 3,580 fpm. This results in 78 cfm of local supply air at each worker's breathing zone. Additional local supply air in the same area is provided by two vertical rectangular diffusers (1.9 and 2.8 square feet) with measured airflows of 579 and 823 cfm, respectively (Figure 4).

Figure 4. Local Supply Air Diffusers.
