**Memorandum**

Report on Compliance with Health and Safety Standards at Native American  
Head Start Facilities (A-09-91-00134)

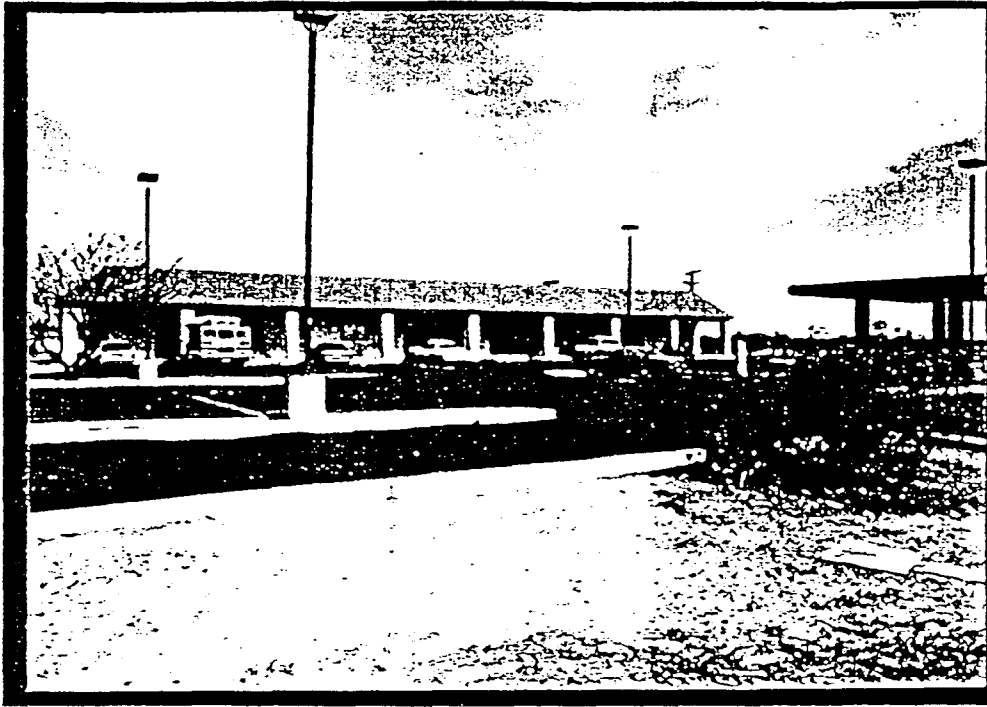
51st Avenue Facility - Komatke, Arizona  
Gila River Indian Community

location since December 1986. During this entire period the facility has been using an asphalt parking lot as a playground. All reports reviewed for this facility, including November 1988, February 1990 and March 1991, cited the need for a fenced, outdoor playground. The March 1991 health and safety inspection report comments that, "No longer should the term 'temporary status or location' be used as a shield to avoid or hinder correcting deficiencies to meet national Head Start standards." A photograph of this facility and its playground is shown at Appendix B-1.

Commercial Building  
Head Start Facility is on Left  
Gas Station/Convenience Store is on Right
