United States-
Environmental Protection
Agency

CHEMICAL ACCIDENT INVESTIGATION REPORT

TERRA INDUSTRIES, INC. NITROGEN FERTILIZER FACILITY PORT NEAL, IOWA

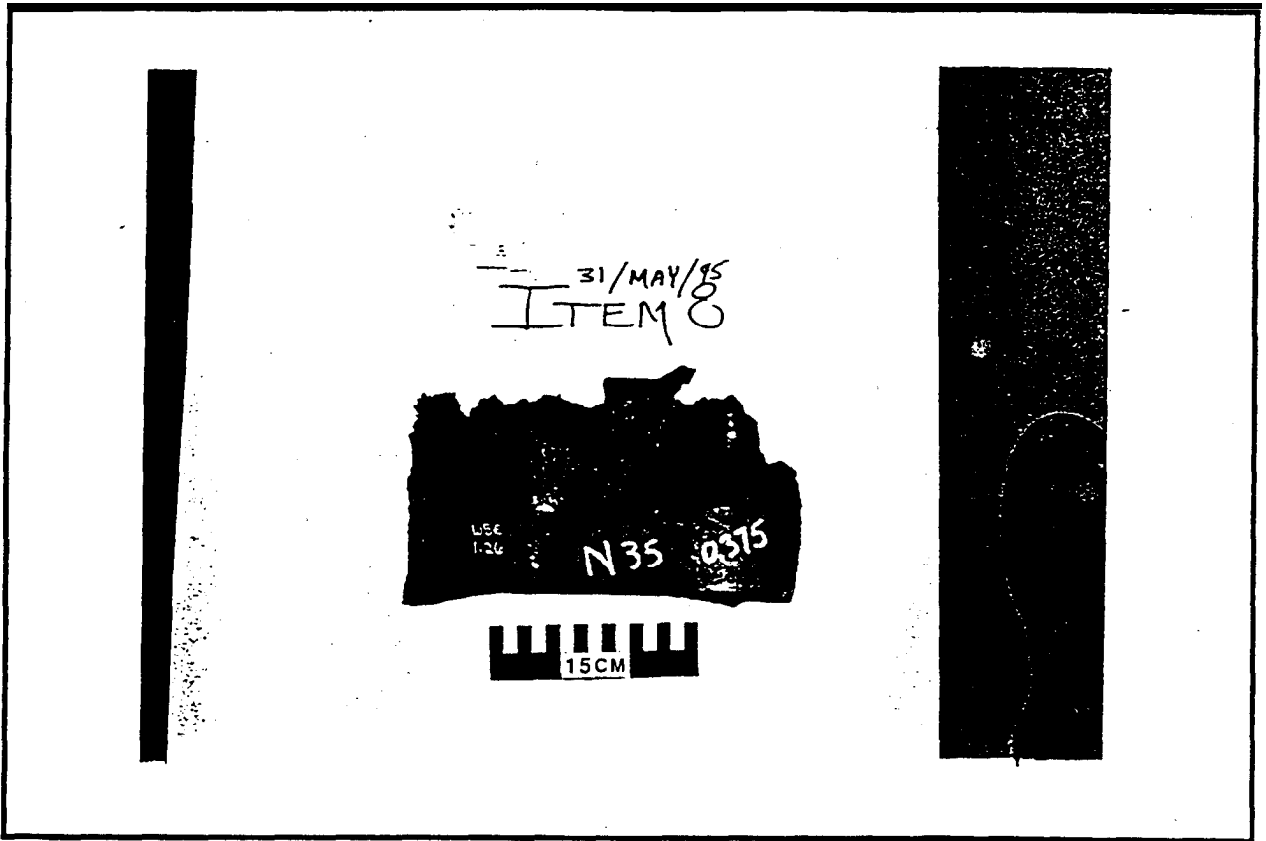
Photo 7 - 2
Neutralizer Fragment

Metallurgical analytical results indicated that the fragment displayed a high-temperature discolored surface and severe erosion in one direction (*Photo 7-2*). The adjacent area showed little discoloration. The opposite surface exhibited severe tearing and fracturing with evidence of high-temperature discoloration (*Photo 7-3*). Unetched cross sections exhibited high-temperature oxidation on the inside diameter with severe surface tearing/seams or laps. The etched cross-sections displayed evidence of severe surface movement and cold working with a one-directional heavy force. Of the fragments analyzed, metalographic analysis suggests that the highest temperature, internal pressure and velocity was located in the area of Item #8. This sample exhibited the most severe surface distortion and high-temperature grain structure change.
