# **EPA CHEMICAL ACCIDENT INVESTIGATION REPORT**

**Powell Duffryn  
Terminals, Inc.  
Savannah, Georgia**

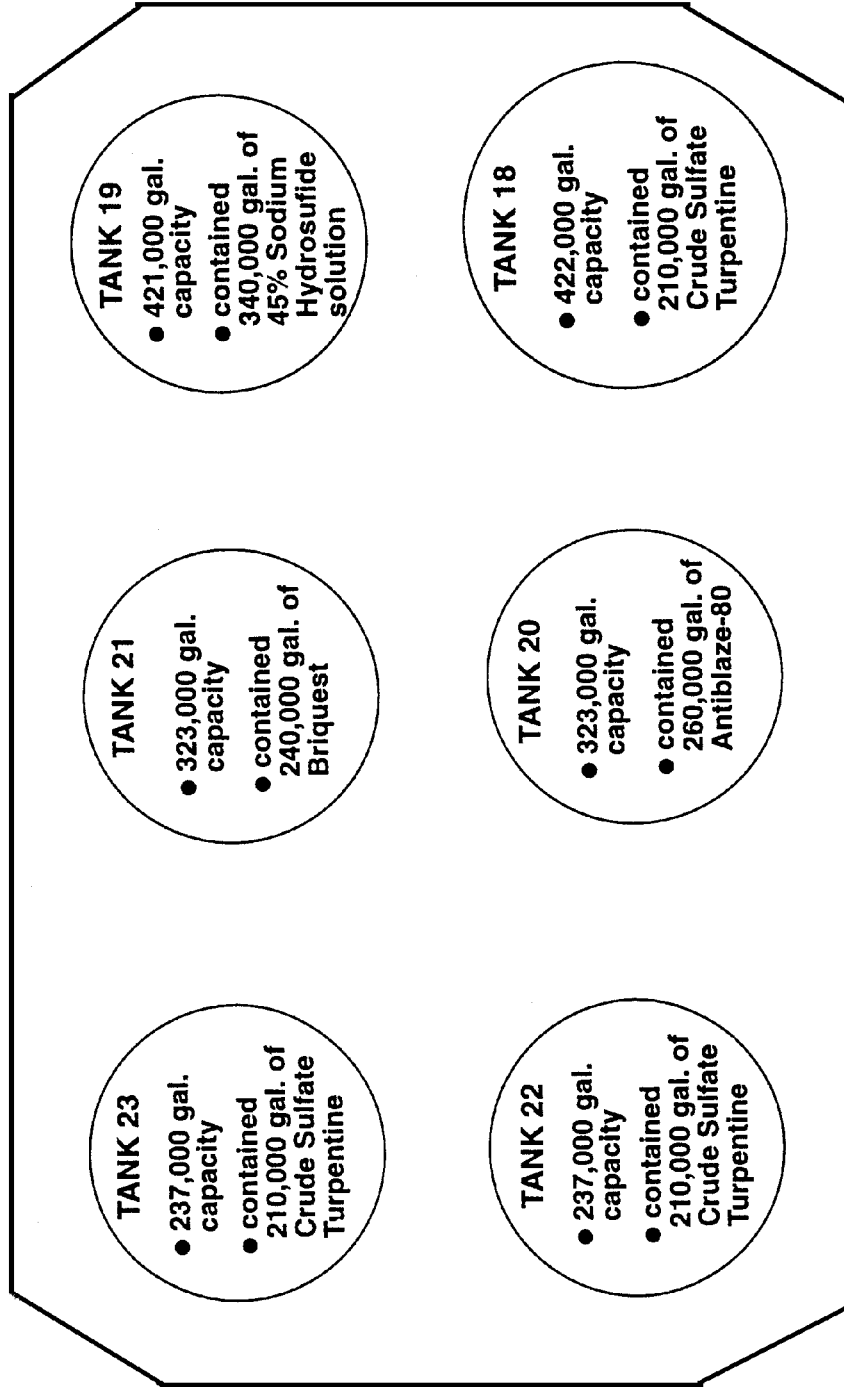
**Exhibit 2**  
**Six-Tank Enclosure, Site of Fire**  
**(100 x 200 feet, surrounded by 5-foot Concrete Berm)**

Sodium hydrosulfide solution, stored in the same enclosure, is strongly alkaline (pH of 10.4 to 11.5) and corrosive. When sodium hydrosulfide is exposed to heat or mixed with an acid (e.g., Briquest), hydrogen sulfide, a toxic gas, can be produced. During the fire hydrogen sulfide was probably produced as a result of the heat from the fire. Since hydrogen sulfide is combustible, hydrogen sulfide produced from heating was probably consumed in the fire. After the fire, the reaction between the sodium hydrosulfide solution and acids in the enclosure area is most likely the source of the hydrogen sulfide released at the PDTI site. As shown in Exhibit 2, Tank 19, containing sodium hydrosulfide, and Tank 21, containing Briquest, were located next to each other in the enclosure.<sup>15</sup>

- Incompatible chemicals were stored in the same walled enclosure area. Sodium hydrosulfide solution was stored in the same enclosure area as acidic cleaning solution resulting in production of toxic hydrogen sulfide vapor when the tanks leaked. The toxic hydrogen sulfide release caused injuries, forced extended evacuations, and hampered response and cleanup.

- Facilities should examine process and storage areas and equipment to ensure that potentially incompatible substances are kept separated. Leaks or spills of incompatible substances from equipment should not go into the same containment or other areas as a result of fire or other incident.

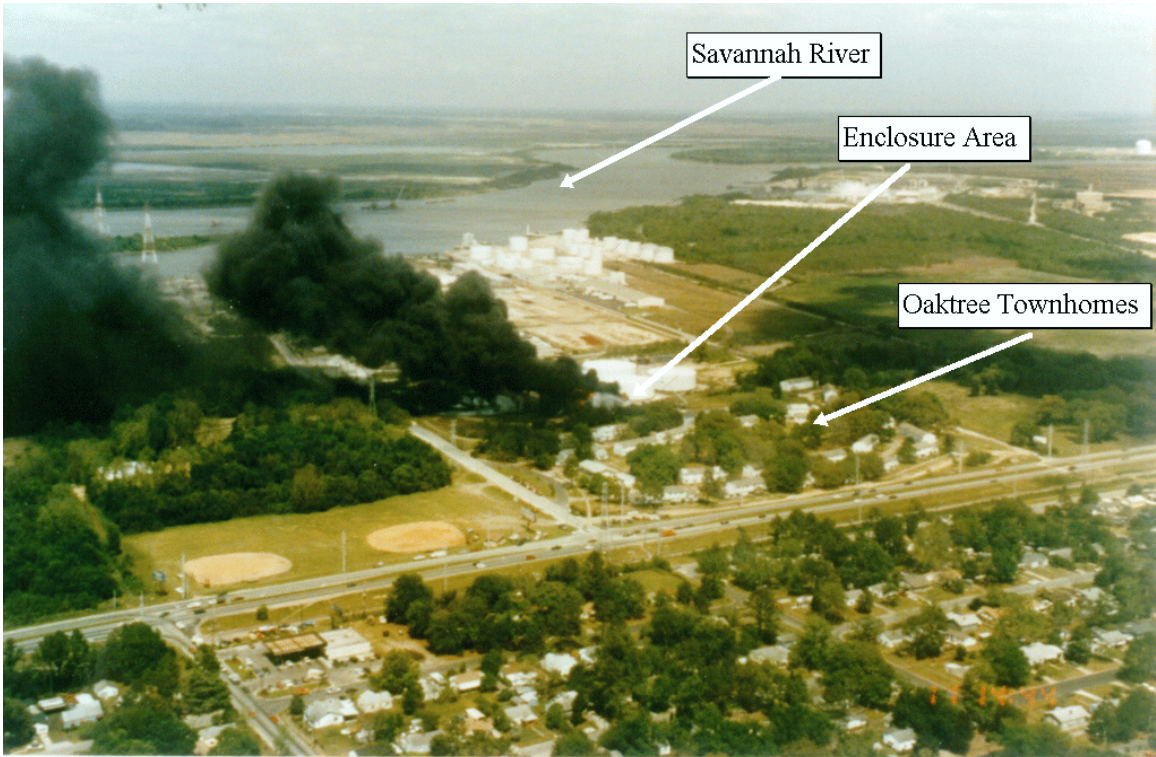
**Exhibit 8**  
Area of Fire and Savannah River <sup>29</sup>

River in relation to the fire in the six-tank enclosure area can be seen in the photograph in Exhibit 8. The fire burned on and off for approximately three days before being extinguished late on April 12, 1995.<sup>3, 30, 31, 32</sup> The three tanks containing CST (18, 22, and 23) were destroyed, and the other three tanks in the six-tank enclosure were damaged. The company's office building, located about 100 yards north of the enclosure, was also destroyed in the fire. Some of the large tanks to the north and east of the enclosure area suffered some degree of radiant heat and smoke damage, but none of them leaked as a result of the damage.<sup>7</sup> Some of these large tanks are shown in Exhibit 9.

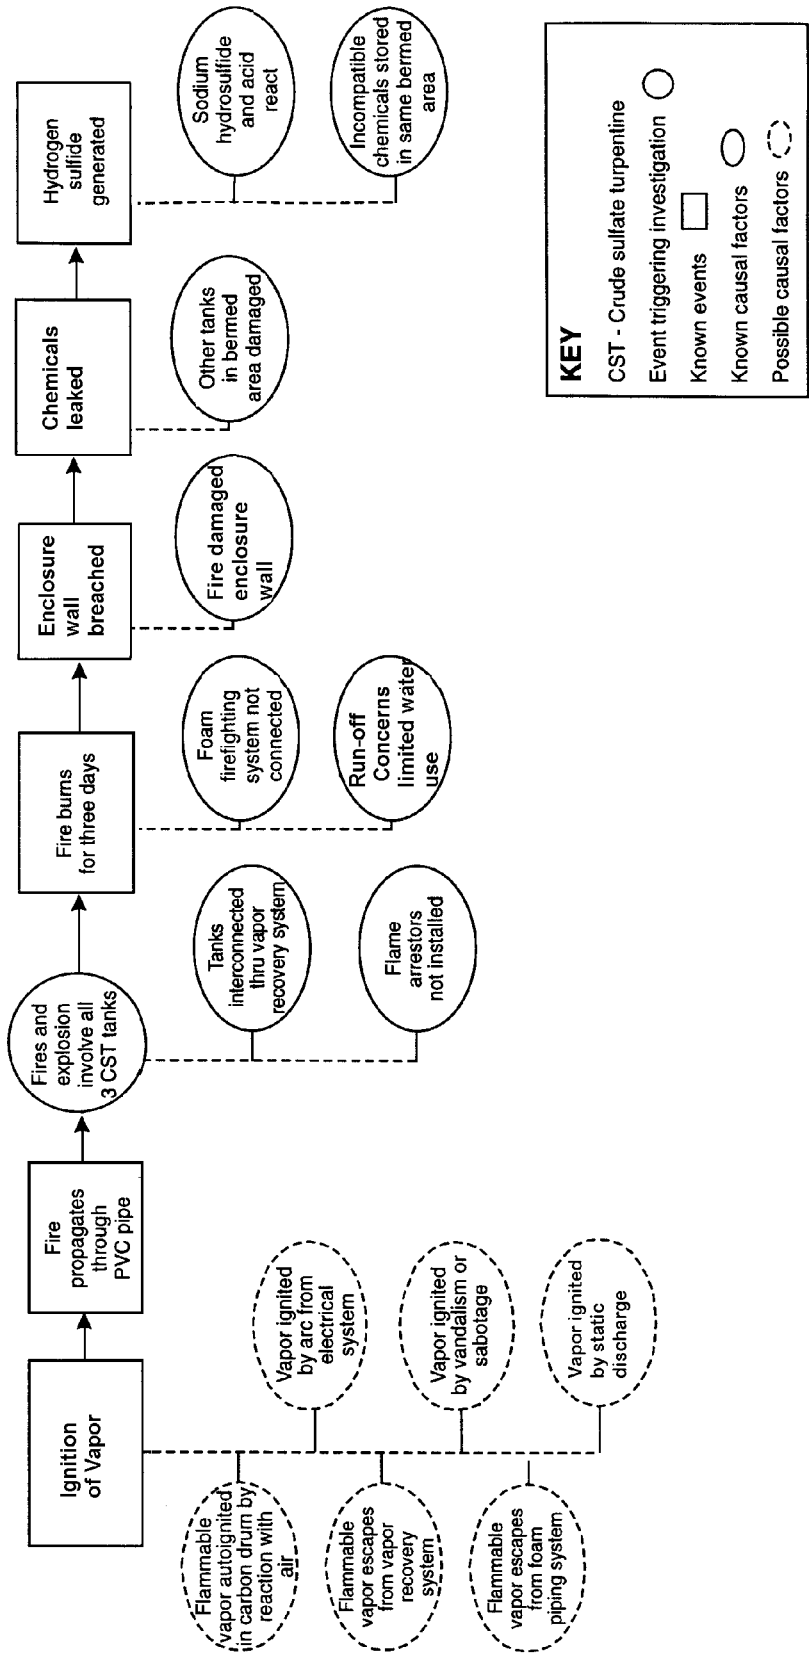
An Event and Causal Factors Diagram for the PDTI accident is presented in Exhibit 10. This diagram presents the sequence of events and causal factors that may have contributed to the occurrence of each of the events. Possible scenarios for immediate cause of the accident, and contributing factors are discussed below. They are included in the Events and Causal Factors Diagram.

The CAIT concludes that the most likely cause of the incident at the PDTI facility was ignition of CST vapors in the carbon adsorption drums due to the inadvertent addition of atmospheric air. The fire then traveled back to the storage tanks through the vent piping, igniting the contents triggering explosions and fire.
