General  
Technical  
Report  
FPL-GTR-161

# Feasibility of Using Building Deconstruction at Wisconsin's Badger Army Ammunition Plant Salvaging Lumber for Reuse in Low-Income Home Construction

Robert H. Falk

December 2005

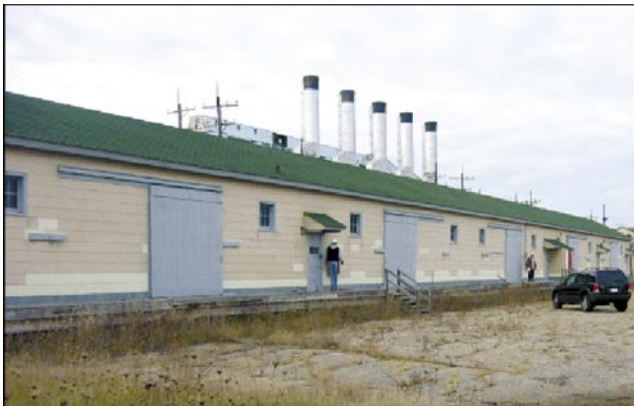
Figure 3—Type 2 similar warehouse 507-4.

Building 507-4 (Fig. 3) was qualitatively rated 8 for deconstruction potential and was considered for further analysis. This building has a raised wood floor structure with minimal interior partitions and finishes.

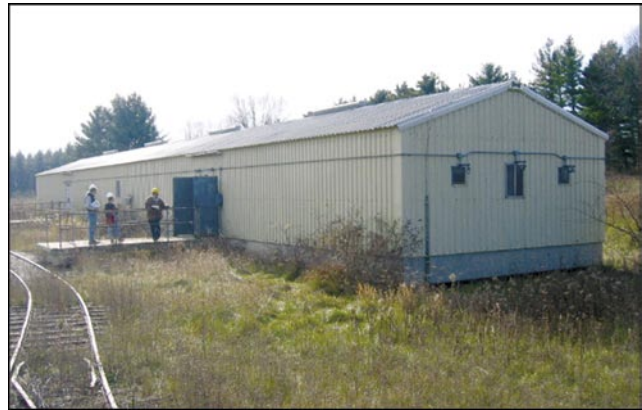
Figure 8—Type 5 alternate–1750-26 rest house.

Building 1750-26 (Fig. 8) is a metal frame and cladding on concrete slab. The slab contains mastic that may be an asbestos-containing material. The metal frame and exterior skin are either entirely recyclable or are able to be dismantled and reassembled elsewhere. Building 1750 was qualitatively rated 8 for deconstruction potential but was not considered for further analysis because we lack data on dismantling metal buildings.

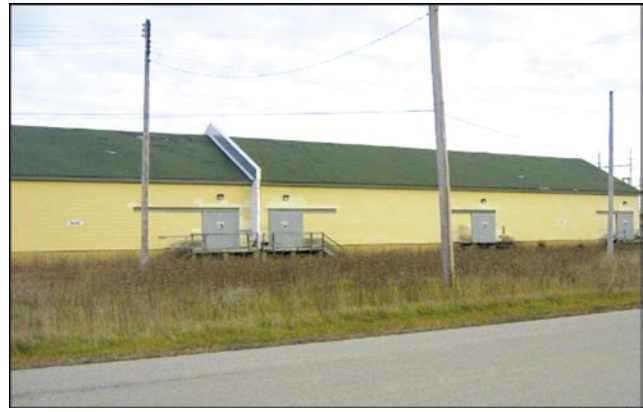
**Figure 10—Type 6 similar–3000 pulp and cotton warehouse.**

Building 3000 (Fig. 10) is on a raised concrete slab and has large dimensional lumber in roof trusses and no interior partitions or debris. This building was qualitatively rated 8 for deconstruction potential and was considered for further analysis.

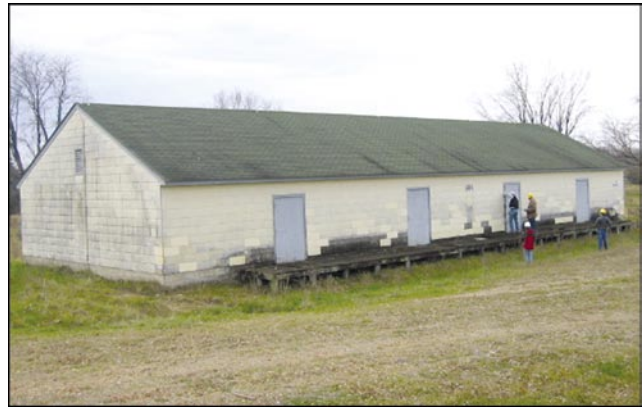
Figure 12—Type 7 similar—1932-32 magazine, cannon.

Building 1932-32 (Fig. 12) interior is entirely unpainted, salvageable lumber with a concrete slab. This would be an excellent building for volunteer or low-skill laborers. This building was qualitatively rated 9 for deconstruction potential and was considered for further analysis.

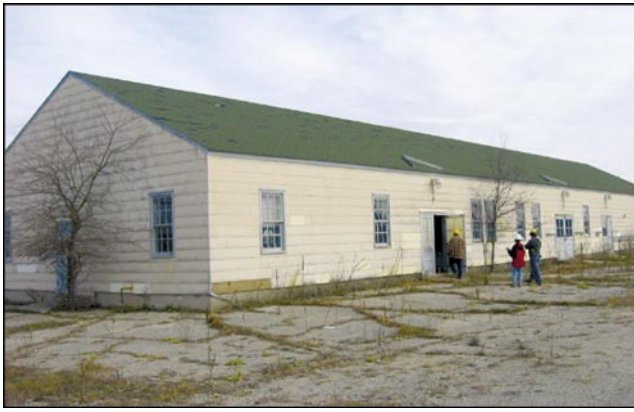
Figure 15—Type 10-6822 maintenance shop.

Building 6822 (Fig. 15) has an exposed roof structure with plywood sheathing with a concrete slab. The exterior sheathing is granule asphalt material over suspect friable asbestos fiberboard. This building was qualitatively rated 6 for deconstruction potential and was considered for further analysis.

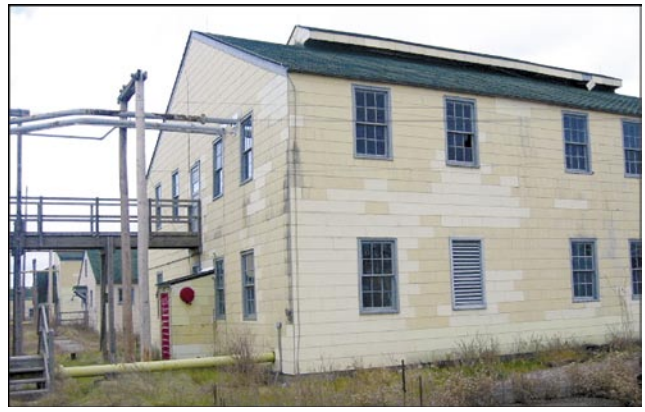
Figure 16—3022 beater house.

Building 3022 (Fig. 16) was qualitatively rated 3 for deconstruction potential and therefore not considered for further analysis. This building has water damage, a high degree of entanglement, and all wood surfaces are painted with what we assume is lead-based paint.

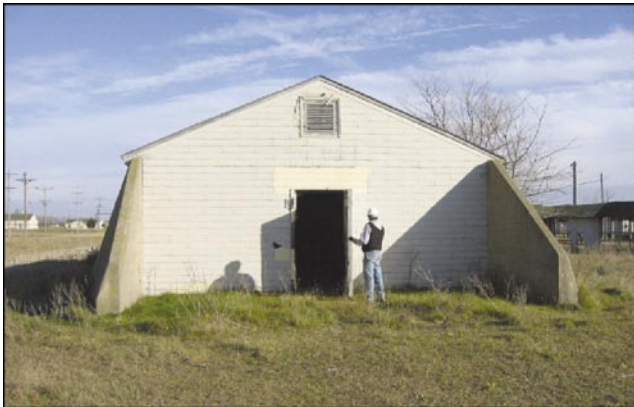
Figure 17—6586-5 inert storage.

Building 6586-5 (Fig. 17) has three of four exterior walls of poured concrete, the roof structure is salvageable, and sheathing on the one wood-frame wall is asbestos-containing material. Building 6586-5 was qualitatively rated 3 for deconstruction potential and therefore not considered for further analysis.

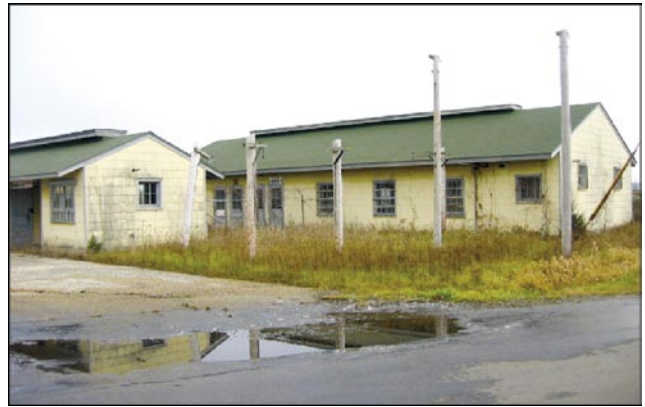
Figure 18—6543-5 gatehouse.

Building 6543-5 (Fig. 18) is a simple one-story building with a high proportion of interior finishes to salvageable lumber. This could be a good building for volunteer or low-skill laborers. Building 6543-5 was qualitatively rated 4 for deconstruction potential and was not considered for further analysis.
