Executive Analysis and Flume Study of the Rock Cross Vane

Authors: Paige R. Puckett and Dr. Gregory Jennings, Department of Biological and Agricultural Engineering

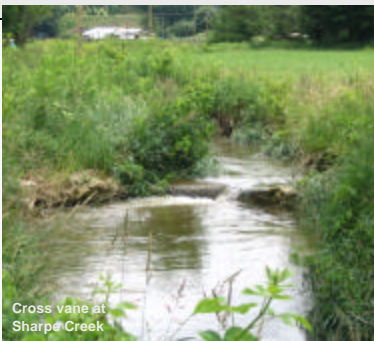
Cross vane at Sharpe Creek
