General
Technical
Report
FPL-GTR-177

Condition Assessment of Main Structural Members of Steam Schooner WAPAMA

Xiping Wang
James P. Wacker
Robert J. Ross
Brian K. Brashaw

June 2008

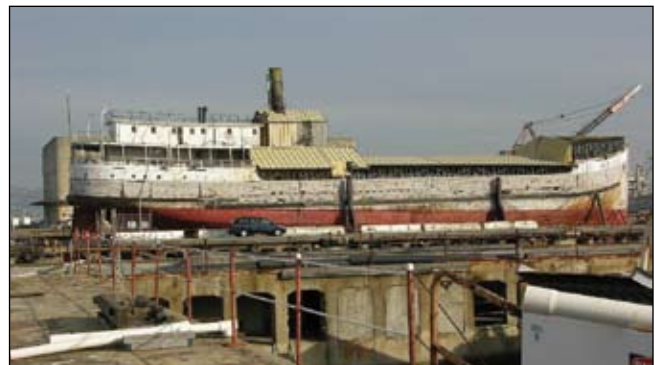
In 1980, the vessel could no longer remain afloat due to severe deterioration and was hauled out of water and placed on Barge 214, berthed at Pacific Drydock Co., Alameda. Since that time, the WAPAMA has remained on the barge and received limited maintenance. Currently, the vessel resides on Barge 214 in a flooded graving dock at the Richmond Reserve Shipyard in Richmond, California, and is unsafe for public access (Fig. 2).

Figure 2. A recent photo of the WAPAMA placed on Barge 214 at Richmond Reserve Shipyard in Richmond, California.

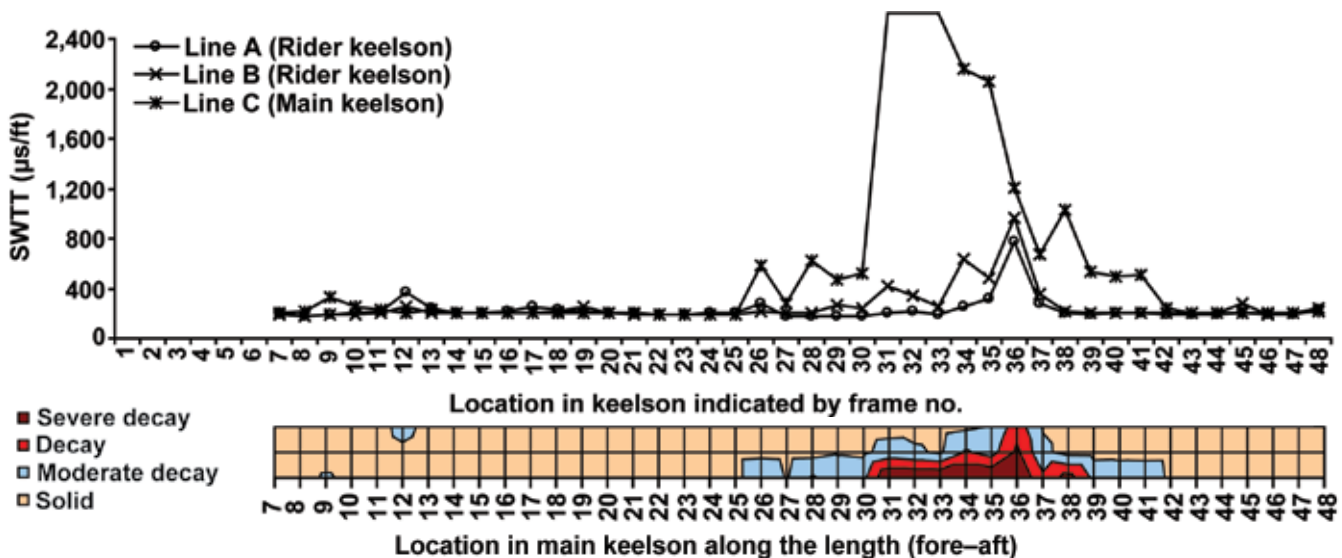
Figure 7. Distribution of stress wave transmission time (SWTT) and mapping of physical conditions of the keelsons.

The deterioration of the keelsons is concentrated between frames 25 and 42, and most severe decay occurred on the main keelson timber between frames 30 and 39. This is also confirmed by micro-drilling resistance tests. Rainwater likely entered this area through the hatch over the years due to failed weather protection and water remained trapped. Water damage in the untested portion of the main keelson between frames 30 and 39 and even beyond could also be significant. Deterioration could be further extended and advanced with the current outdated weather protection.

No significant deterioration was found between frames 7 and 25 according to stress wave scanning results. The tween deck, which extends from frame 11 to the forward end of the hatch at frame 26, has apparently protected the keelsons from direct exposure to rainwater dripping from above (through main decking). The micro-drilling resistance test revealed isolated internal rot (5.5–9.5 in.) at the location of frame 12. A similar condition at frame 11 was reported in a 1986 survey report (Tri-Coastal Marine, Inc. 1986).

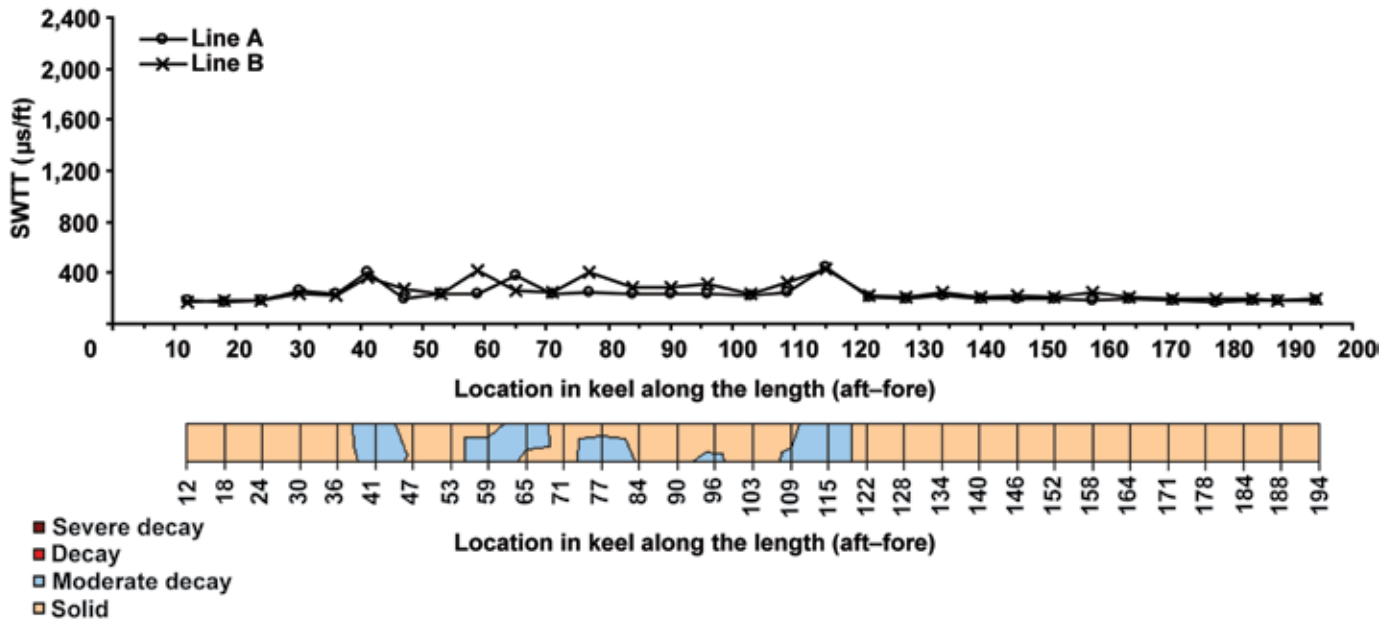
Figure 8. Distribution of stress wave transmission time (SWTT) and mapping of physical conditions of the keel.

Moderate deterioration was found at several areas of the keel, as indicated in the mapping. Although no severe decay is present in the keel, the hogging in the mid-section of the ship has caused significant mechanical damage (shear failure) to the keel as evidenced by cracks or splits along the grain. This is confirmed by a previous report that the keel was broken when the ship was placed on Barge 214 (Tri-Coastal Marine, Inc. 1986).

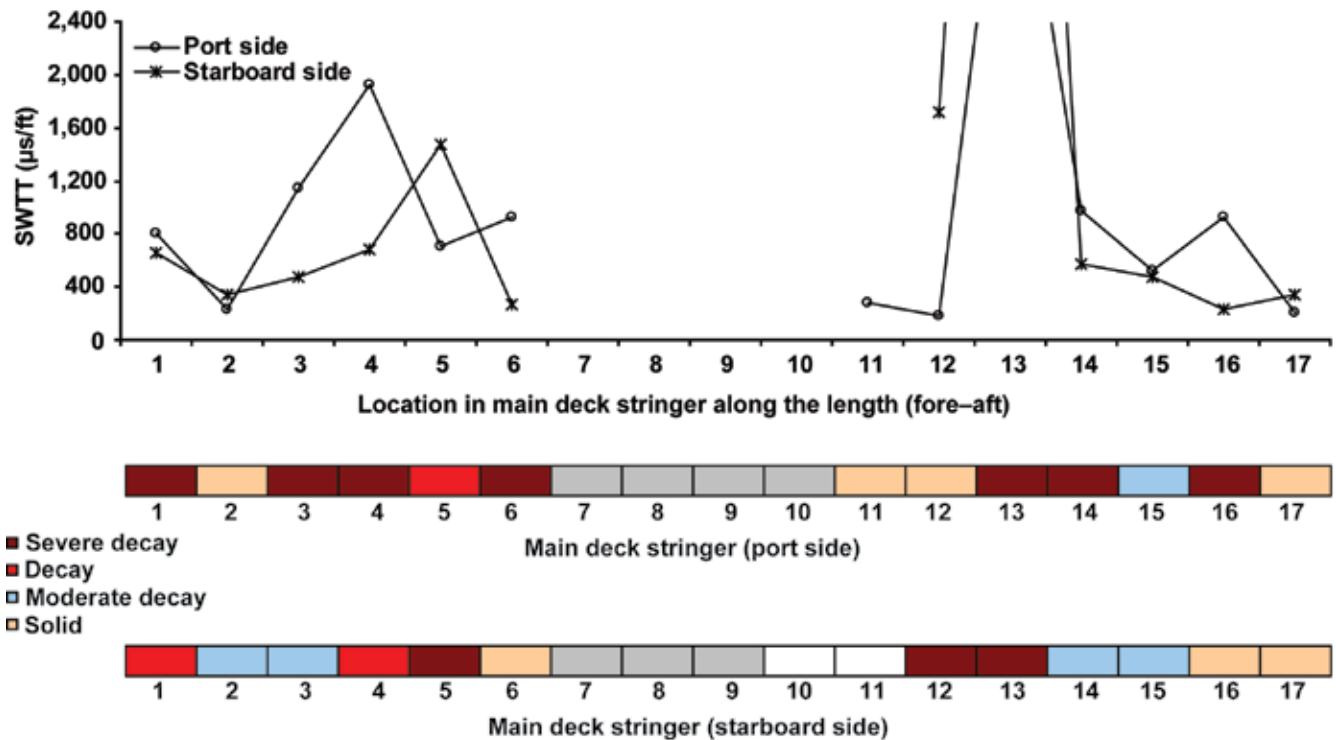
The main deck stringers have lost most integrity due to severe deterioration. Visual signs of rot, splits, and checks are present in most portions of these members. To quantify the

Figure 9. Stress wave transmission time (SWTT) and physical conditions of the main deck stringers.

The main deck stringers were spot-checked with stress-wave timing and micro-drilling resistance testing. Severe deterioration was confirmed in both side stringers and assistant stringers. Overall, the main deck stringers have lost nearly all structural integrity.

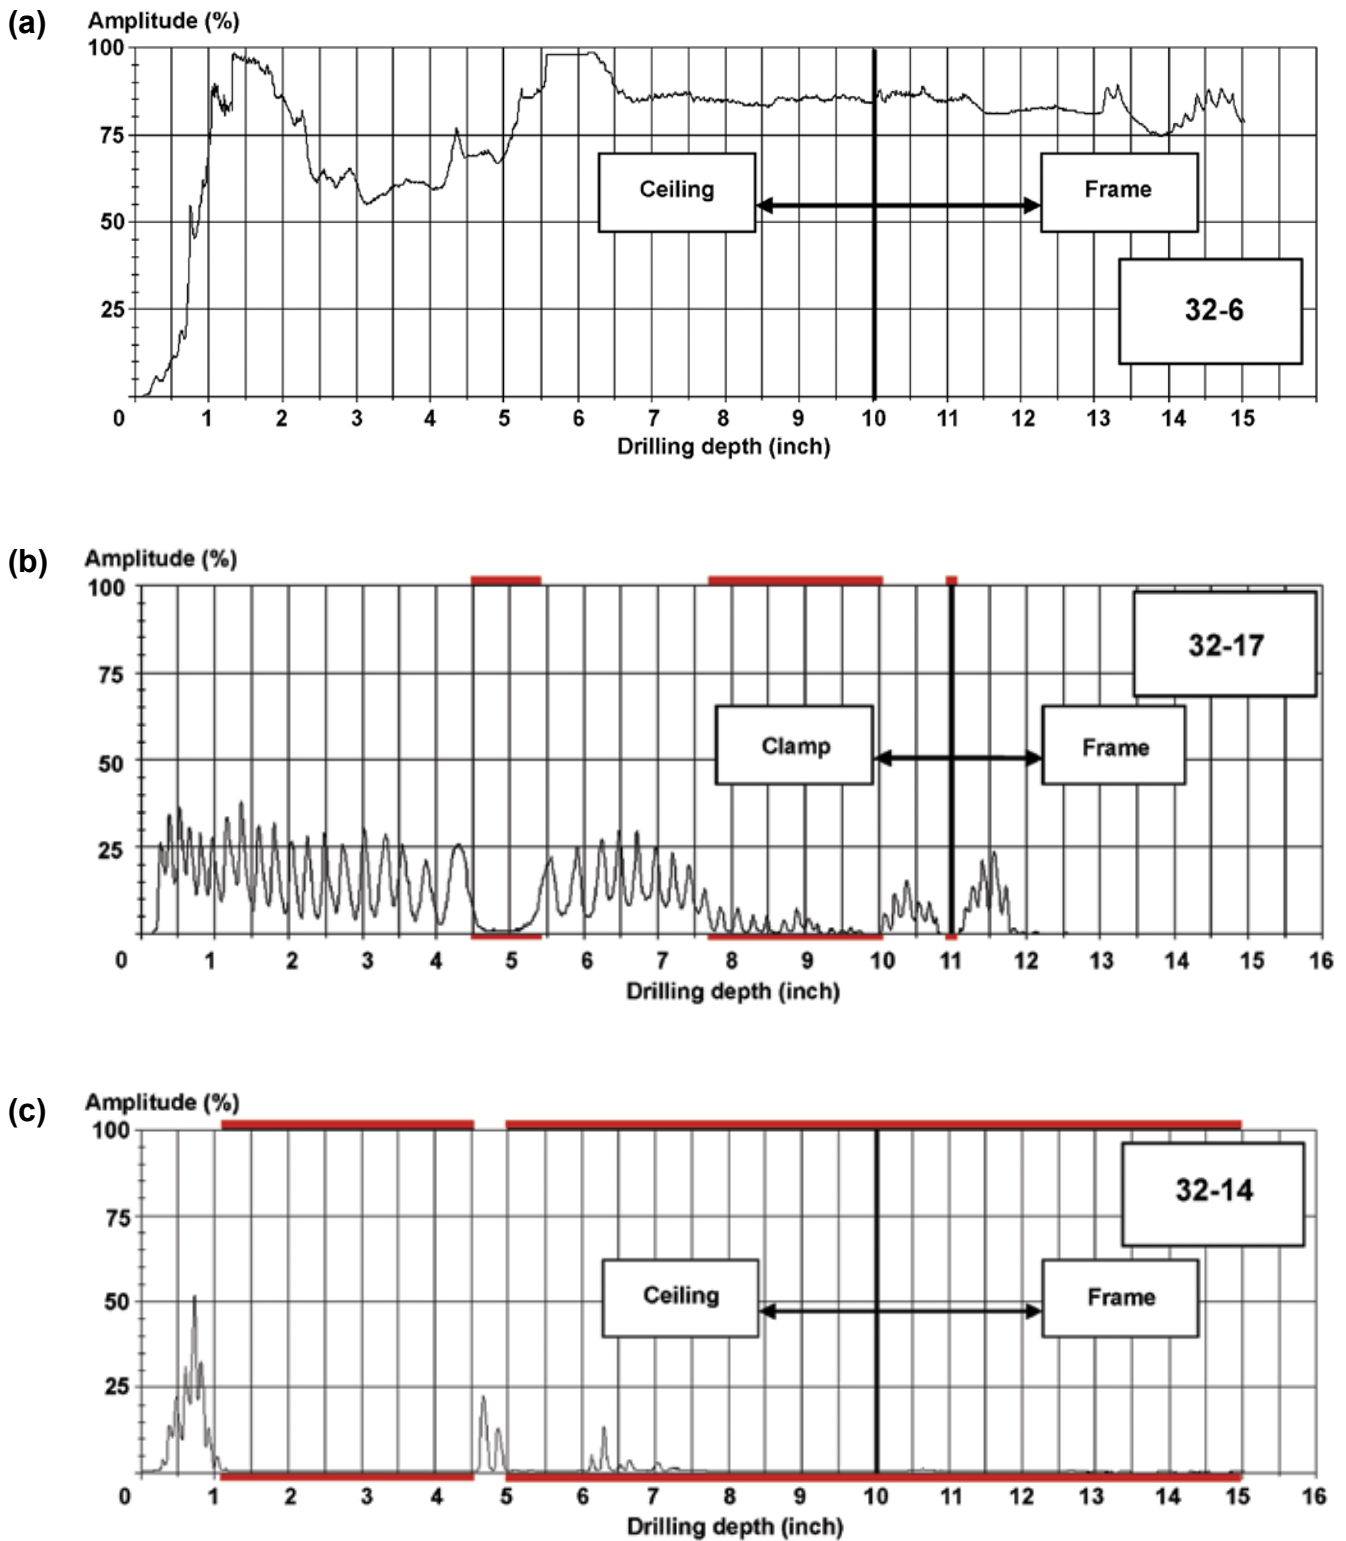
Figure 10. Typical results from micro-drilling resistance tests: (a) sound wood; (b) moderate deterioration; (c) severe deterioration.

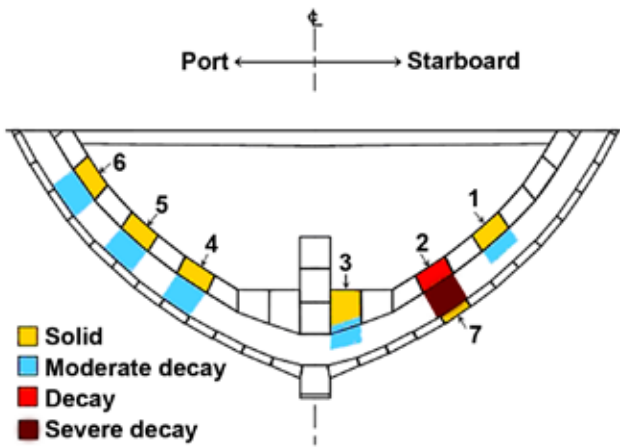
A schematic summary of micro-drilling resistance data collected at hull frame 8 is provided in Figure 11. Severe decay was detected at two of seven (29%) drilling locations at this section. Most of the ceiling planks and the first assistance keelson (starboard) are in good condition, with decay present only in the ceiling plank at drill location 2. Moderate decay was detected in the inside upper portions of the hull frame drill locations, with severe decay present at drill location 2. There were visual indicators of water seepage through overhead tween and main decks, which probably caused this deterioration since the WAPAMA was lifted onto Barge 214.

Figure 11. Mapping of physical conditions of the cross section at frame 8 (micro-drilling resistance interpretation).

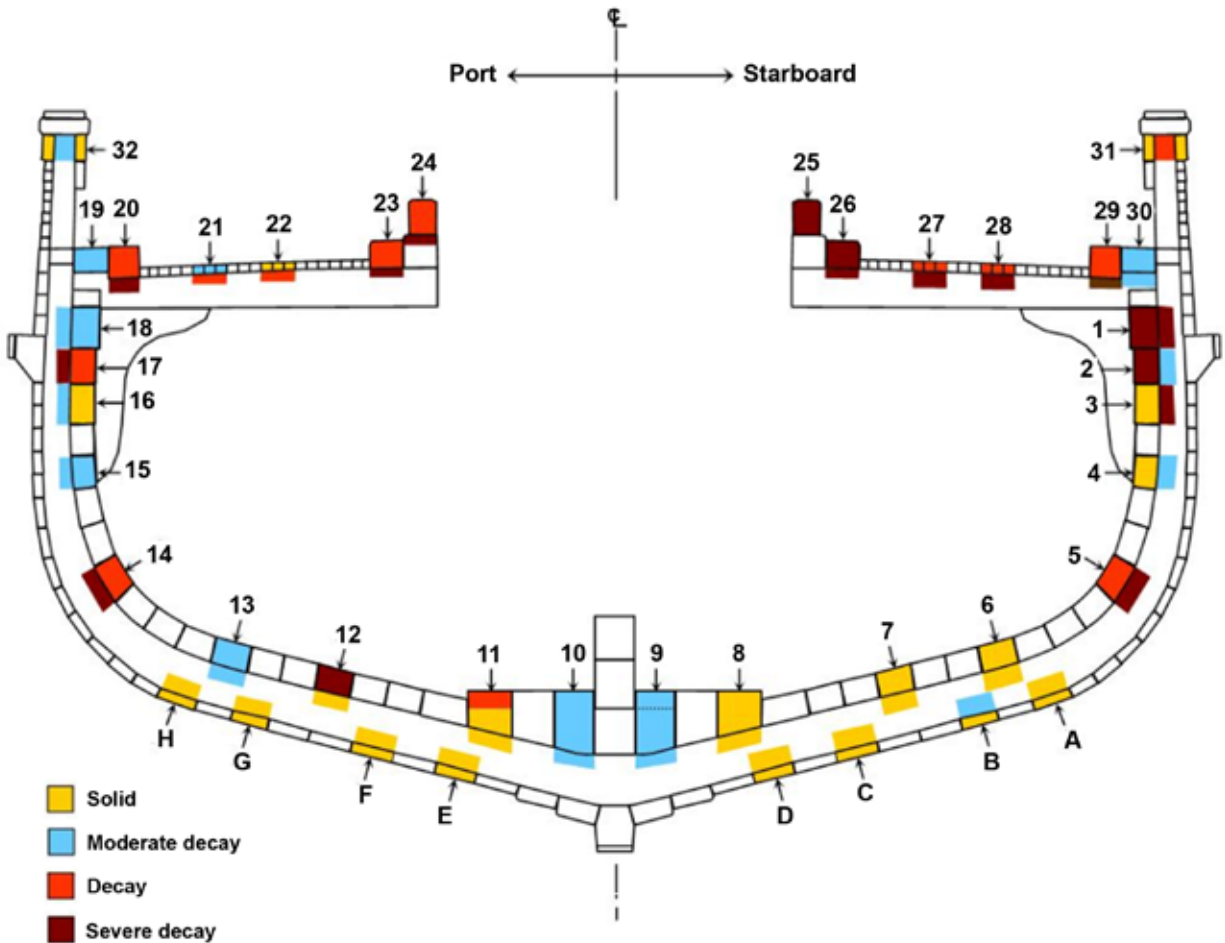
A schematic summary of micro-drilling resistance data collected at hull frame 32 is provided in Figure 12. Severe decay was detected at 15 (38%) of the drilling locations, with most of these areas located in the members at the main deck level (stringers and main deck beams) or near the main deck level (clamps, hull frame). Deterioration of the lower hull members and keelsons was mostly moderate. Deterioration ranging from decay to severe decay was detected at nearly all drilling locations drilled downward from topside main deck. The outer waterways 19 and 30 and portside main deck planks (21 and 22) showed signs of moderate decay. Deterioration ranging from decay to severe decay was detected in clamps 1, 2, and 17, ceiling planks 5, 12, and 14, the 3rd assistant keelson portside (11), and the inside upper portion of the hull frame 1, 3, 5, 14, and 17. Drillings upward into the outer hull detected mostly sound wood with only moderate decay present in the outer lower hull frame B.

Figure 12. Mapping of physical conditions of the cross-section at frame 32 (micro-drilling resistance interpretation).

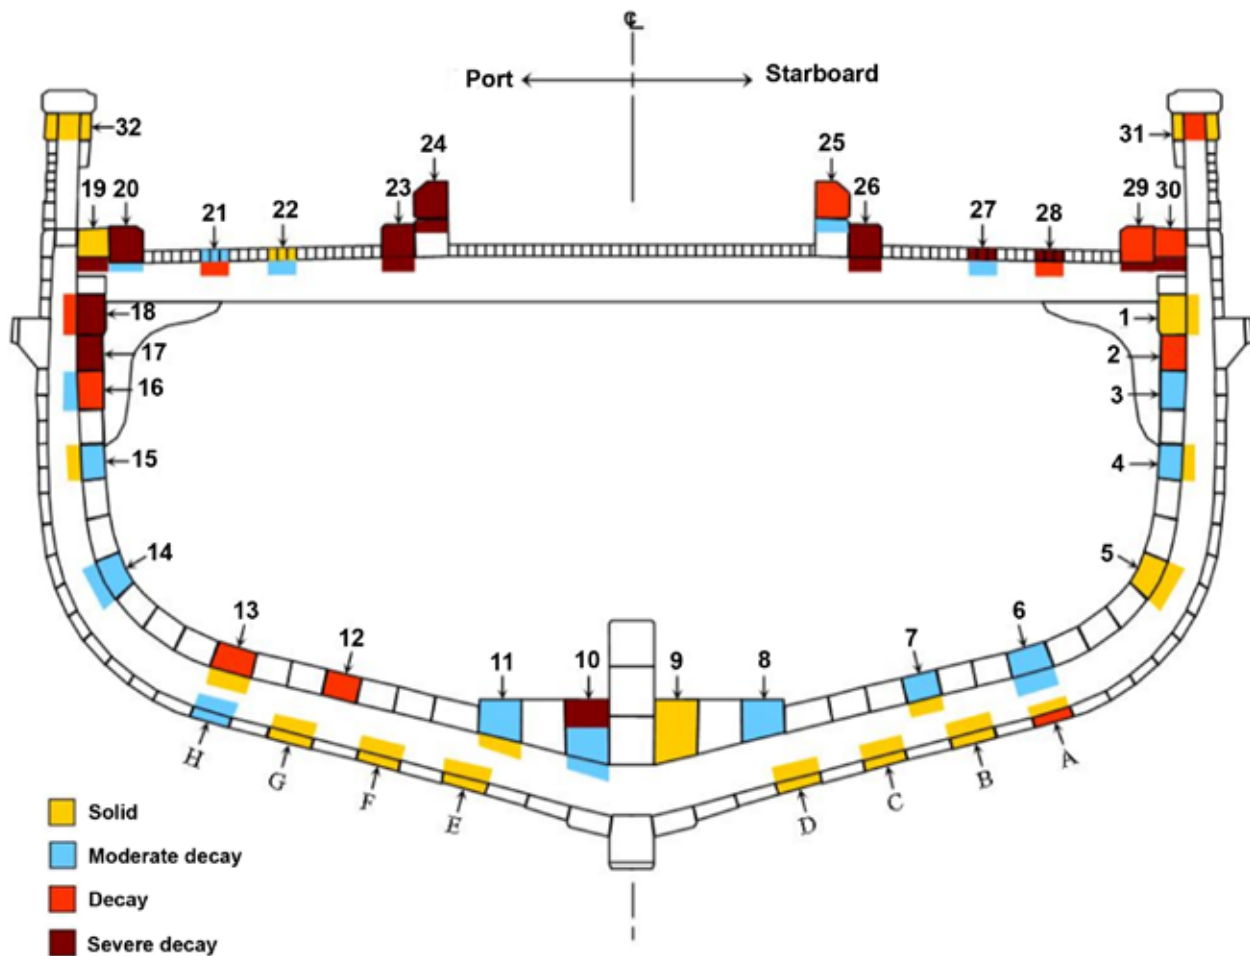
A schematic summary of micro-drilling resistance data collected at hull frame 48 is provided in Figure 13. Severe decay was detected at 12 (30%) of the drilling locations, with most of these areas located in the members at the main deck level (waterways, stringers, main deck planks, and main deck beams) or near the main deck level (clamps). Deterioration of the lower hull members and keelsons was mostly moderate. Deterioration ranging from decay to severe decay was detected at nearly all drilling locations drilled downward from topside main deck, except main deck plank 22. Deterioration ranging from decay to severe decay was also detected in clamps 2, 16, 17, and 18, the 1st assistant keelson portside (10), ceiling planks 12 and 13, and the inside upper portion of the hull frame 18. Drillings upward into the outer hull detected mostly sound wood, with deterioration noted only in outer hull plank A and in outer hull plank/hull frame H.

Figure 13. Mapping of physical conditions of the cross-section at frame 48 (micro-drilling resistance interpretation).

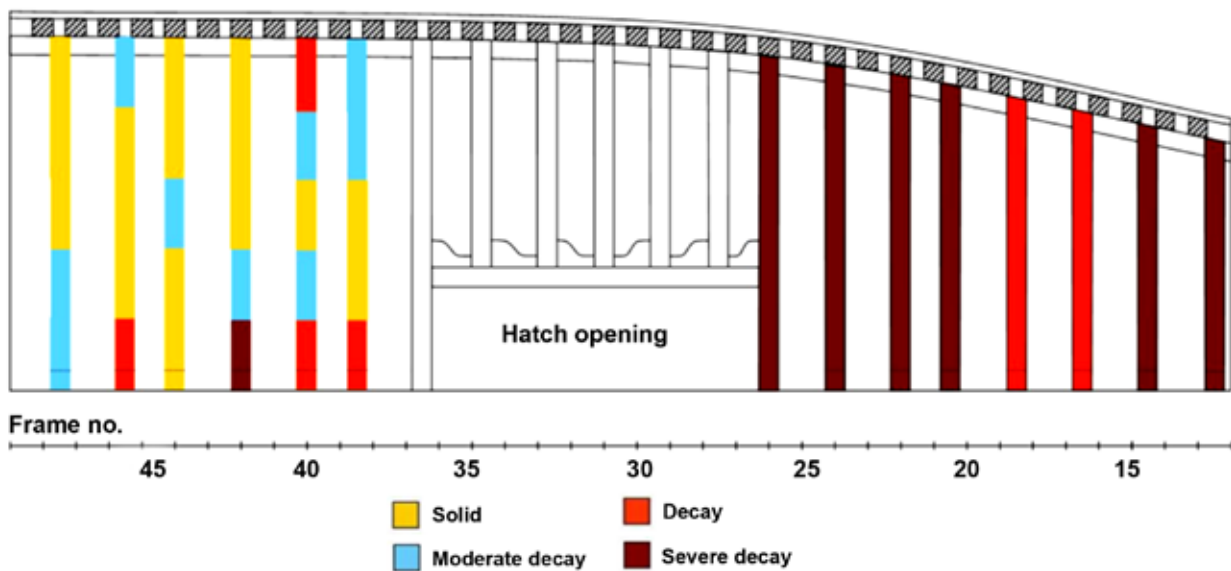
Stress wave transmission data confirmed that the main deck beams above the tween deck are in an advanced state of deterioration. Decay and severe decay were detected at all beams, as indicated by the stress wave transmission times in Table 2. Beams located at or near hull frames 13, 15, 20, 22, 24, and 26 have almost lost their entire strength and are considered having zero load capacity. In addition, severe deterioration was found in the hanging knees at frames 15 and 26, which raises serious concerns on the rest of the hanging knees that have not been tested.

The condition of the main deck beams at rear cargo hold varied. Decay to severe decay is present at the beam ends over the stanchion for most beams. The exception is the deck beam located near hull frame 44, which is sound. At the beam ends near the outer hull frame, only the beam at hull frame 40 shows decay, the beams near frames 38 and 46 shows moderate decay, and the beams near 42, 44, and 48 are generally sound. The condition of the main deck beams away from their supports is mostly sound, with moderate deterioration detected at some beams. The main deck beam in the best condition is at hull frame 44. Severe deterioration was present only at the end support (over the stanchion) at hull frame 42.

Figure 15. Mapping of physical conditions of portside main deck beams (plan view).

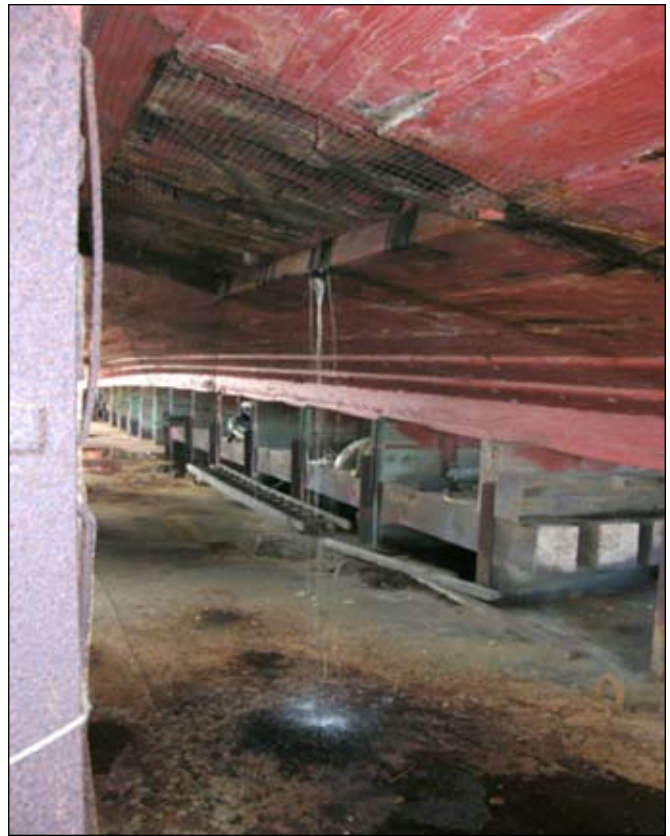
Repair or replacement of the temporary roof shelter over the main deck is recommended. The current weather protection over the main deck is clearly ineffective in preventing intrusion of rainwater, as evidenced by water seepage from the

underside vents in the outer hull. Moisture is saturating several key structural components on the main deck and in the cargo hold. An effective roof will prevent further decay until restoration work is initiated.

Hull planks removed to vent cargo hold (note rainwater seepage)

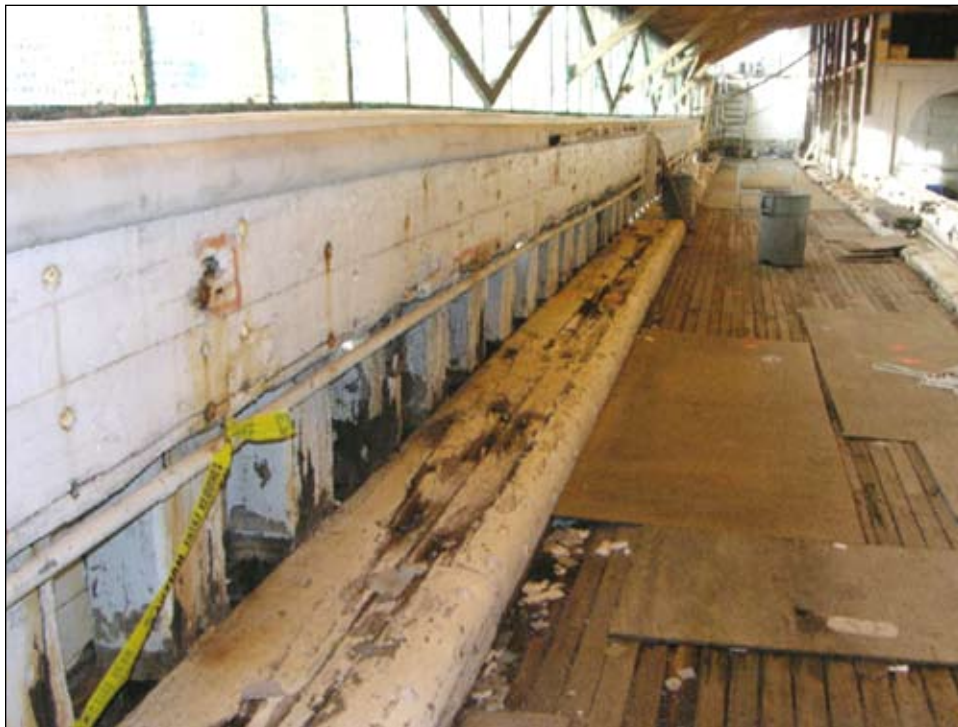
Waterways and bulwarks were evaluated at several locations with micro-drilling resistance testing at the main deck. Most severe deterioration was present in the waterways, whereas many of the bulwarks had moderate to severe decay.

Starboard view of deteriorated waterway and main decking
