Section 9 Stability Analysis

9.1 UTexas4 Embankment Stability Analysis

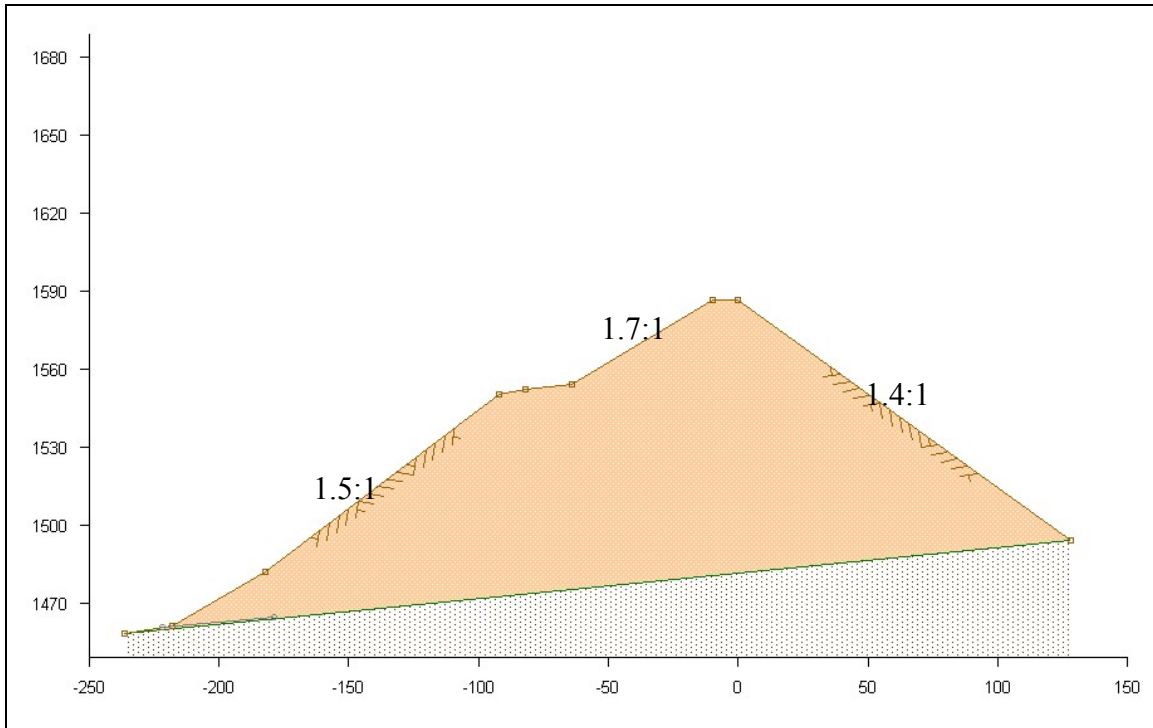
Figure 9.1– Embankment Cross Section

Questions were raised about the steepness of the downstream slope in the area of the breach. A second topographic section was made at the north end of the breach to assess the steepness of the slope in that area. Due to slope failures immediately adjacent to the breach, the section was taken 80 feet northeast of the breach edge (refer to Line 2 in Appendix D – Figure D.1). Figure 9.1 shows the cross section which represents the as-built configuration of the breach section.

The upstream slope (right side of above drawing) is 1.4H:1.0V. The portion of the downstream slope that is above the access road is 1.7H:1.0V, and the portion of the downstream slope below the access road is 1.5H:1.0V. The downstream slope used in the stability analyses for the section taken at the center of the breach was 1.5H:1.0V. Rather than cutting into the original embankment to construct the access road, it appears the access road was placed with material dumped on top of the original embankment. The slope of the road fill material is slightly steeper than the original downstream embankment slope (1.5H:1.0V versus 1.7H:1.0V, respectively). The steeper slope of 1.5H:1.0V was used to represent of the downstream slope in the area of the breach.

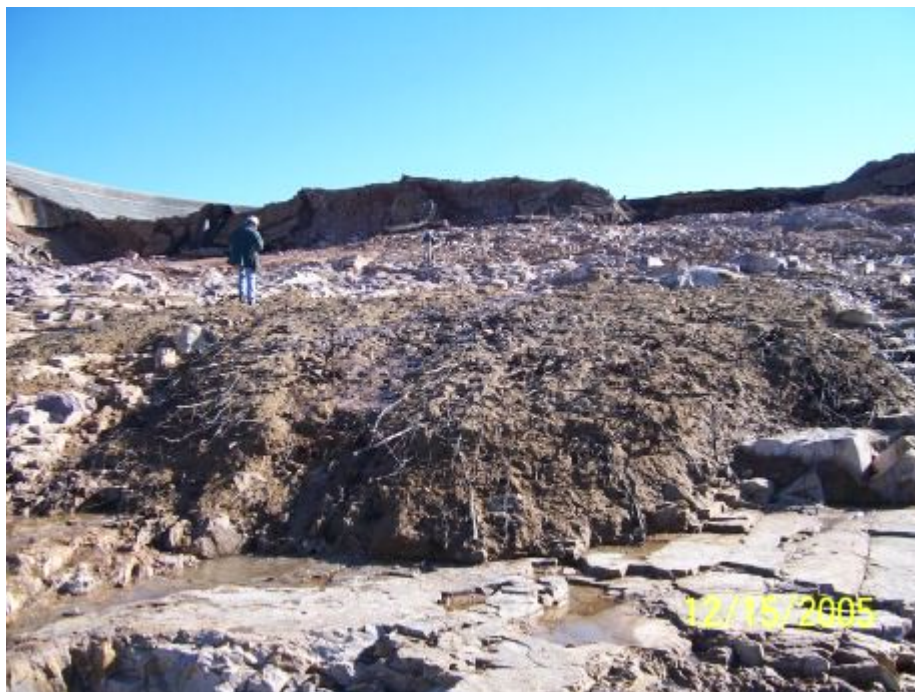
Figure 9.3 - Residual topsoil on top of fresh rhyolite.

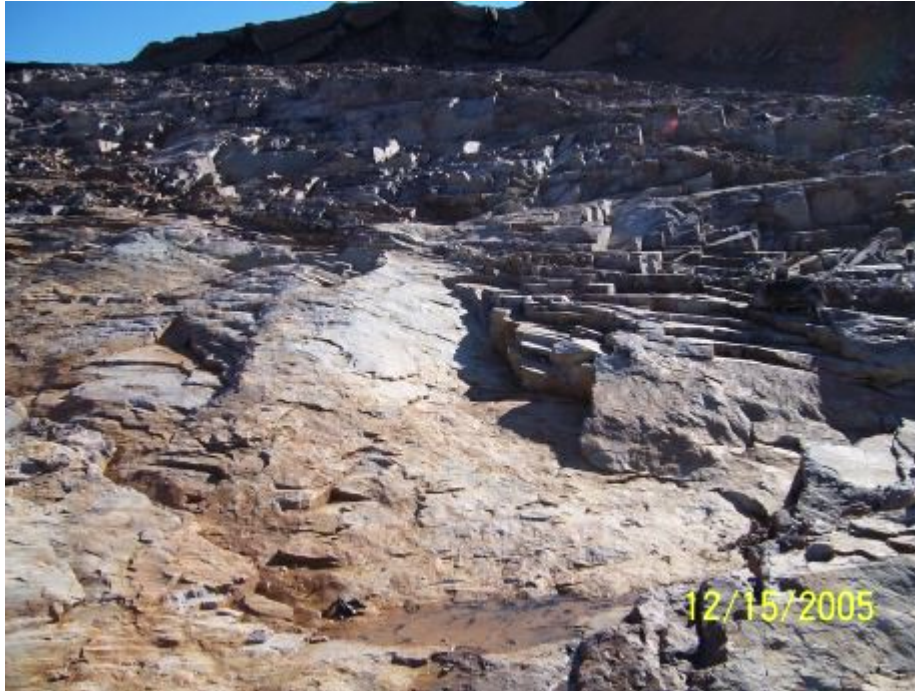
Paul C. Rizzo Consultants prepared a geologic map of the foundation area, which was used to evaluate the engineering behavior of the various materials present. The bedrock is a jointed rhyolite that is considered competent rock. No singular, continuous planes of weakness were observed within the bedrock that could be modeled as a failure plane. However, there is an area in the south side of the breach, that trends along the centerline of the low pond in the northwest corner of the reservoir floor, which contains weathered rhyolite (Figure 9.2). The material is slightly cohesive in some areas and granular in others and still contains some of the original rock fabric. Along the north side of the breach, near the road that ran along the toe of the dam, there is an area with about 6 to 18-inches of a clay rich soil with roots and organics, resting directly on fresh rhyolite (Figure 9.3). Most of the area of the breach is fresh competent rock with no traces of soil or weathered rock (Figure 9.4).

Figure 9.4 - Fresh rhyolite bedrock surface.

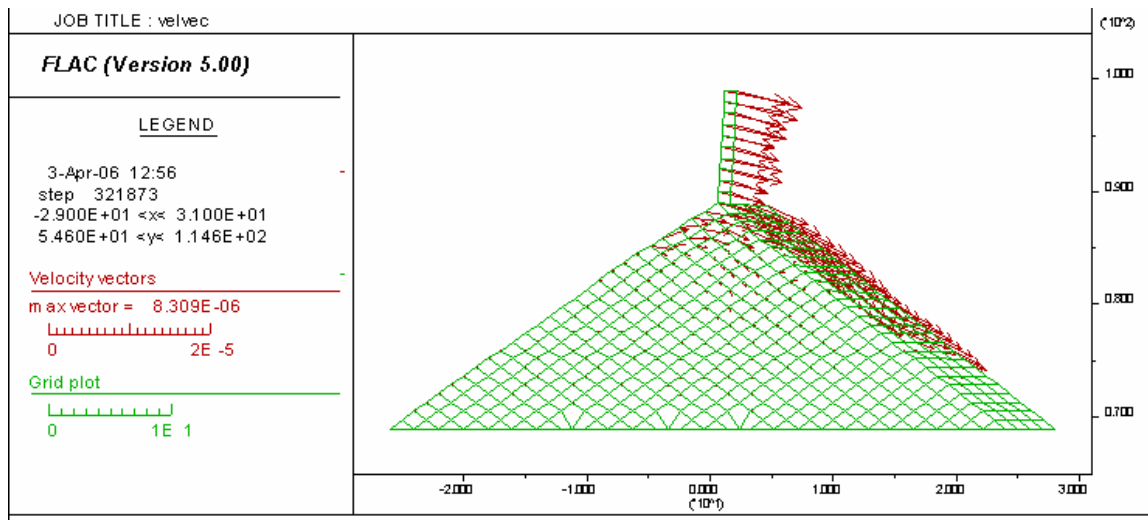
Figure 9.5 – FLAC Analysis

The analysis was stopped when the top of the parapet wall deflected more than 1 foot, which occurred when embankment erosion approached the toe of the wall. This deflection would cause significantly more overtopping to occur, further undermining the wall. Also, it is possible the geomembrane and concrete liner would have ruptured due to the significant wall movement allowing substantial leakage through the open joint, accelerating the loss of embankment material beneath the wall. (See Figures 9.5 and 9.6)

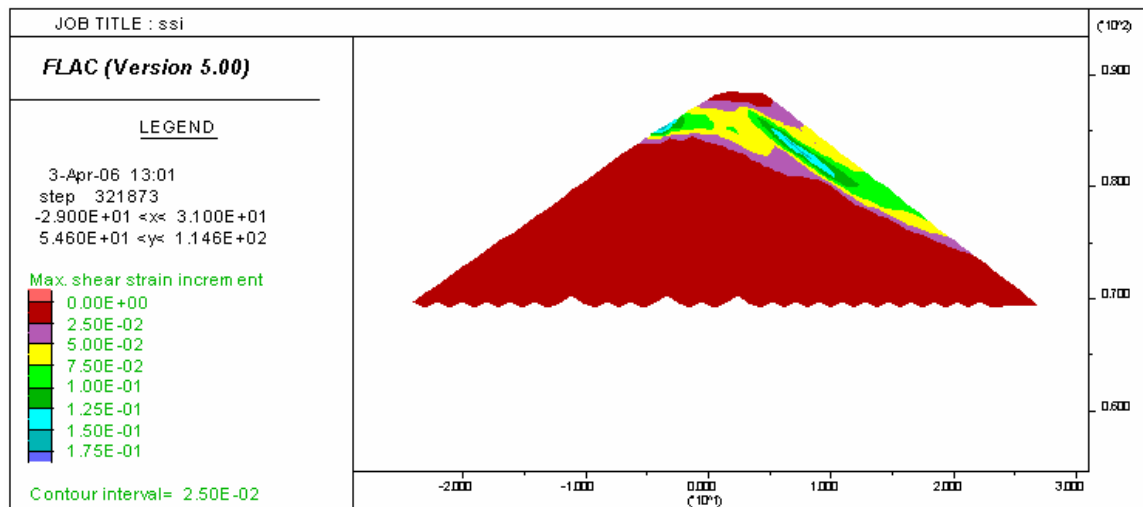
Figure 9.6 - Shear strain from the final FLAC iteration.

Note the band of high shear strain parallel to the slope
