## 4 Alabama Observations

### 4.1 Flood Observations: Damages and Successes

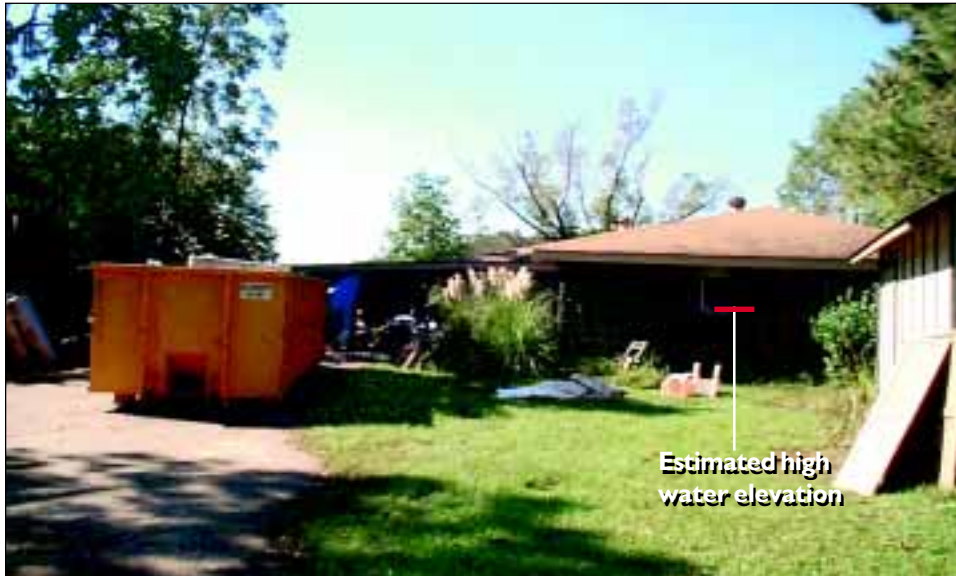
Damage consisted mostly of loss of contents; damage to exterior and interior finishes, including doors, cabinets, carpeting/flooring, and painted surfaces; inundation of air conditioning compressors; and damage to wallboard and insulation. In the Dog River area, houses experienced up to 5 feet of flooding (Figure 4-1). The Fish River area experienced 4 to 5 feet of flooding. In one instance, a pre-FIRM house built on a slab-on-grade foundation sustained damage while a post-FIRM elevated addition apparently was not affected (Figure 4-2).

**FIGURE 4-1** Homeowner removing damaged contents from house flooded along the Dog River.

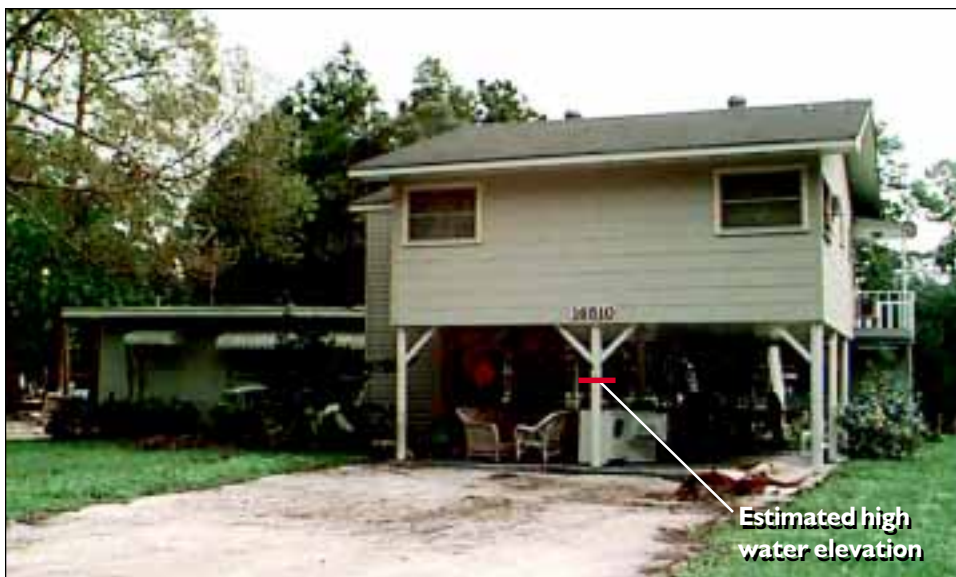
**FIGURE 4-2** Approximately 5 feet of flooding at this house along the Fish River caused no damage to the elevated addition.

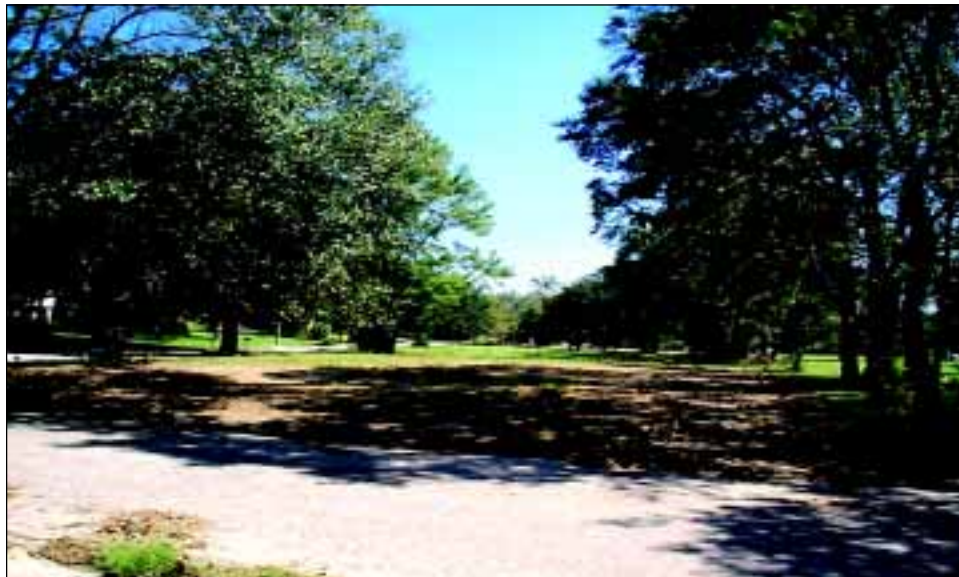
**FIGURE 4-3** The previous location of several repetitive-loss properties in Mobile County that had been acquired and demolished.

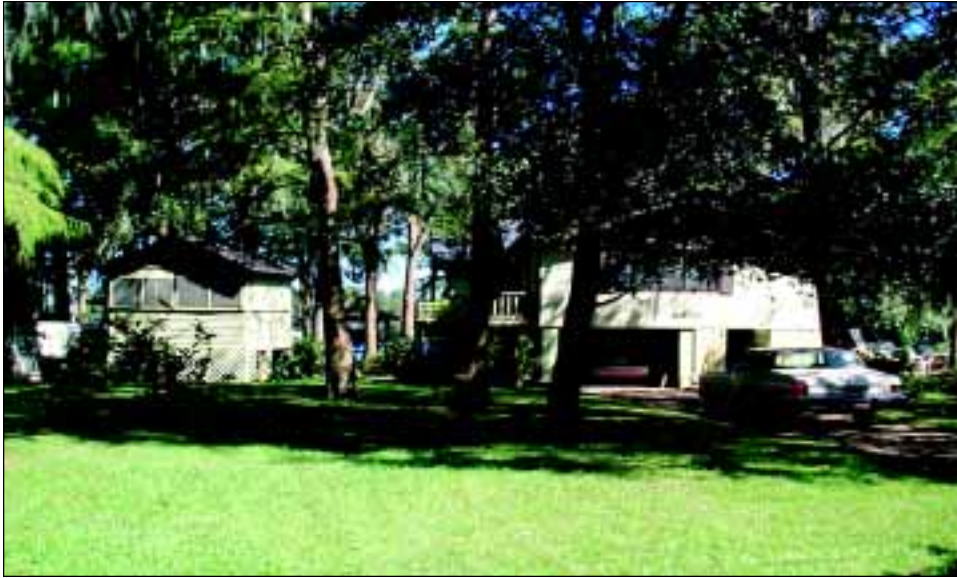
**FIGURE 4-4** Elevated house along the Dog River that suffered minimal flood damage.

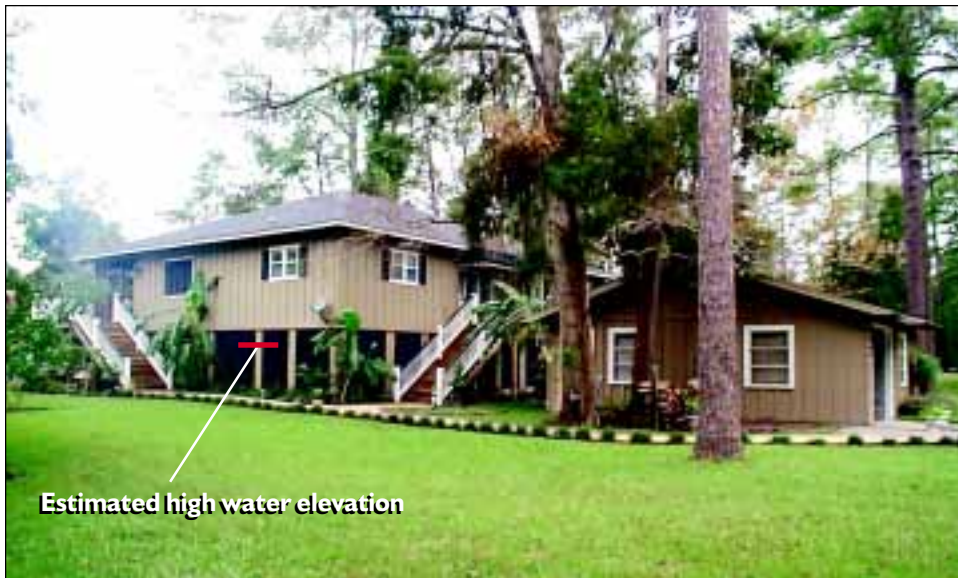
**FIGURE 4-5** House along the Fish River, elevated through FEMA's HMGP that suffered minimal flood damage.

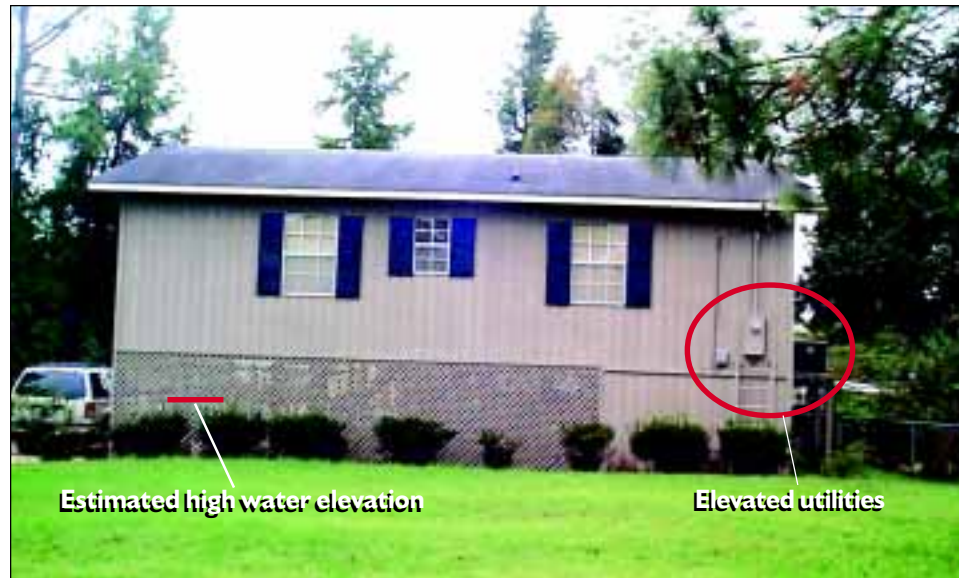
Elevated structures still have some degree of residual flood risk. The house pictured in Figure 4-6 was previously elevated by the homeowner and subsequently was flooded approximately 1 inch to 2 inches above the first floor by Hurricane Danny. Fortunately, flood levels in this area during Hurricane Georges were less than those experienced during Hurricane Danny. The only damage to this home during Hurricane Georges was to the contents stored below the first floor.

**FIGURE 4-6** Previously elevated house along the Fish River suffered damage to contents below the first floor. Note that the homeowner also elevated utilities on the right side of house, preventing loss or damage.

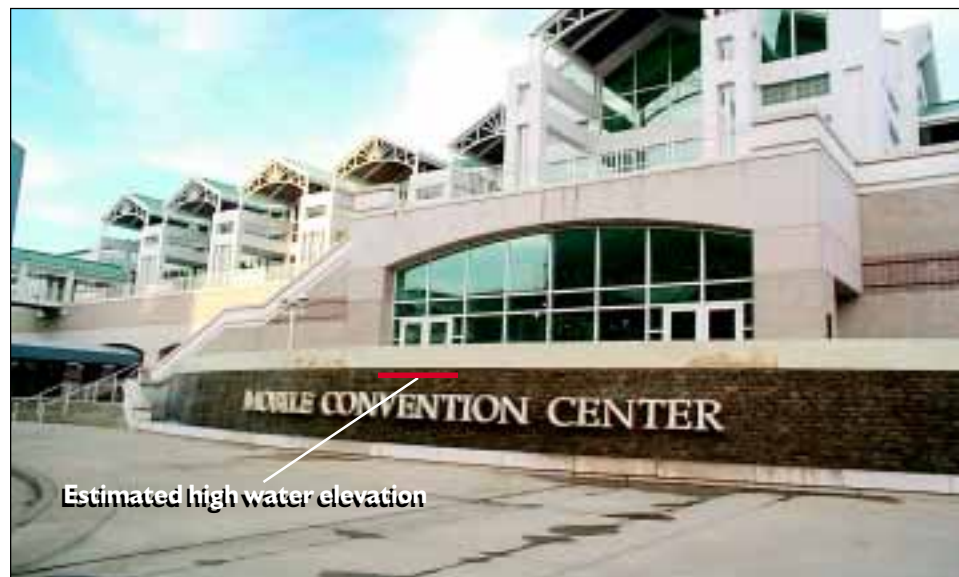
Located in Upper Mobile Bay, the Mobile Convention Center, which was constructed in 1993, is the centerpiece of downtown Mobile's revitalization efforts (Figure 4-7). Elevated above the BFE, the Convention Center received only minor damage from Hurricane Georges. Total damage — including flood fighting and cleanup costs — has been \$156,000 to date with approximately \$350,000 estimated for additional repairs. Most of the damage incurred was due to wind-driven rain that entered around windows and doors. Since the Convention Center was properly elevated, it was able to resume operations within three days after Hurricane Georges. In addition, the center received additional bookings from other

**FIGURE 4-7** Despite approximately 7 feet of flooding in this area, the Mobile Convention Center suffered only minor damage and was operational when the floodwaters receded.

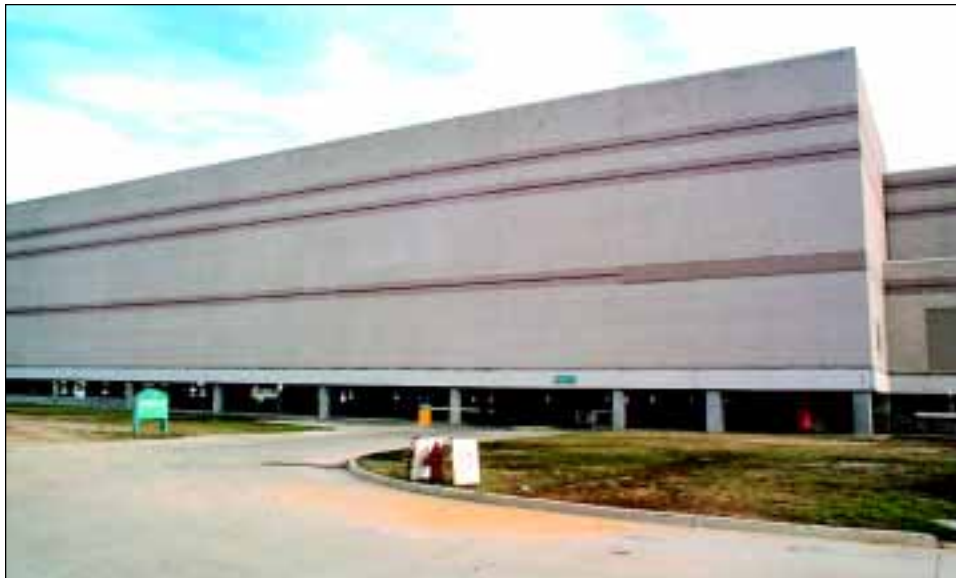
nearby facilities that were damaged by the storm. The design and elevation of this building was an economic success in terms of both the damage avoided and the business that was not interrupted (Figure 4-8).

**FIGURE 4-8** The area below the BFE is used for parking and required only minor clean-up following the flood.

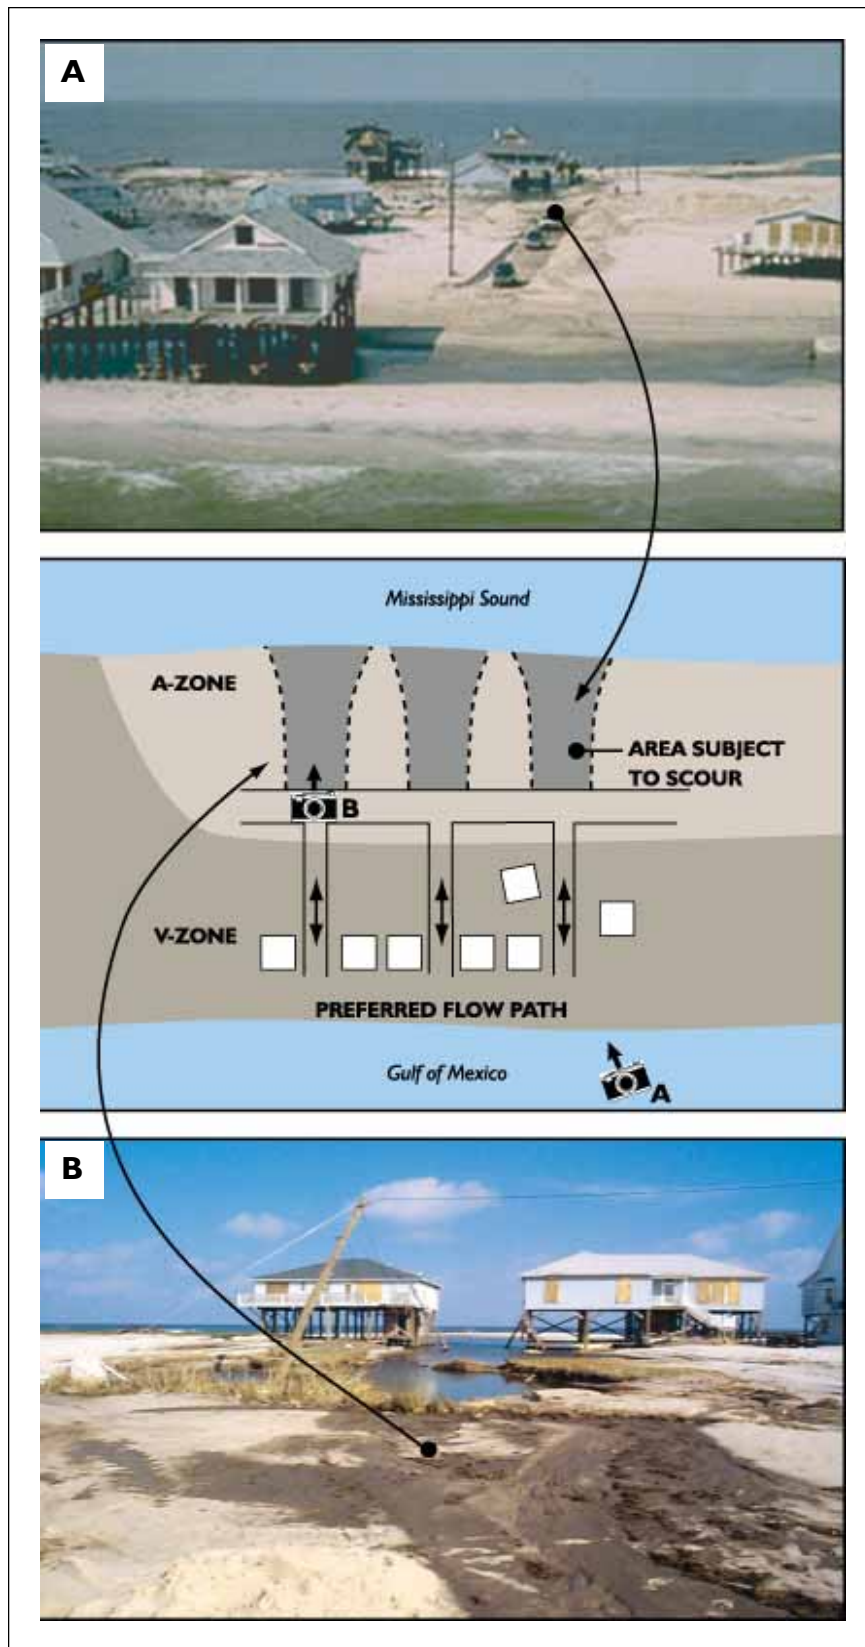
Significant erosion of the Gulf Coast beach occurred on Dauphin Island. Overwash was evident across virtually the entire width of the western end of the island. The eastern end of the island, which has greater topographic relief, vegetation, and dunes, fared well. No significant shore-parallel dunes or other protective berm existed on the western beaches prior to the storm. Most overwashed sand ended up being deposited in the roads. Vertical beach loss due to erosion on the Gulf side was estimated to be 3 to 6 feet. Scour was localized around obstructions (posts/piles, abandoned concrete septic tanks). In addition, 3 to 6 feet of erosion occurred beneath several A-Zone houses located on the back-barrier shoreline across from shore-perpendicular streets (Figure 4-9). Side streets located perpendicular to the shoreline provided a preferred path for storm surge and retreat flow across the island.

**FIGURE 4-9** Side streets perpendicular to the shoreline, combined with a break in the existing scattered dunes and vegetation where the side streets meet the main east-west road, provided a preferred path for storm surge and retreat flow across the island.

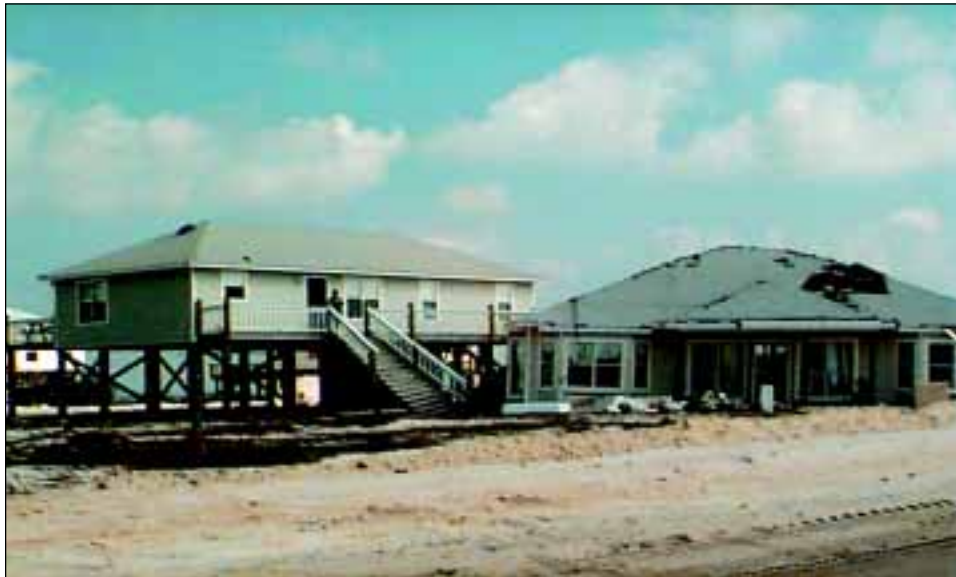
A combination of inadequate pile embedment with erosion and scour resulted in the failure of several homes on pile foundations on the windward/southern side of Dauphin Island (Figure 4-10). While some structures did not suffer complete losses, they did suffer severe damage due to the surge. Damage included loss of piles, movement and/or settlement of piles, leaning or partial collapse of the structure, washout and scour around piles and around and under grade level concrete slabs, loss of exterior access stairways, and loss of lower level enclosures.

**FIGURE 4-10** The structure on the right lost its pile foundation system and was washed into the structure on the left.

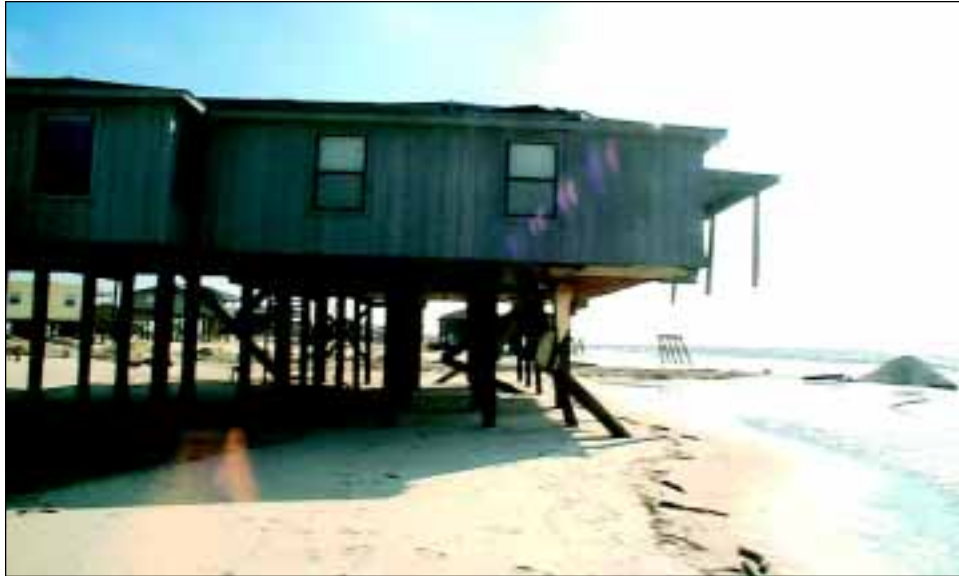
In some cases, pile failures were exacerbated by inadequate embedment depths and increased scour around piles as a result of concrete collars or slabs (Figures 4-11 to 4-14). The use of crossbracing was not widespread. Crossbracing observed was for serviceability and not intended to provide structural support or to prevent permanent deformation.

**FIGURE 4-11** This house lost its deck and sustained structural damage to the Gulf side of the house.

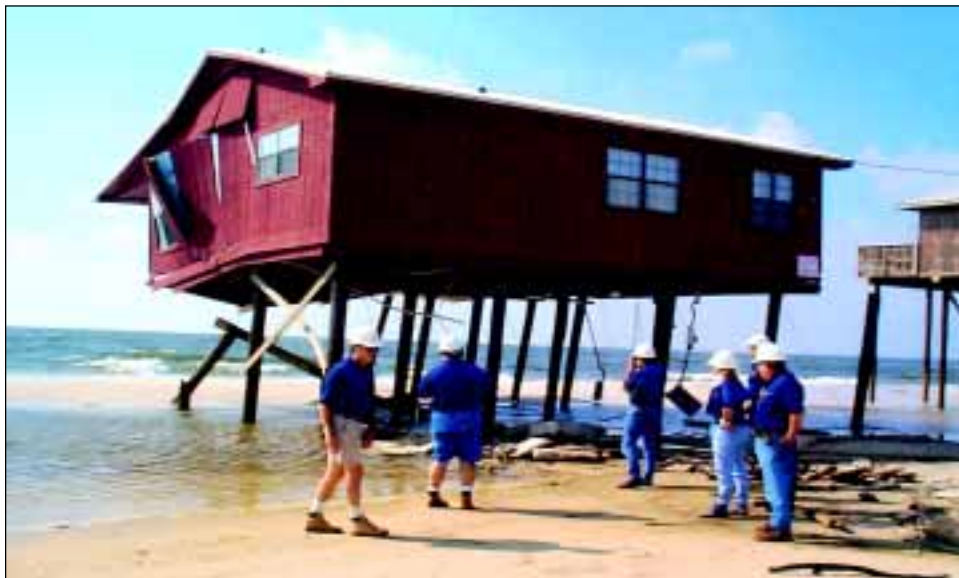
**FIGURE 4-12** The BPAT observing a partially collapsed front-row structure.

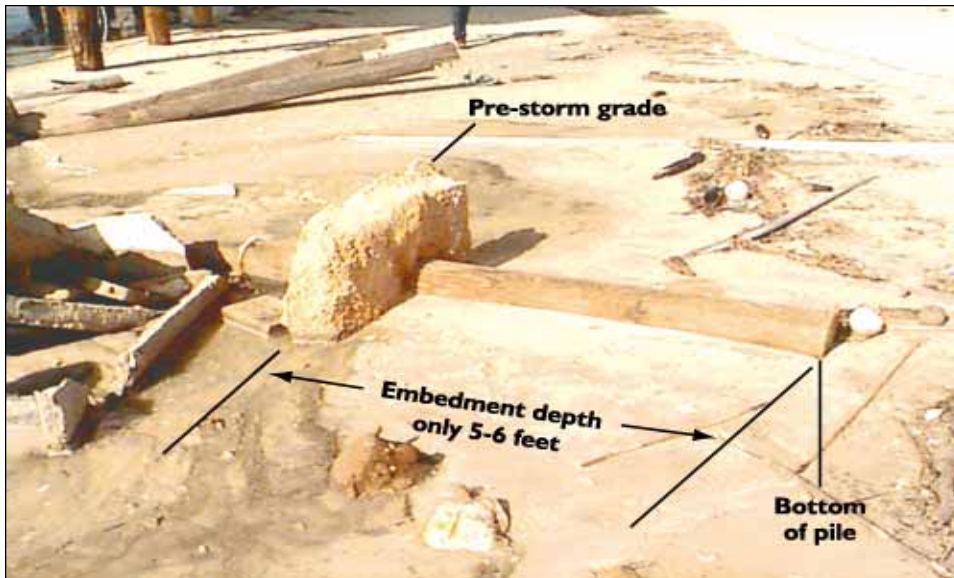
**FIGURE 4-13** Pile failure due to scour around concrete collar and inadequate embedment depth.

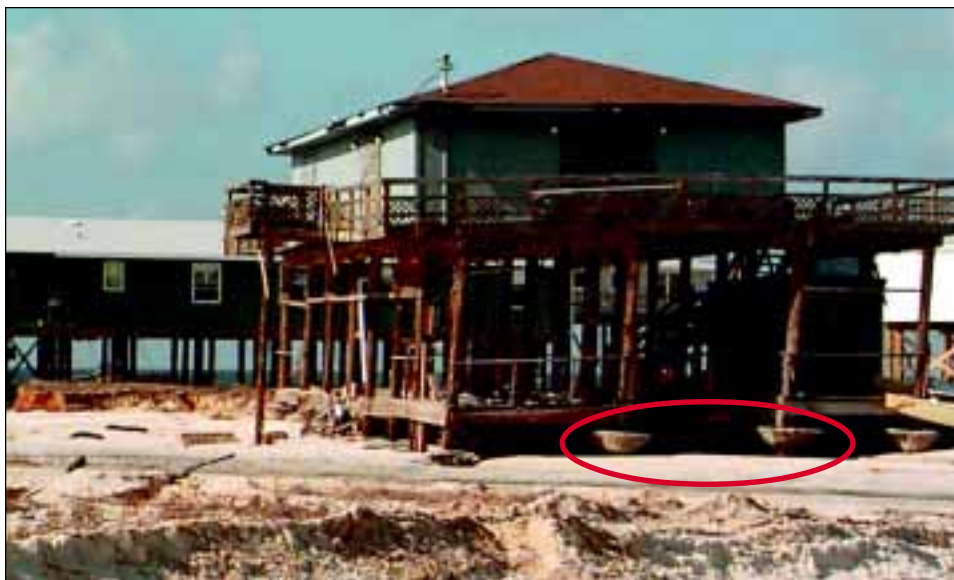
**FIGURE 4-14** This house suffered pile settlement due to scour around piles with concrete collars. In addition, note the loss of stairs and damage to lower-level enclosed area.

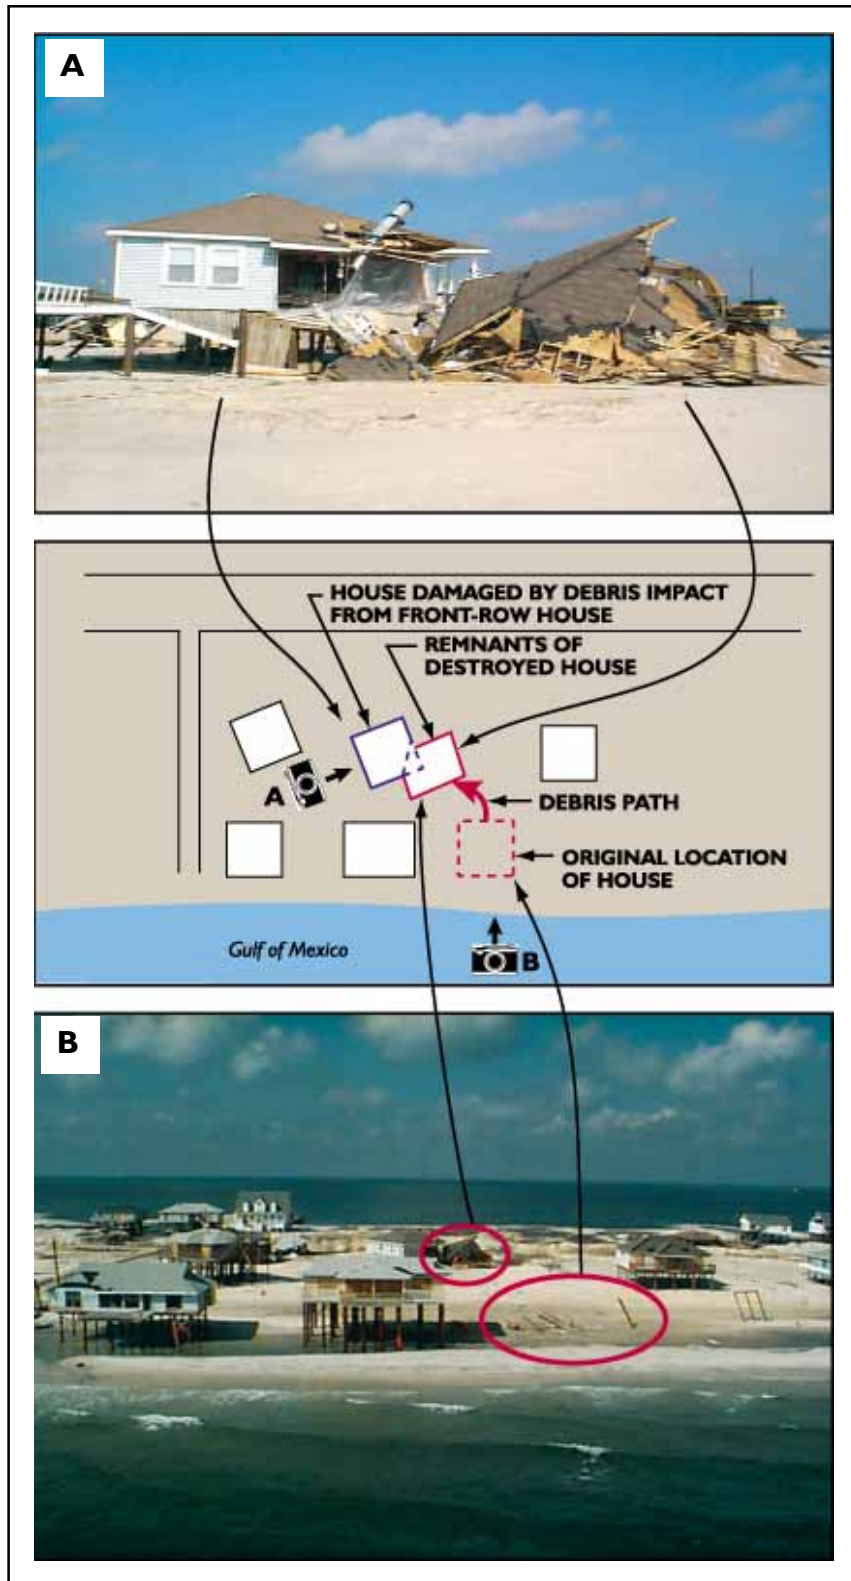
Waterborne debris impact caused a significant amount of damage. Several front row homes on Dauphin Island failed due to inadequate pile embedment and erosion/scour. The debris from these failed structures affected adjacent and landward structures (Figure 4-15 and 4-16). In most cases, the structure affected would not have been damaged otherwise or would have received only minor damage if it had not been impacted by waterborne debris. Debris impact from dislodged decks and stairs was more common than the debris impact from entire dislodged houses. This type of debris was carried by the storm surge and damaged buildings (Figure 4-17).

**FIGURE 4-15** Significant debris impact created by destruction of a front-row house.

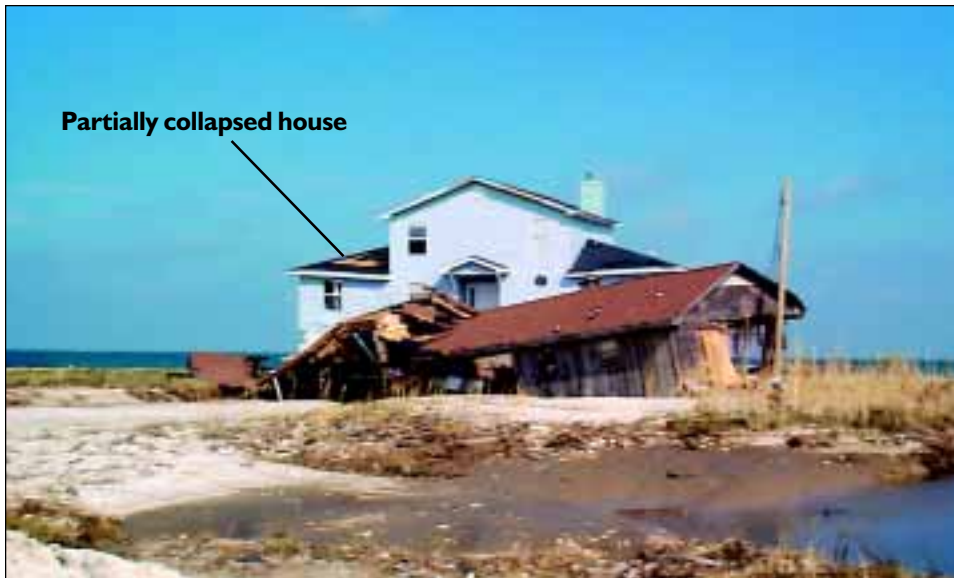
**FIGURE 4-16** House on back side of Dauphin Island suffered partial collapse when impacted by a dislodged house from the Gulf side of Dauphin Island.

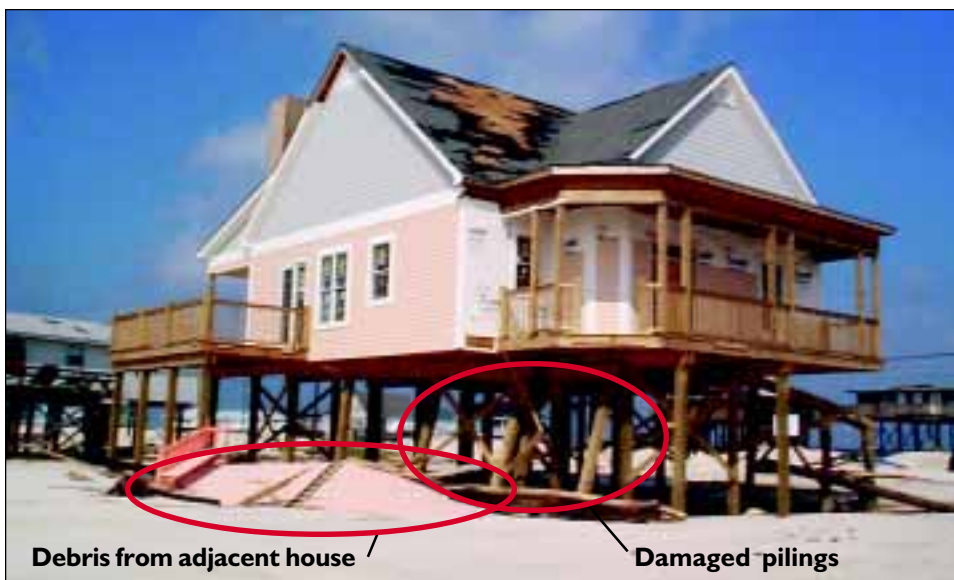
**FIGURE 4-17** Damage to piles of a newly constructed house caused by impact of waterborne debris from a nearby collapsed deck.

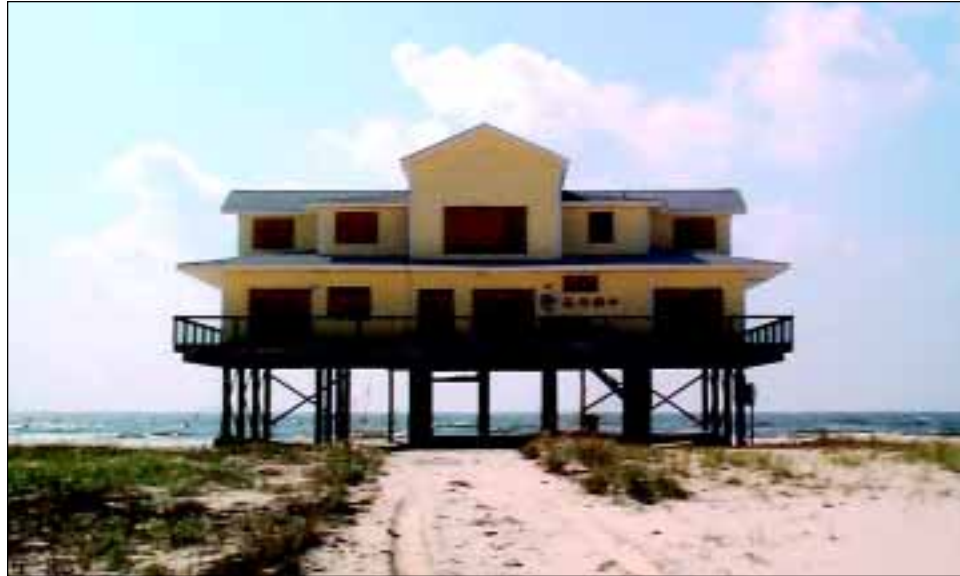
Most homes and portions of the infrastructure on Dauphin Island performed well (Figure 4-18). This success can be attributed to sound local building code requirements, enforcement of 10-foot minimum pile depths, and compliance with NFIP V-Zone construction standards. The majority of the observed failures were to older houses built to lesser standards and lower elevations prior to FEMA's inclusion of wave height effects on the community's FIRM.

**FIGURE 4-18** This house sustained no damage with the exception of loss of stairs and items stored below the first-floor elevation.

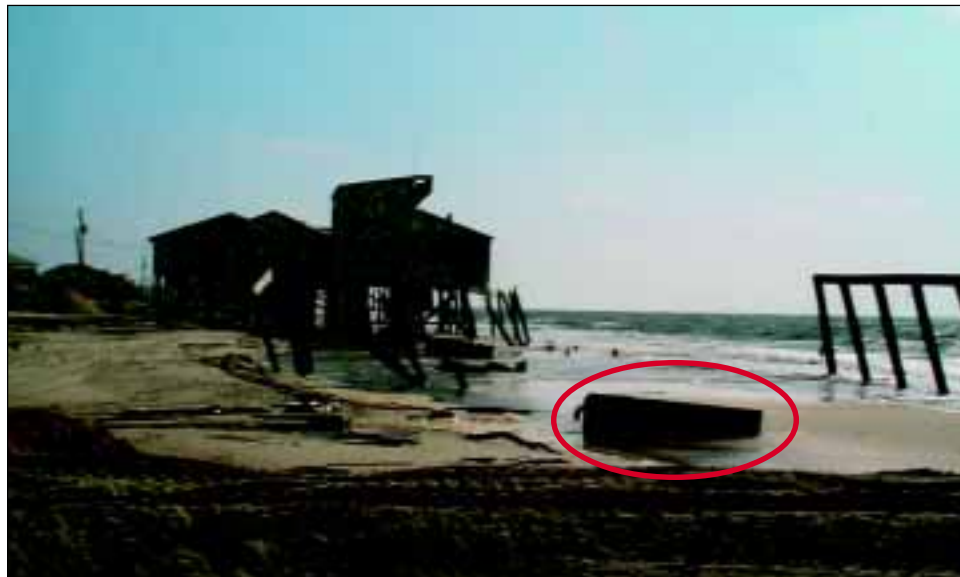
**FIGURE 4-19** Old concrete septic tanks (circled) and drain fields have been superseded by the new municipal sanitary sewer system. The old systems still create a hazard as waterborne debris.

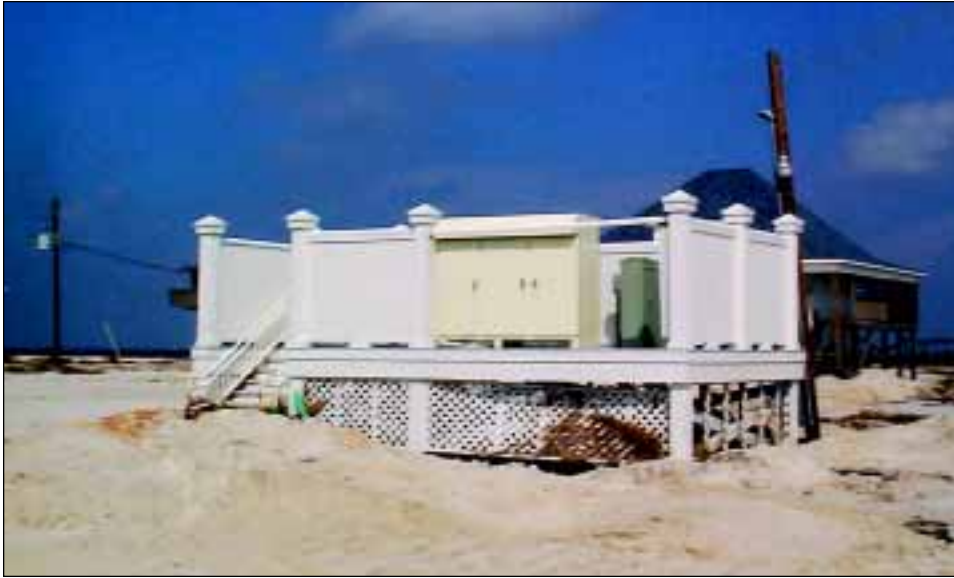
Dauphin Island's attention to utility systems was another example of successful mitigation. In response to repetitive damage to individual septic systems by past storms, the community installed a new municipal sewer system. The system performed well and suffered only minor damage as a result of the storm. Extensive beach erosion from Hurricane Georges would have required complete replacement of the individual septic systems for homes that were converted to the municipal system (Figure 4-19). In addition to the sanitary sewer system, the community is also elevating utility platforms for cable television and telephone switching stations to minimize damage due to coastal surge. As shown in Figure 4-20, the elevated platform performed well and adequately protected the utility boxes.

**FIGURE 4-20** Other than losing part of the lattice screening, this elevated utility platform performed well.

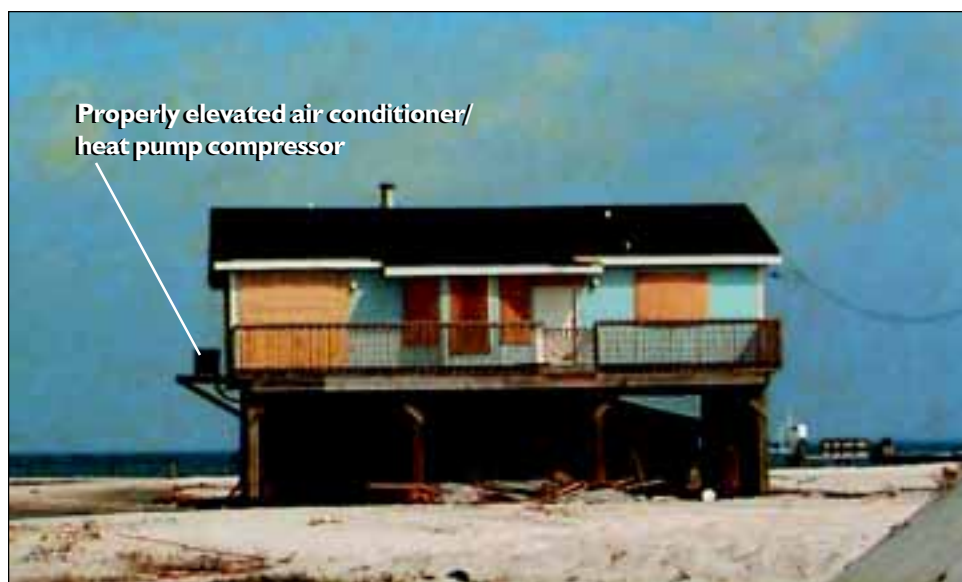
For the most part, when structures were elevated an effort was also made to elevate air conditioning/heat pump compressors and other similar on-site utility equipment. When elevated to the BFE and placed on adequately supported platforms the facilities performed well (Figure 4-22). Where installation was inadequate, they generally failed (Figure 4-23).

**FIGURE 4-22** This cantilever platform performed well.

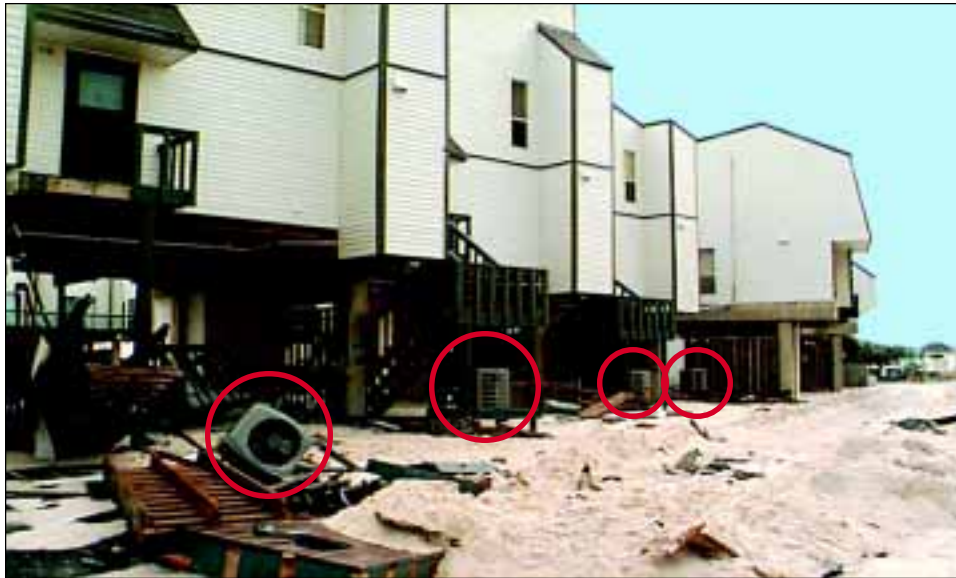
The placement of on-site exterior utility equipment (air conditioner/heat pump compressors) was a concern at both Dauphin Island and Fort Morgan/Gulf Shores areas. In several instances, damage occurred because these utilities were not elevated and not properly anchored.

**FIGURE 4-23** These air conditioner/heat pump compressors in Gulf Shores were not elevated and therefore were severely damaged.

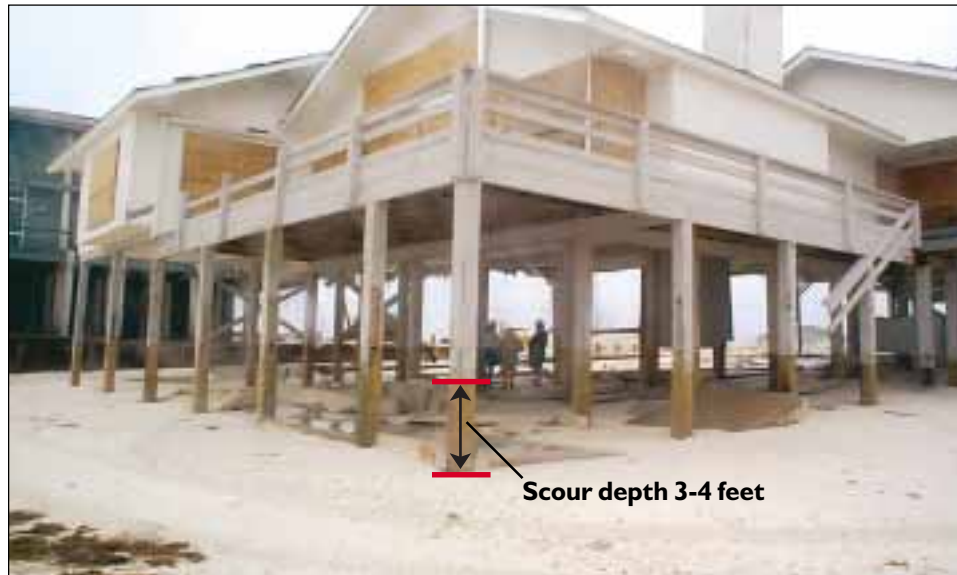
**FIGURE 4-25** Despite the loss of 3 to 4 feet of sand, this structure performed well. Note at-grade slabs broke away as intended.

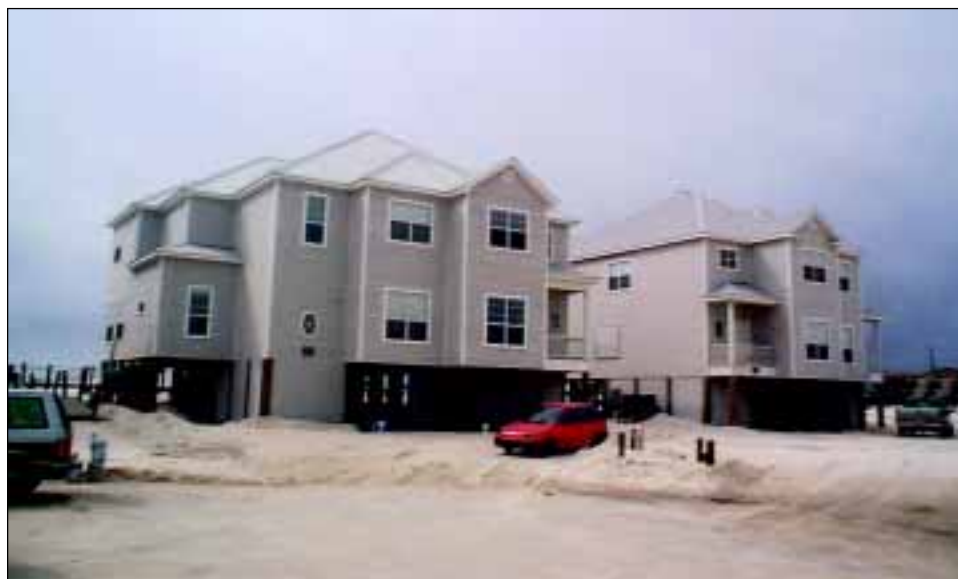
**FIGURE 4-26** These multi-family buildings in Fort Morgan suffered no damage from coastal storm surge. Proper elevation, siting, and building materials contributed to their success. Note roof design that minimizes the use of gable ends.

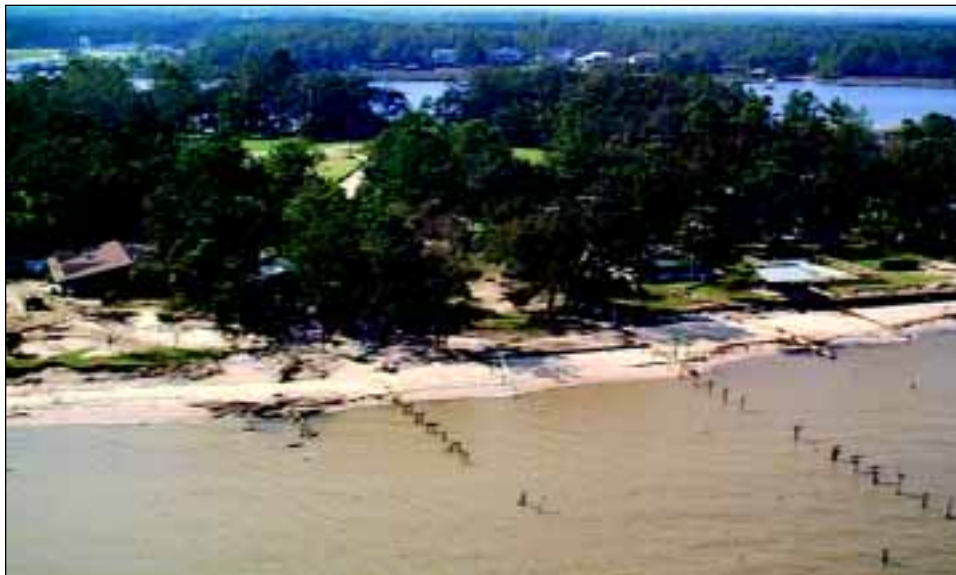
**FIGURE 4-28** Typical shoreline erosion along low-lying areas adjacent to Mobile Bay.

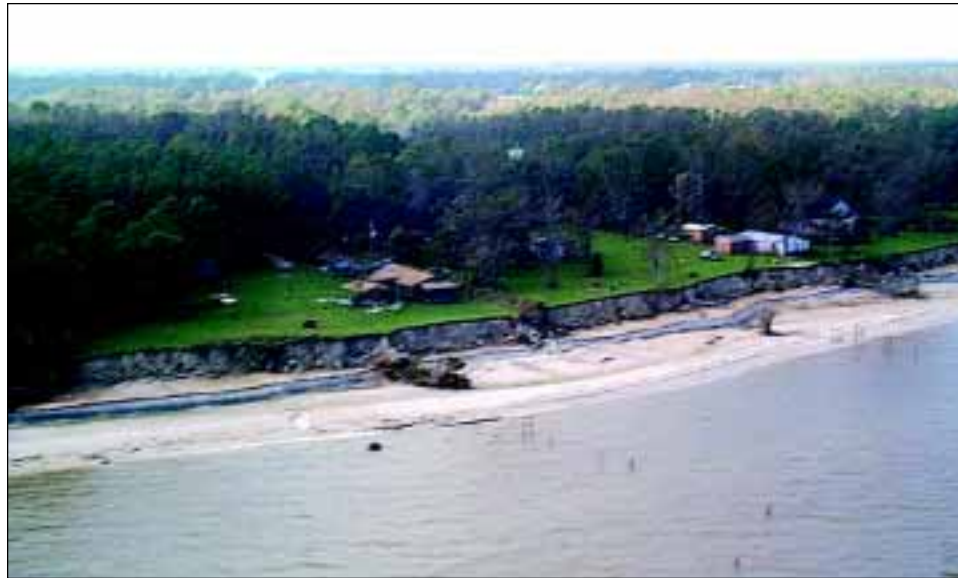
**FIGURE 4-29** Typical erosion along bluffed shoreline areas of Mobile Bay (western side).

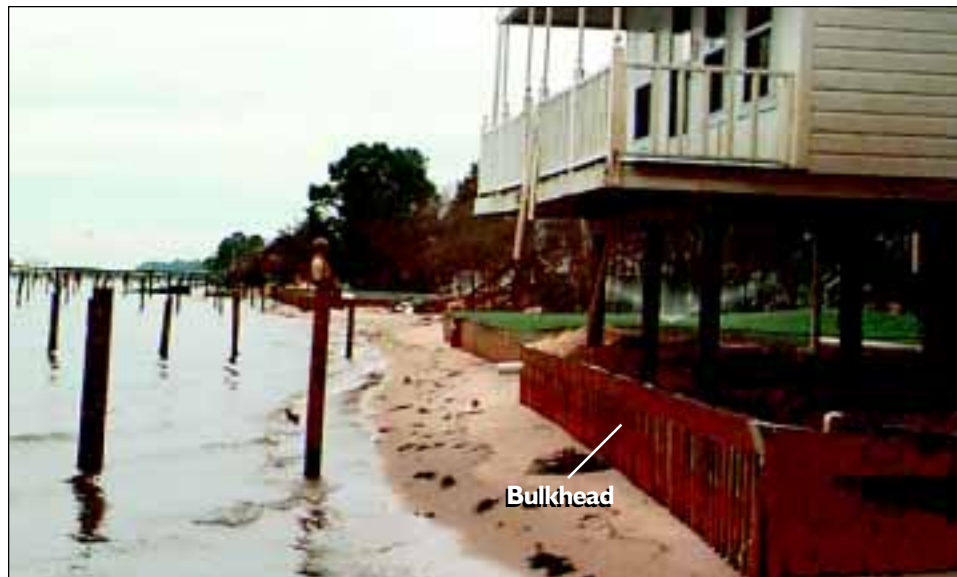
Wave action removed sand in front of bulkheads and overtopping removed much of the material from behind. Erosion was retarded by a relatively resistant, hard red clay layer located at a depth of 8 to 14 inches below grade. Following the hurricane, most bulkheads were still structurally sound as shown in Figure 4-30. Additional horizontal scour adjacent to bulkheads, caused by wrap-around/focusing of wave energy, was common along Mobile Bay.

**FIGURE 4-30** Bulkheads on Mobile Bay still in place after storm.

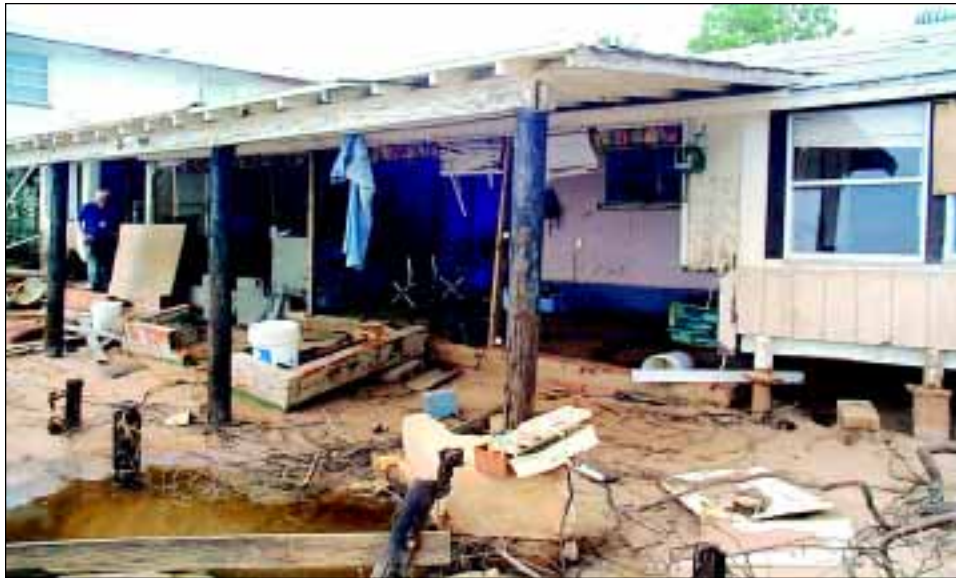
**FIGURE 4-31** Non-elevated pre-FIRM structure severely damaged by coastal storm surge.

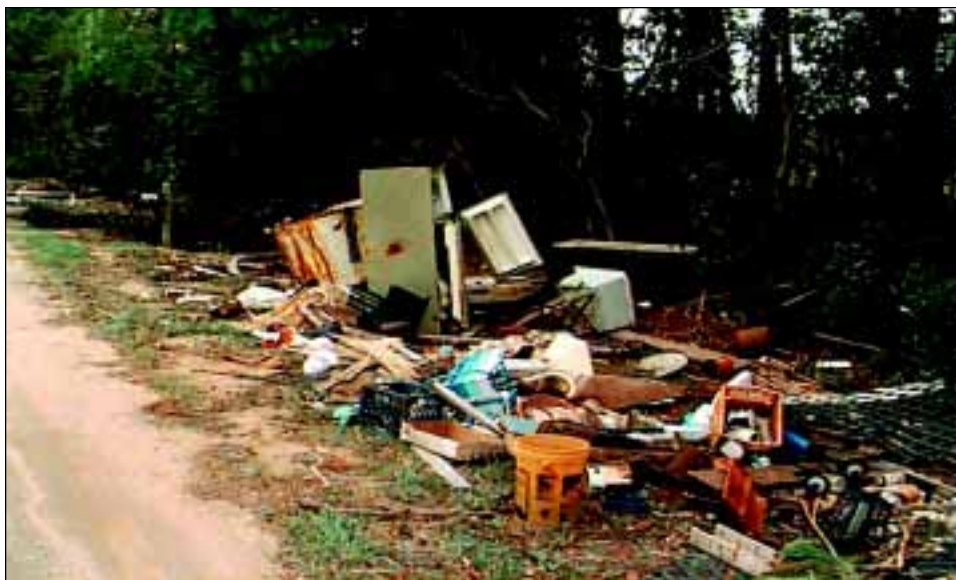
**FIGURE 4-32** Debris accumulation along coastal roadway.

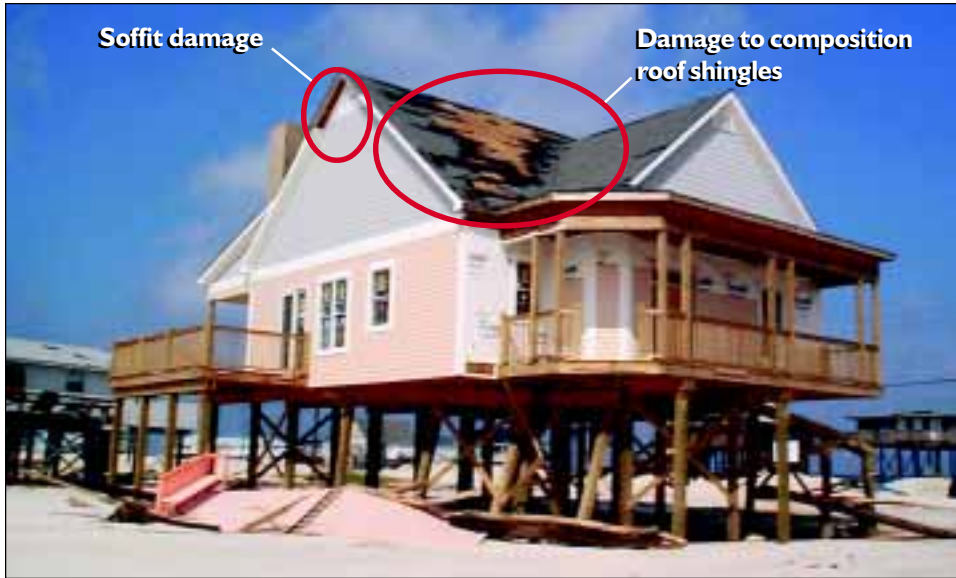
**FIGURE 4-34** Wind damage to composition roof shingles and siding on newly built coastal home.

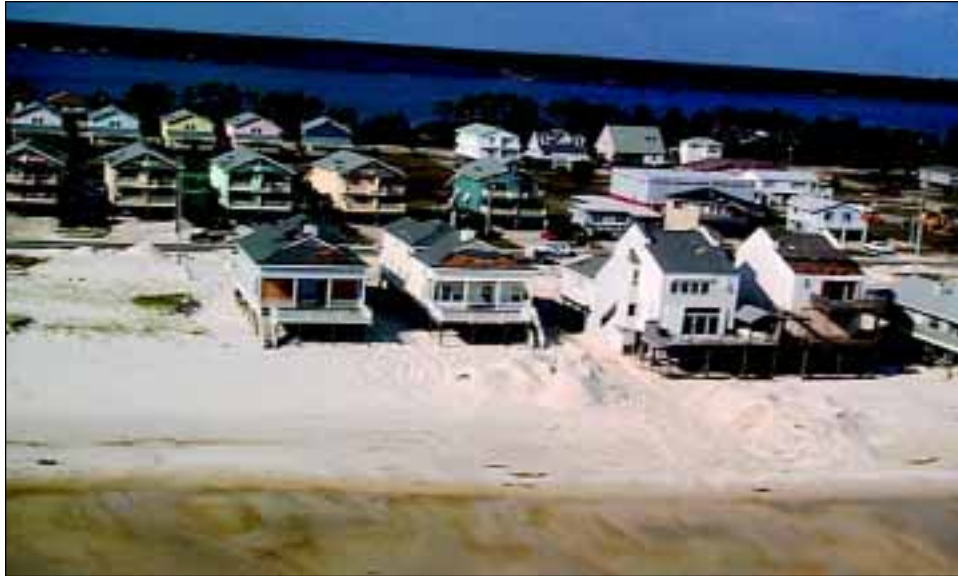
**FIGURE 4-36** Houses in Gulf Shores with roof damage. Note loss of roof covering on front-row buildings.

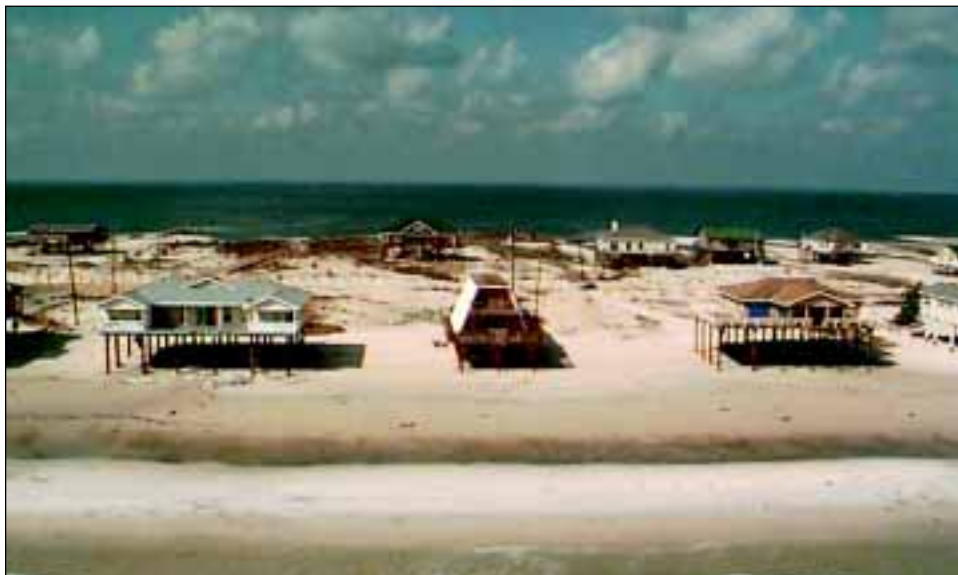
No significant wind damage was observed in Alabama's inland or coastal areas. In inland areas, roof damages were minor and buildings that did require repairs and cleanup were those infiltrated by wind-driven rain. The lack of significant wind damage along the Alabama Gulf Coast can be attributed to two factors: the wind velocities were not a design event, and improved building standards, methods and materials that were implemented as a result of past hurricanes performed successfully. For example, on Dauphin Island, the town developed specific requirements for the installation of asphalt/composition roof shingles, requiring six nails per shingle and the first two courses to be cemented to the roof underlayment. According to the local building official, implementation of these measures resulted in only minimal damage to asphalt/composition shingle roofs from Hurricane Georges (Figure 4-37). The BPAT was able to confirm that damage to roof shingles on Dauphin Island was, in fact, minimal.

**FIGURE 4-37** Fully exposed front-row houses that exhibited minimal wind damage.
