## 4 Alabama Observations

### 4.1 Flood Observations: Damages and Successes

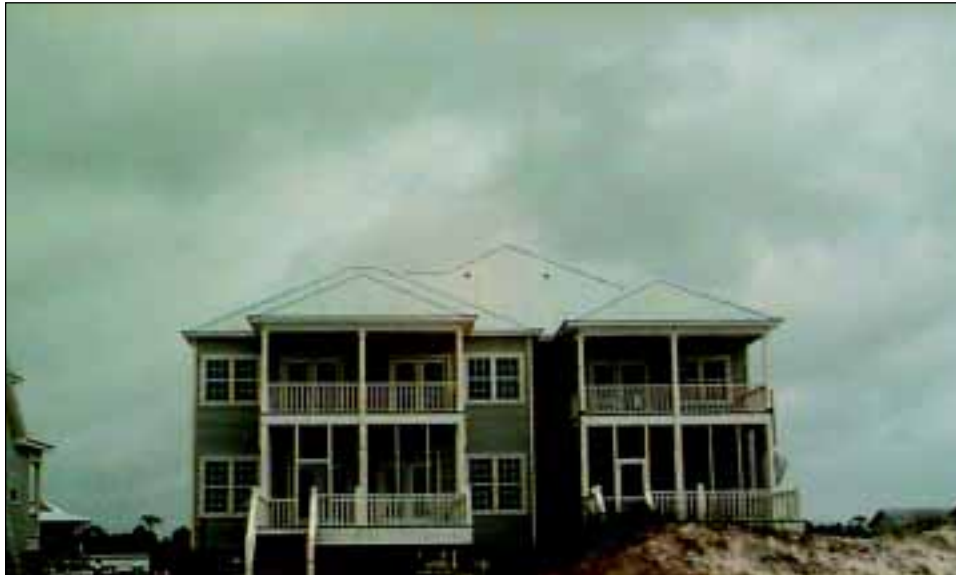
Metal roofs are becoming more common along the Alabama coastal and inland areas, specifically on Dauphin Island, Gulf Shores, and the Mobile Bay area. During this disaster, metal roofs appeared to have sustained little damage (Figure 4-38). However, since they are relatively new, their success must be further evaluated and based on longer exposure to salty, corrosive conditions and other environmental factors. The long-term performance of fasteners/connectors has been a particular concern in the past. In addition, most metal roofs the BPAT observed probably were not exposed to design level or greater winds.

**FIGURE 4-38** Metal roofing system on multi-family building in Fort Morgan performed well.

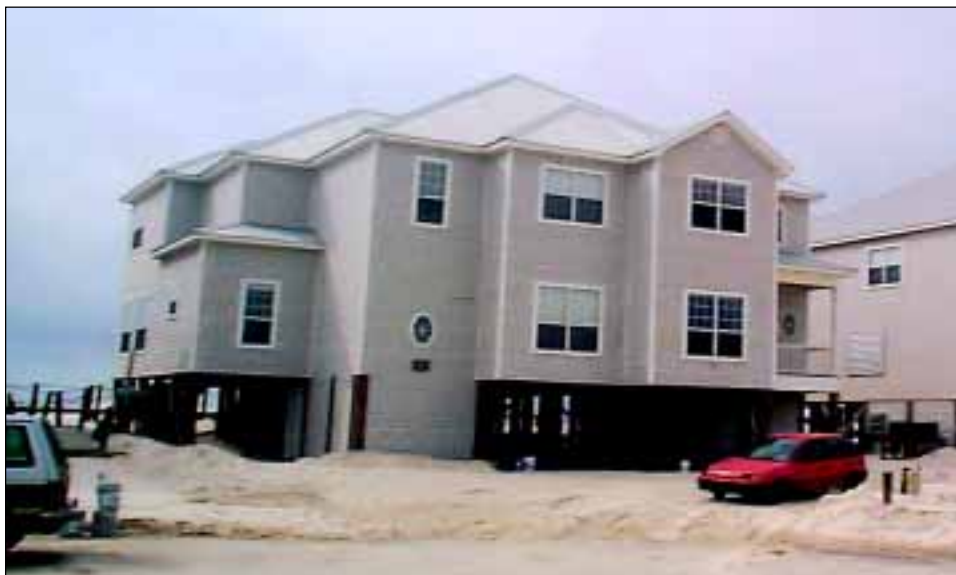
The BPAT discovered two structures in the Fort Morgan area with fiber-reinforced concrete siding. Upon inspection, this siding appeared to suffer no wind damage. The strength and rigidity of the material, the use of stainless steel nails, and the adherence to a specified nailing pattern apparently contributed to the successful performance of the siding (Figure 4-39).

**FIGURE 4-39** Fiber-reinforced concrete siding suffered no damage.
