Final Report

Tornado Damage Investigation

Greensburg, Kansas

October 24, 2007

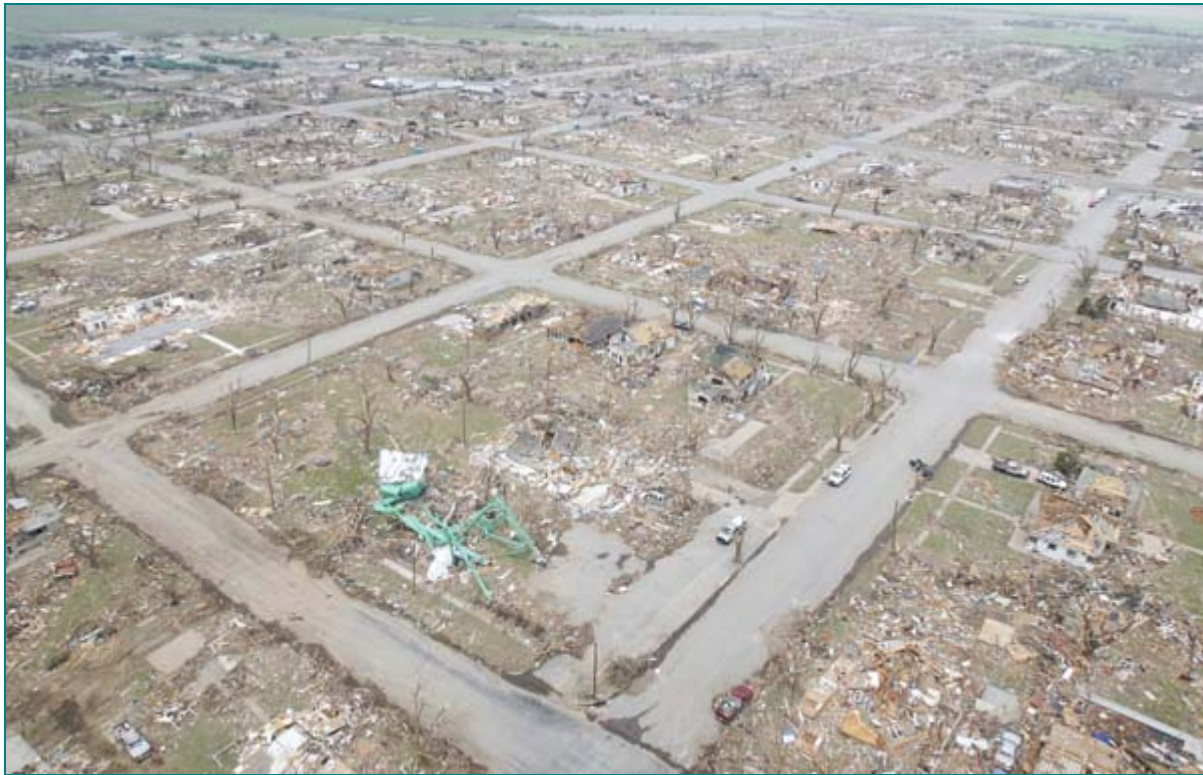
Figure 1: Greensburg, KS, after May 4, 2007 tornado event

1. The primary site observations were obtained from an initial study of overhead imagery and initial site inspections conducted on May 10-11, 2007:
 - a. The most severe swath of damage through the center of town was approximately five to six blocks wide. The damage on either side of this swath was less for about one to two blocks on each side, with even less damage observed for another one to two blocks on the extreme outer edges of the damage swath. See Figure 1 for an aerial view of Greensburg after the event and Figure 8 for a map of the damage swath.

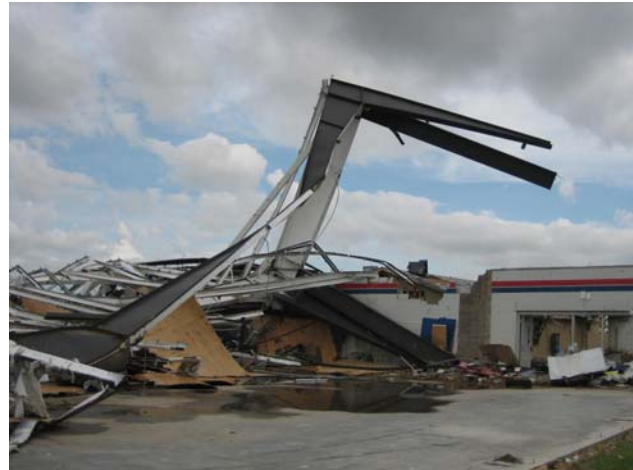
Figure 2: PEMB Elementary School

The school is a PEMB located on the southeast edge of Greensburg. This is the side of town that received the strongest tornado winds coming from the east. Figure 2 shows the school gymnasium blown over and leaning to the west, consistent with the wind coming from the east.

The calculated wind speed of 153 mph represents a DOD 8 for a metal building system (building type number 21) in the new EF Scale. The DOD 8 is described as total destruction of the building resulting from an expected wind speed of 155 mph. The Greensburg wind speed result for this elementary school PEMB provides one data point on the DOD 8 scale that corresponds with the field damage, as represented by the four failed column base plate bolts.

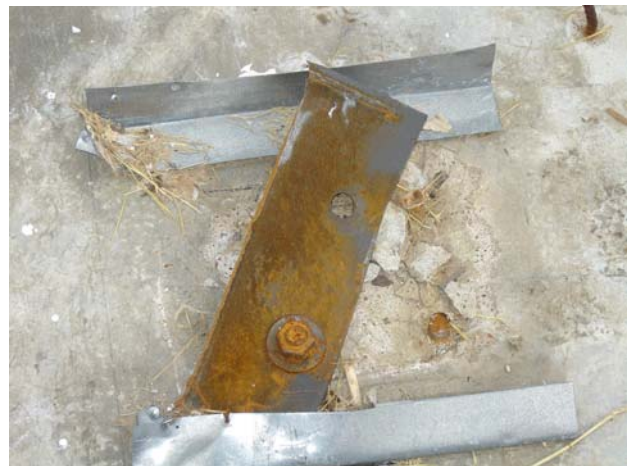
Figure 3: Bolt Failure

A key damage observation judged to be useful in determining the wind speed that caused the building collapse was the failure at a column base plate where all four steel bolts sheared off. The bolt failure was a twisting (shearing) tensile failure as illustrated in Figure 3 (example shown had three bolts sheared off).

The bolts were assumed to be A307 and are 5/8" in diameter. The ultimate tensile load required to snap the bolt was determined to be 25 kips³ (k) per square inch (ksi) or 7.67 k for a 5/8-inch diameter bolt. The required uplift would be 30.68 k for the column attached to this base plate. The tributary area for this column was 30 feet (height of wall) times 20 feet (column spacing).

The wind pressure (q) required for this force is $30.68\text{k}/600 \text{ square foot (sf)} = 51.1 \text{ pounds per square foot (psf)}$. The wind speed (velocity, V) required to develop 51.1 psf using the external pressure coefficients noted below could have ranged from 134 mph to 330 mph. The Study Team judged the combination of external and internal pressure coefficients that equal 1.0 fairly represent what the physical evidence suggested. The use of external and internal pressure coefficients that sum to 1.0 results in the velocity being approximately 153 mph (3-second gust) when the velocity pressure equation is solved for V (Velocity) and when $q = 51.1 \text{ psf}$.

Depending on how the building really failed, the roof coefficient (from ASCE 7) could be -0.9 and the wall coefficients could be +0.8 to -0.5. The internal pressure coefficients were assumed to be +/- 0.55 for a partially enclosed condition. A gust effect factor of 0.85 was used. There are many things that could have happened to shear four bolts in a column base plate. In one possible scenario, the building could start to collapse and then the weight of the building would push the building over, pulling the base plate from the concrete and shearing off the four bolts.

Let's assume the failure is a brittle snapping/tension failure so each bolt fails at $(25 \text{ ksi})(0.3068 \text{ in}^2) = 7.67 \text{ k}$ and the column connection failed at $(7.67 \text{ k})(4 \text{ bolts}) = 30.68 \text{ k}$.

With the unknowns on the failure mode, let the term $(GC_p \pm GC_{pi}) = 1.0$ and solve for V , which yields **$V = 153 \text{ mph}$** . This method neglects the reduced capacity of the column/base plate connection since presumably, the roof and column are being pulled up by the wind.

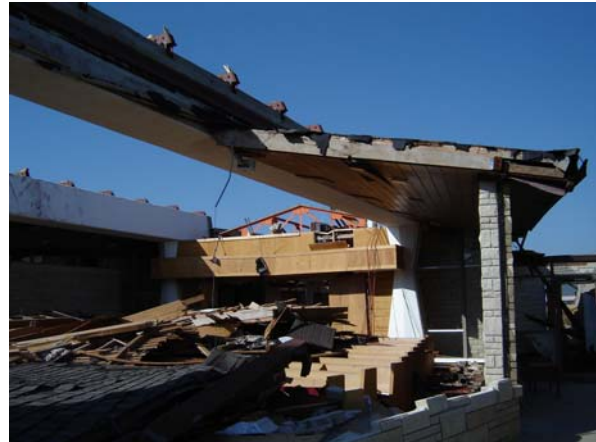
Figure 4: Laminated Roof Beam Failure

The First United Methodist Church is located on the west side of Greensburg in an area that appears to have experienced mostly EF0-EF2 wind speeds (a range of 65-137 mph, see Figure 8) based on its ranking using the EF Scale (Section 3.1). The church roof was framed with 3 ¼-inch wide by 11½-inch deep laminated timber beams. These beams were bolted into steel saddles on each side of the church sanctuary. The saddles were connected to concrete girders shown in Figure 4.

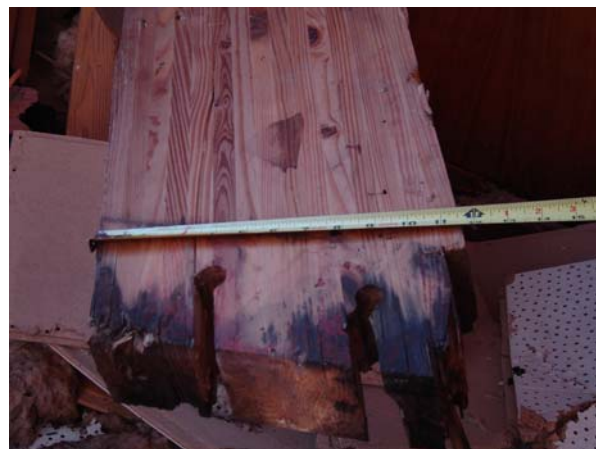
Figure 5: Glulam Beam from Church

The failure mode appears to be roof uplift. Uplift forces acting on the roof appear to have separated the laminated beams from the steel saddles as illustrated in Figure 5. As the laminated beam separated from the steel saddles, the original bolt holes became slots at this failure point. The bolt slots that are ripped in the beam are 4¼-inch long. There appeared to be some deterioration in the end of the beam that would likely reduce the shear strength parallel to the grain of the beam.

The shear design value from the National Design Specification for Structural Glued Laminated Timber is 200-250 pounds per square inch (psi). The failure shear value might be approximately the same given the condition of the end of the beam.

The calculated area of each slot failure is 13.32 square inches (sq in), or 27.62 sq in for the two slots. It is likely the wind started lifting up on the roof and while the roof failure might have been complete and total within seconds, the failure could have occurred as a result of a series of events. As the roof lifted, the bolt slots are likely to have failed some, giving the bolts room to move and thus creating further stress on the wood, eventually allowing the wood beam to pull away from the bolts that secured the wood beam to the steel saddles. If the bolt slot was

lengthened to only 1 inch, instead of the full 4 ¼ inches, and this constituted failure, the force required to pull the wood beam up 1 inch is 1 inch x 3 ¼ inches x 200 psi = 650 pounds (lbs) x 2 bolts = 1,300 lbs.

The uplift force had to overcome the weight of the wood beam, which was approximately 227 lbs, so the total uplift force required was 1527 lbs.

The beams were spaced 4 feet on center and spanned 20 feet. There was a 3-foot overhang on each edge of the roof. The tributary area for the beam receiving the uplift pressure was approximately 64 sf. The uplift pressure was 1,527 lbs/64 sf = 23.2 psf. Assuming roof external pressure coefficients of -0.9 and a partially enclosed condition, the wind speed calculated from these conditions is 91 mph.

The wood laminated timber beam is 3-1/4 inches wide x 11-1/2 inches deep. The failure is parallel to the grain tension in the wood since the bolts "sliced" through the end of the beam from the bolt holes. The bolts appeared to remain attached to the steel saddles that were used to support the end of the beam.

The area of failure considering that 1 inch of movement in the bolt hole constitutes failure is $(1\text{ inch})(3.25\text{ inches}) = 3.25\text{ in}^2$. Failure for the 2 bolts using shear failure of 200 psi = $(3.25\text{ in}^2)(2\text{ bolts})(200\text{ psi}) = 1300\text{ lbs}$.

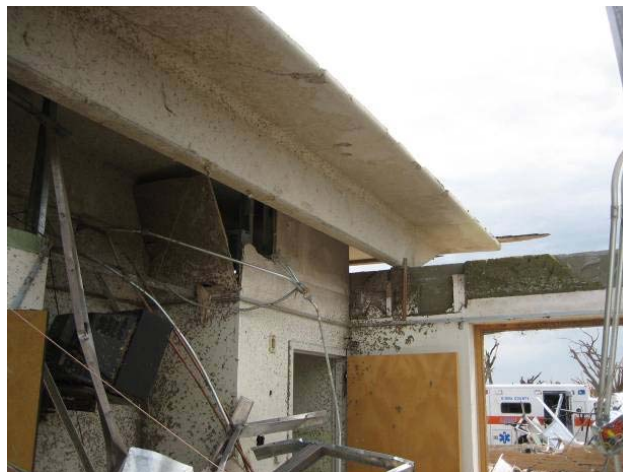
Figure 6: Hospital with Precast Concrete Twin Tees

The hospital is located north of Garfield Street and between Grove and Walnut Streets. The hospital roof was flat and framed with precast concrete double tees 40 inches wide and spanning 34 feet with 3-foot overhangs on each end (Figure 6). The precast concrete tee was calculated to weigh 9,979 lbs. There was an additional 15 psf of roof covering (roof felts and gravel ballast) on the roof at the time of the tornado strike. The precast concrete tee was not attached at all to the wall; it was only resting on the wall and held in place by gravity. The failure mode was the precast tee lifted off the hospital walls and was moved 80 feet from its original location on the roof. It is uncertain how the concrete tee reached this location. It could have tumbled across the roof or been picked up and thrown.

There was a new PEMB at the hospital that was also damaged (described in a case study in FEMA 577). The DOD for the damage observed at that PEMB building indicated an expected wind speed of 155 mph. These results are consistent with the other wind speed determinations for the hospital.

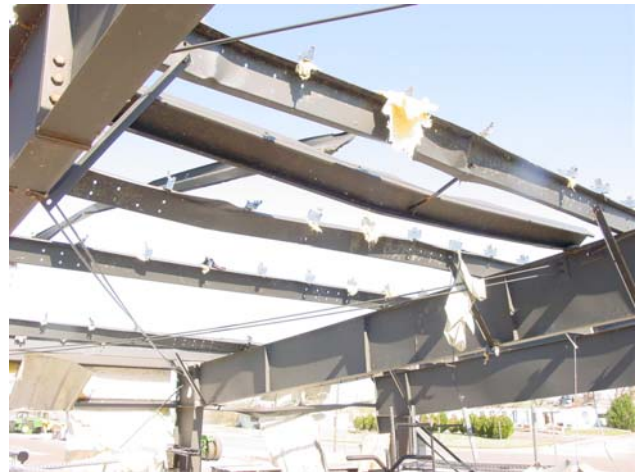
Figure 7: PEMB for the John Deere Building

The John Deere Building is located on the northwest side of Greensburg near the western edge of the tornado. The building is a PEMB and was damaged by winds that came from the west. The primary damage was to the steel roof purlins. Most of the structural framing remained intact as illustrated in Figure 7. The failure mode was the purlins failed in buckling as the roof sheathing was torn off. This failure mode is a good determinant of the wind pressure as a DOD damage state is roof purlin buckling on PEMBs.

From the EF Scale for metal building systems (building type number 21 on the scale) in the new EF Scale, DOD 5 is for buckling of roof purlins with an expected speed of 118 mph. The calculated speed of 122 mph agrees with the EF Scale DOD value. The 122 mph wind speed represents a tornado rated an EF2.

The failure mode studied in this building was buckling of the steel roof purlins, which are 'Z' shaped. The thickness was 1/16 inch or 0.0625 inch. The 'Z' shaped channel was 8 inches deep, 16 feet long, and had 3-inch wide flanges that formed the 'Z'. The moment of inertia about the axis that buckled (y axis) was calculated to be 0.281 in⁴ (determined by $bt^3/12 \times 2$ flanges; the thickness of the flange that constituted the y axis was so small to be negligible).

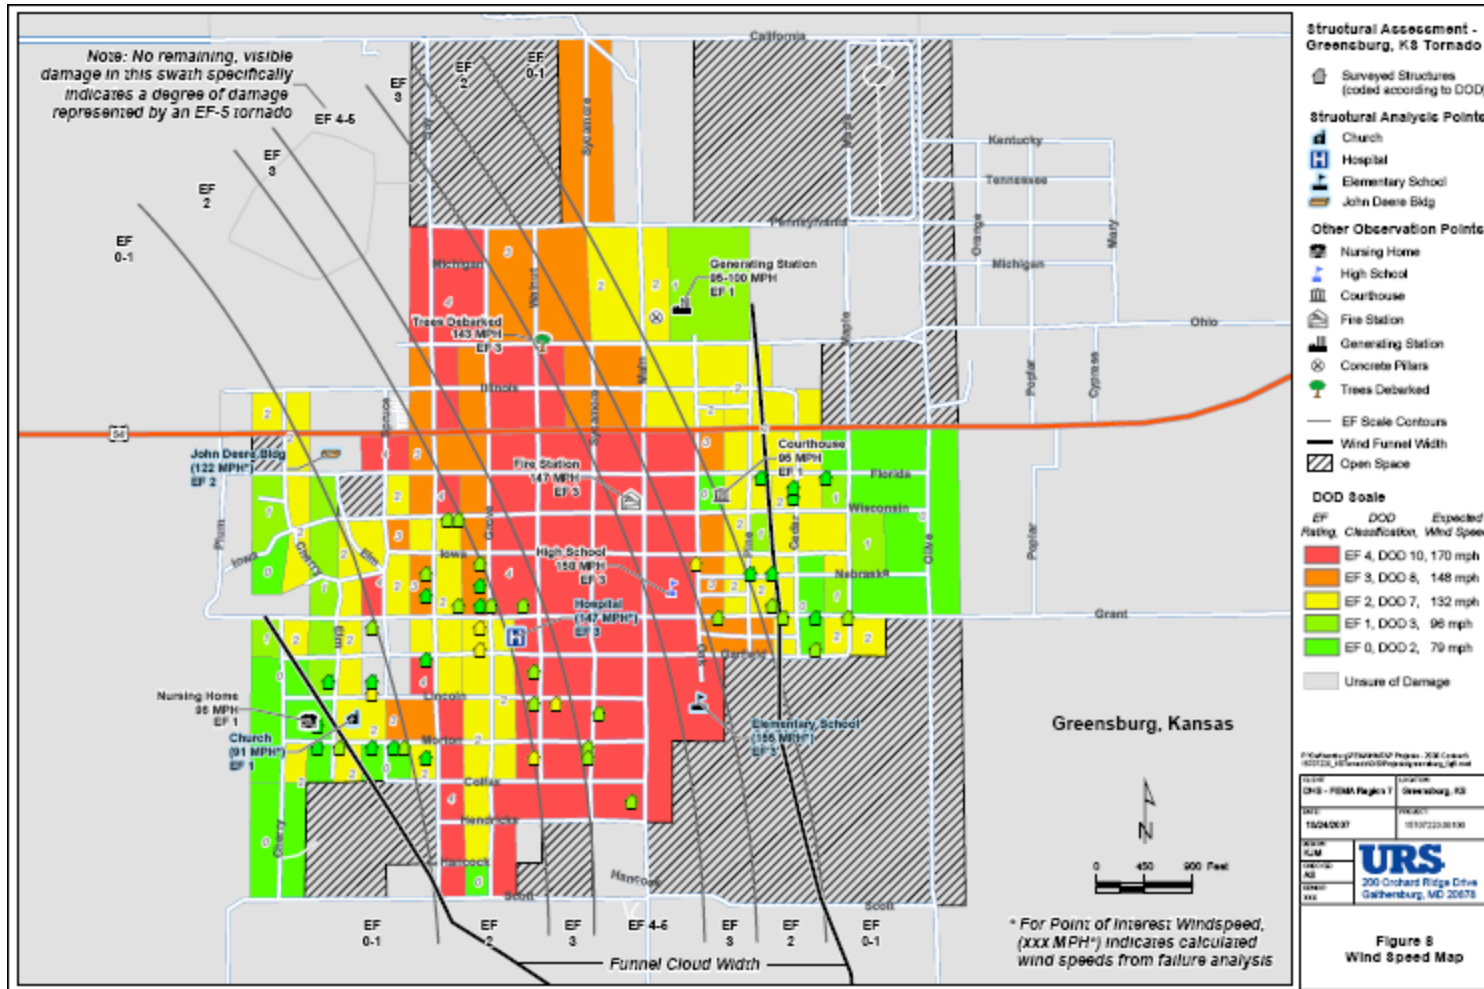
Figure 8: Wind Speed Map for Greensburg, KS Tornado

The 46 buildings surveyed for damage and used to estimate the wind speeds based on DOD are shown on the map (Figure 8). Where possible, the specific DOD for the building is shown. The results of the calculated wind speeds for the four sites where detailed structural analysis was performed are also shown on Figure 8. The wind speeds calculated from structural analysis were consistent with the wind speed swaths derived from the DOD information.

During the site visits, damage to other infrastructure (i.e., power station, courthouse, high school, fire station, etc.) was observed and these facilities are identified on Figure 8. Calculations of estimated wind speeds that could have caused the damage were not performed for these buildings or vegetation.
