Project name: Little Chippewa Creek Dam

Summary: Separation of spillway conduit joints due to foundation movement

Conduits through Embankment Dams

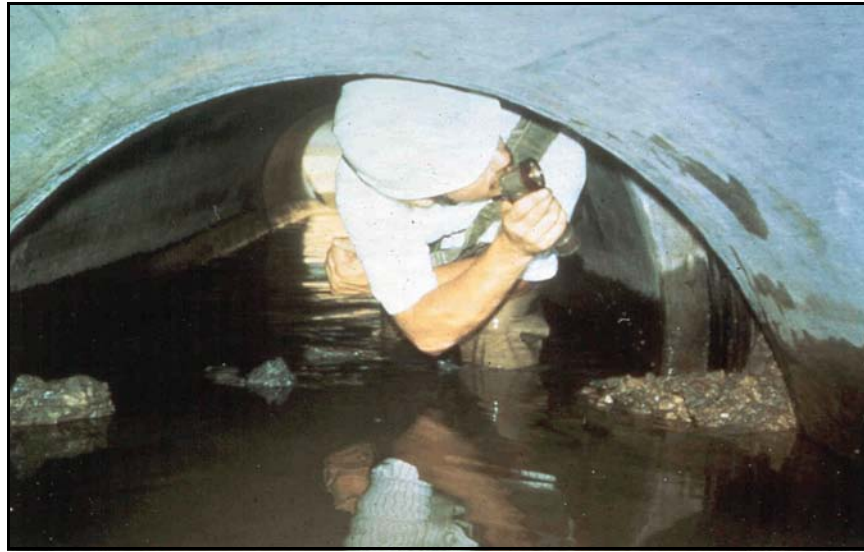
The bottom of the pipe under the maximum earthfill height settled by about 1.5 feet, and the joints of one section of the pipe separated by more than 1 foot (figure B-49). The engineers investigating of the failure reported that the foundation soils under the

Figure B-49.—The pipe joints separated when foundation movement occurred during construction of the embankment dam.

pipe, visible through the open joints, were soft, wet silts that resembled “stiff grease.” The engineer reported that no sands or gravels were encountered, and that the soil could be probed easily with a hand ruler to depths of 6 feet below the pipe. The report also indicated that the sheet metal shields on the outside of the joints appeared to support the embankment soils and minimized migration of soil into the open joints.

The permanent repairs included removal and relocation of the failed principal spillway conduit and appurtenances; reconstruction of the embankment dam in the vicinity of the failed spillway; installation of a new spillway at another location; addition of 70-foot-wide stabilizing berms to the upstream and downstream sides of the dam; addition of chimney drain across the reconstructed area of the embankment dam and around the new spillway pipe; and addition of a cut-off trench across the emergency spillway control section to seal the emergency breach channel.

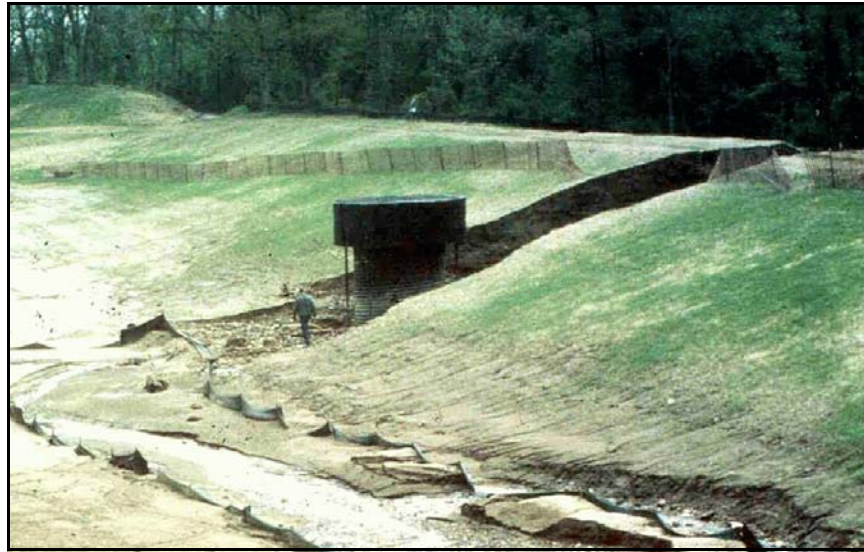
The embankment dam failed less than a year after it was completed, when a relatively small storm filled the pool to the top of the riser. Failure was attributed to internal erosion of embankment fill along the outside of the pipe (figures B-50 and 51). The original spillway pipe was likely placed in a vertically sided trench excavated through the nearly completed embankment dam. This construction technique is not recommended, as it makes compaction of the soil under the sides of pipe very difficult.

Poorly compacted fill in this area results in poor support of the pipe, which causes excessive deformation of the pipe and may cause the joints to separate. In addition, the sides of the trench may tend to support the fill, allowing it to “bridge” across the excavation, preventing the fill from consolidating under its own weight. This can create areas of low soil density under the pipe where seepage can occur. In addition, differential settlement and hydraulic fracture can result.

Figure B-50.—Loveton Farms Dam failure as viewed from upstream. Note that the walls of the failure area are nearly vertical. The construction records indicate that a large portion of the embankment dam was placed prior to installation of the CMP.

The embankment dam was redesigned to include seepage controls. The structure was rebuilt in 1990 using essentially the same embankment dam and spillway

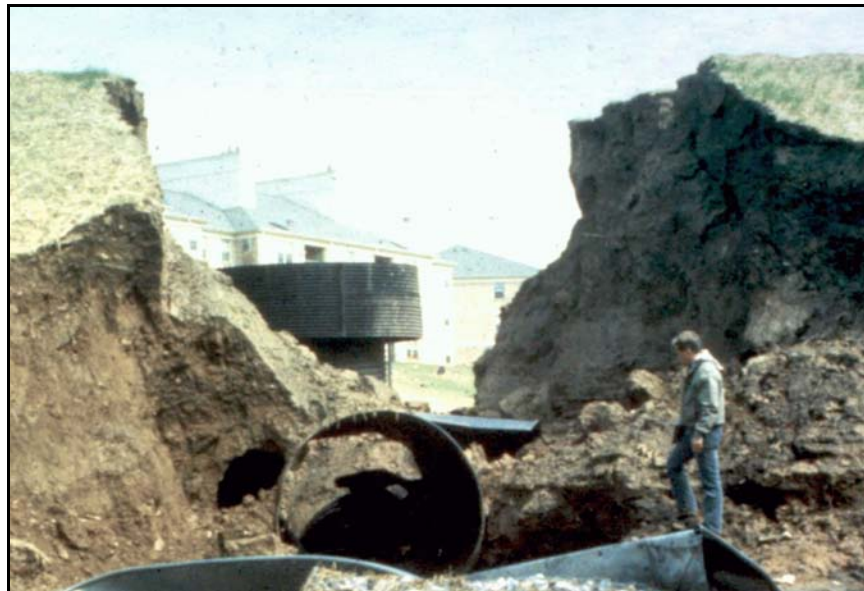
Figure B-51.—Loveton Farms Dam after failure as viewed from the downstream end of the 78-in diameter CMP spillway. Note that one of the antiseep collars, which were about 14 feet square, is visible in the breach.

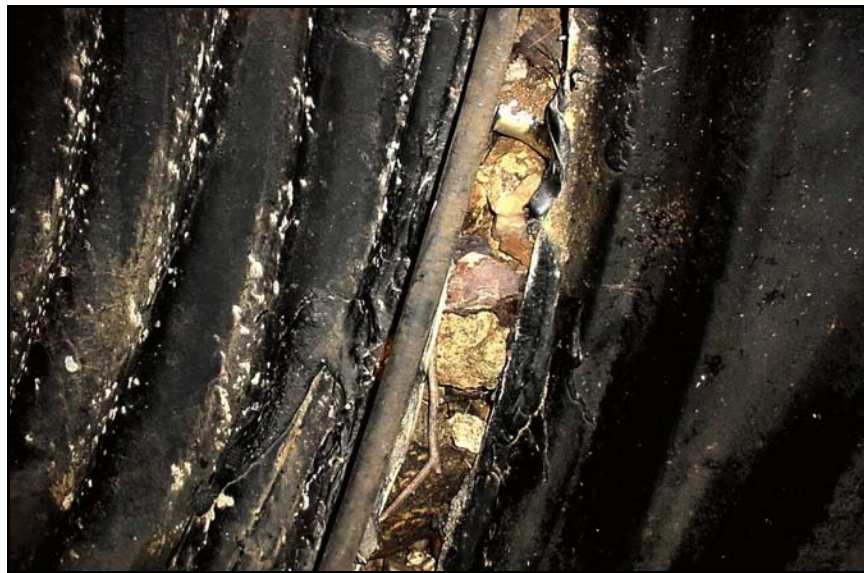
Figure B-52.—The failed embankment dam was repaired with a new 78-in diameter CMP spillway. However, soon after reconstruction, this failed joint was discovered at the upstream end of the pipe near the riser. A large void was also observed in the adjacent embankment fill. Note the o-ring gasket has been displaced from the joint.

pipe. During an inspection in 1994, large voids (3 feet diameter and 20 feet long) were noted in the embankment around the upstream end of the pipe, and the first joint downstream of the riser had suddenly separated by about 0.1 m.

The embankment dam was determined to be unsafe, and the riser portion of the spillway was removed to minimize impounding of water until a more detailed inspection could be conducted. A more thorough investigation of the embankment dam utilizing seismic tomography revealed that nearly all of the embankment fill around the conduit was of low density. Since the soils are frost susceptible (silty sands and sandy silts of low plasticity), it is quite possible that freezing damaged the soils adjacent to the conduit. The melting of ice lenses that may have formed in the backfill would leave voids through which internal erosion could occur. Also, the formation of ice lenses can create forces large enough to deform the thin steel pipe, causing the joints between pipe sections to open.

The embankment dam was deemed to be unsafe and is scheduled to be removed.

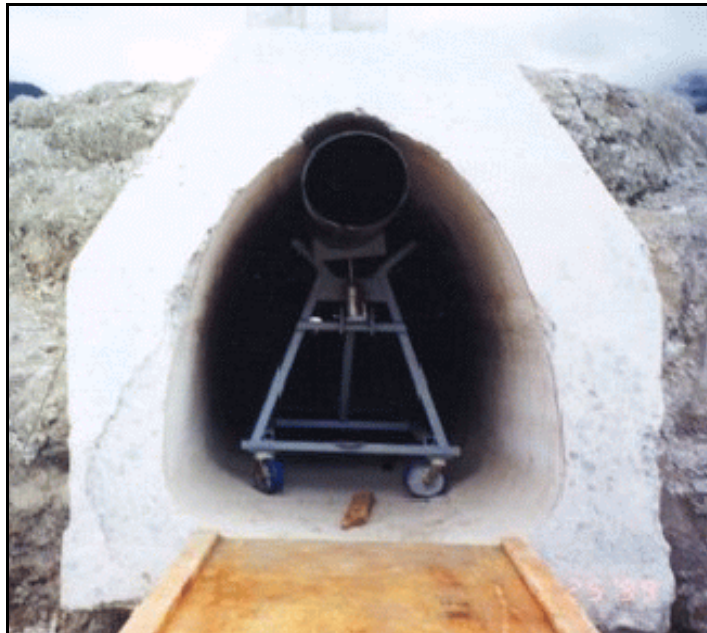
Figure B-53.—Existing 6-foot diameter elliptical conduit.

McDonald Dam is located near Polson, Montana on the Flathead Indian Reservation. A section of the 6-foot diameter elliptical conduit (figure B-53) was removed and replaced. Installation of both 52- and 16-inch diameter bypass pipes was completed in the conduit replacement section, and a hydrostatic test of the 16-inch diameter bypass pipe was performed. The hydrostatic testing was performed in increments and eventually tested the entire lengths of the 52- and 16-inch pipes, as well as existing pipe installed in an earlier contract. Due to the existing 2-inch diameter air vent at the intake structure (tower), a portion of the pipe was pressure tested at 20 lb/in² instead of the 30 lb/in² required by the specifications.

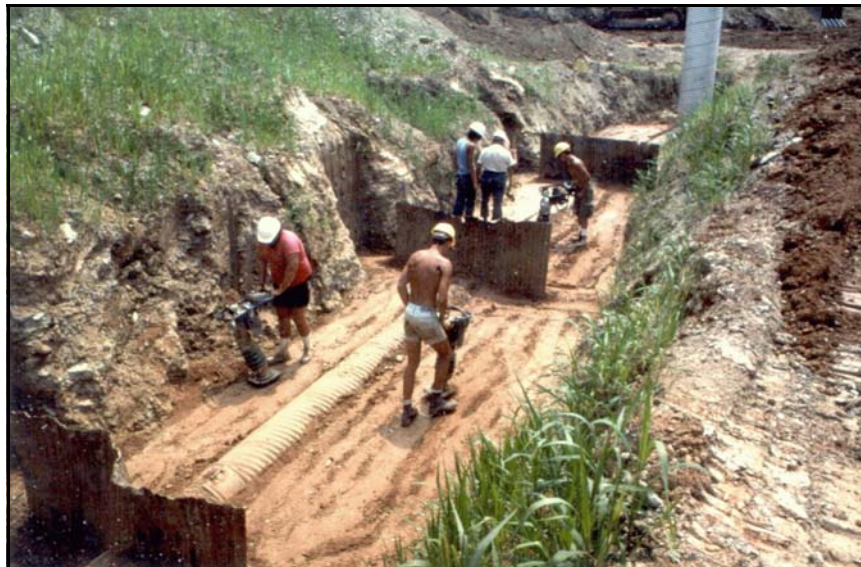
The embankment dam was constructed in 1988 as a “temporary sediment basin.” Although an engineer prepared plans for the structure, no engineering supervision was provided during construction. Local materials (decomposed shale and erodible silts) were used to construct the embankment dam. A CMP spillway with conventional antiseep collars was constructed in a trench excavated into the foundation and backfilled with low plasticity silts and decomposed rock fragments from the excavation (figure B-54).

Figure B-54.—The embankment dam was constructed with antiseep collars.

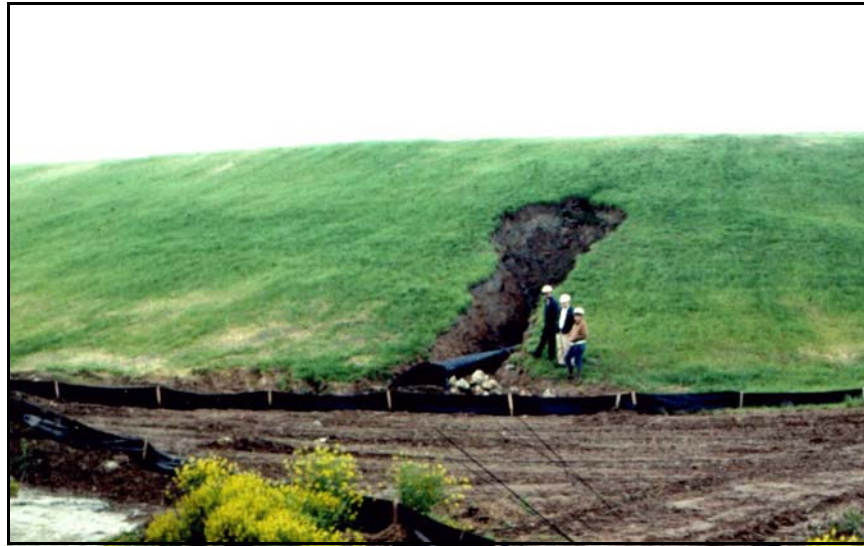
The structure was placed into use the following year, and it failed upon first filling. When the pool level was only about 2 to 3 feet deep, flow along the outside of the pipe resulted in loss of the adjacent soils by internal erosion (figure B-55).

Figure B-55.—When the pool level of this embankment dam was only about 2 to 3 feet deep, flow along the outside of the CMP resulted in loss of the adjacent soils.

The spillway structure was removed and replaced and has performed satisfactorily.

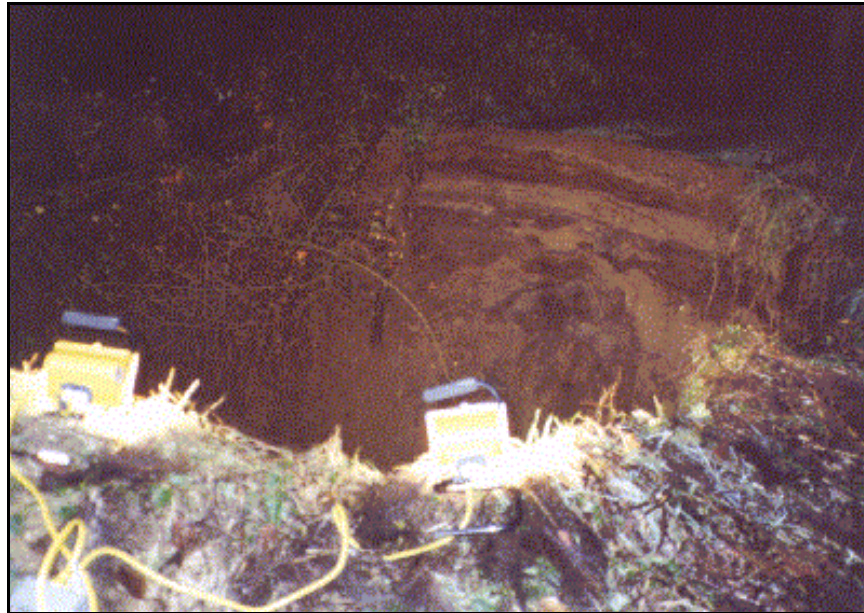
On December 11, 1996, a sinkhole 20 feet in diameter and 17 feet deep opened up in the crest of the embankment dam (figure B-56). At the time the sinkhole developed, the property on which the embankment dam sat was uninhabited due to the recent death of the property owner. The sinkhole was discovered by neighbors walking the streambed to investigate the cause of muddy streamflows. This was fortuitous in that the sinkhole was discovered before it led to an embankment failure. The sinkhole appeared to have resulted from a collapse in the top section of the cast-in-place box culvert that served as the principal reservoir outlet. The failed segment of the conduit allowed overlying masses of embankment soil, over time, to repeatedly drop into the conduit, where flows then flushed the soil downstream. This sequence of events was supported by the record of stream flows in a downstream gauging station. The gauge record shows normal flows interrupted by a series of near zero creek flows immediately followed by short, abnormally high channel discharges. The zero flows are interpreted as incidences of soil masses falling into and plugging the conduit. The following anomalous high flows represent a blowing out of the plug and a release of backwater in the conduit and inlet tower upstream of the plug.

Figure B-56.—Sinkhole in the dam crest the night of December 11, 1996.

As an immediate response to the threat of an embankment dam breach, county maintenance staff filled the sinkhole with some 200 yards of angular cobbles and boulders. The State dam safety staff saw no viable alternative to the county's scheme to address the immediate crisis. Finer grained soils would likely have been sluiced through the top of the collapsed box conduit. This could have worsened the situation by plugging what limited outlet capacity remained after sediment had largely blocked the conduit. Nonetheless, it was obvious that the rockfill was but an interim measure, and immediate follow-up action was necessary to lower the reservoir and permanently resolve the public safety threat. Three days of pumping were necessary to lower the reservoir to allow excavating a trapezoidally shaped breach of the embankment dam (figure 57). The floor of the breach was armored with a geotextile fabric and capped with much of the rock originally dumped into the void the night of the failure. To improve fish passage, an attempt was made to include a number of pools along the breach channel at the direction of the Washington State Department of Fish and Wildlife. The Washington State Water Quality staff assisted in blanketing the disturbed sections of the embankment dam with hay to minimize further sediments entering the water course.

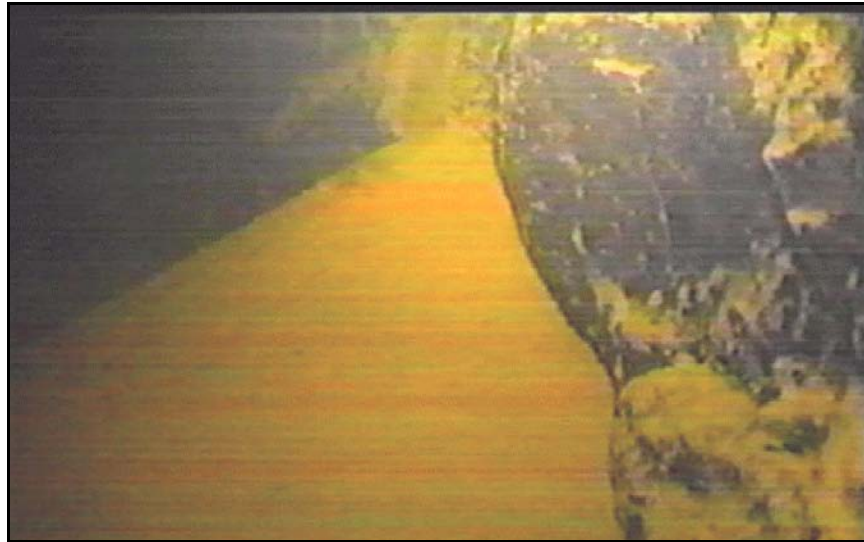
Figure B-59.—The camera-crawler encountered fine sandy materials that appeared to be entering the conduit through a defect in the sidewall. This view is looking upstream at the right side wall. The conduit had not been operated since the fall of 2003. These materials had collected within the conduit over the last 7 months.

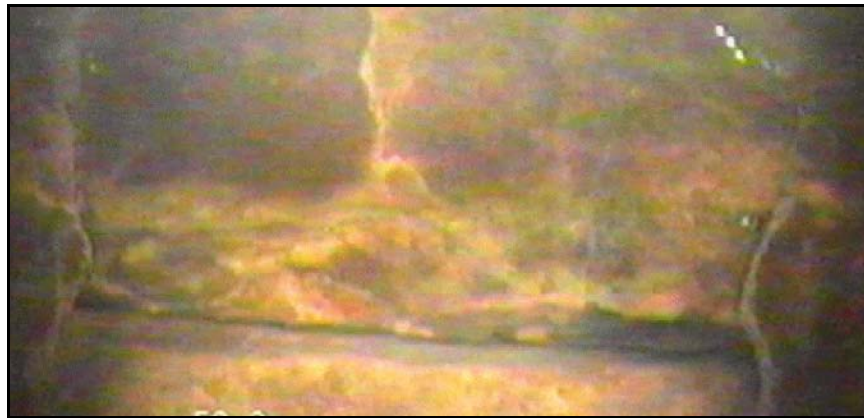
Figure B-60.—Just into the masonry conduit an open defect (crack), shown in the lower part of the figure, exists in the crown of the conduit. This defect allowed sandy materials to enter the conduit.

A contractor was mobilized to lower the reservoir level to elevation 4880.0 using high capacity, low head pumps (12-inch diameter). The reservoir drawdown was limited to 1 foot per day. After the reservoir was lowered to the desired elevation, a siphon was installed to provide downstream irrigation releases. Figure B-61 shows the siphon discharge irrigation releases. Based on the deteriorated condition of the conduit, the BIA decided to abandon the outlet works by grouting it closed. The

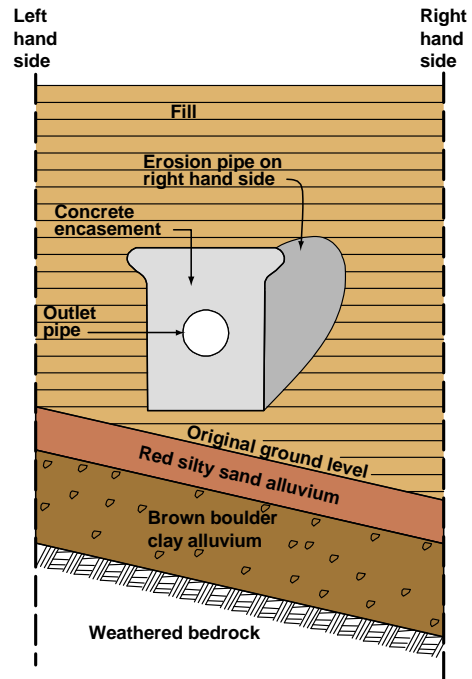
Figure B-64.—Cross section through the outlet conduit showing pipe, encasement and erosion tunnel.

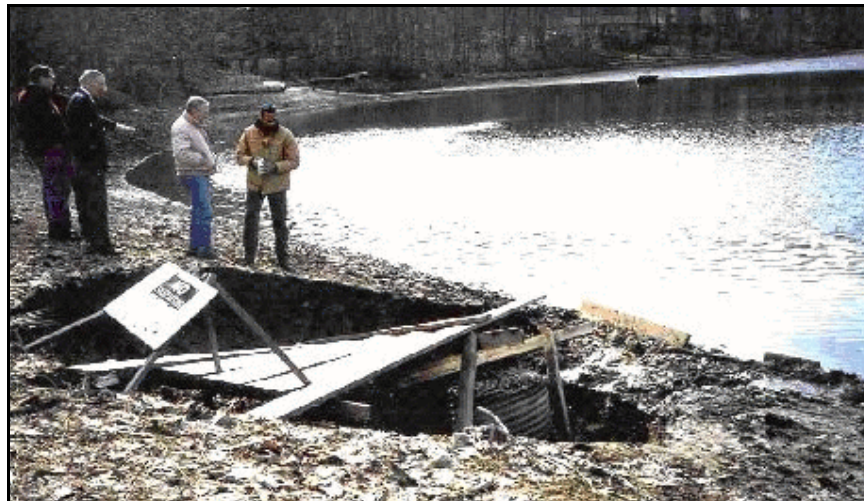
Figure B-67.—When the 35-year old corrugated metal pipe riser collapsed, a large portion of the low hazard embankment dam was washed away. This left a void about 30 feet in diameter and 10 feet deep around the original riser.

A CCTV inspection of the barrel portion of the CMP revealed that the remaining sections of pipe were in good condition. The engineer elected to slipline the existing 24-inch diameter barrel with 20-inch (outside diameter) Snap-Tite® pipe (SDR 32.5). The space between the two pipes was filled with a grout composed of fly ash and cement (compressive strength 2,500 lb/in²), and a new aluminum riser was constructed within the upstream portion of the embankment dam.

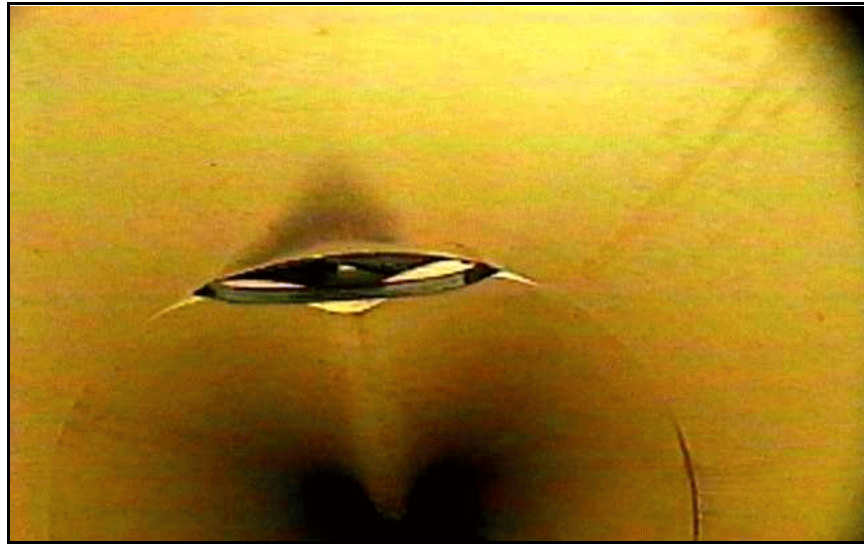
Figure B-70.—An open joint was discovered in a 16-inch PVC temporary diversion pipe under the 118-foot high embankment dam.

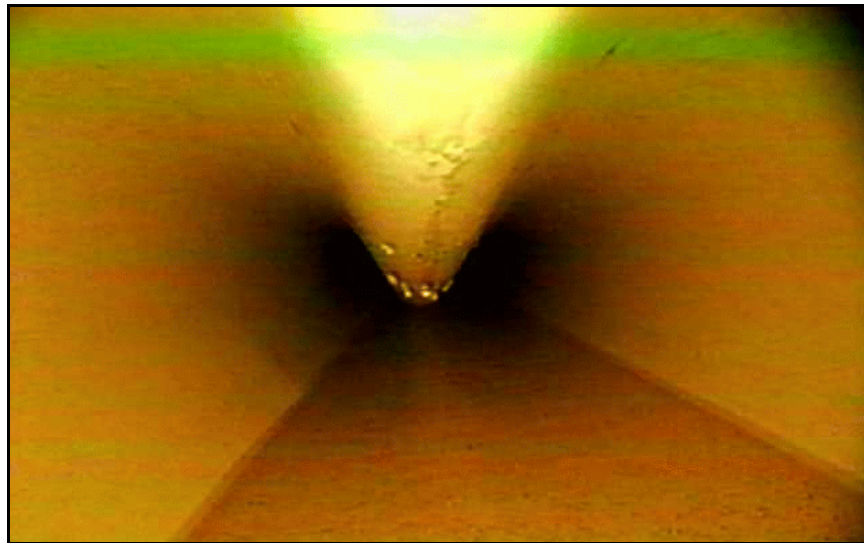
Figure B-71.—A portion of the temporary PVC diversion pipe was found to be severely deformed.

to court. If they had proceeded with the modification, this would have resulted in an unsafe pipe, subjected to full reservoir of more than 100 feet of head pressure running through the base of the embankment dam, with a valve at the downstream end. The presence of the separated pipe joint could ultimately have resulted in a disaster.

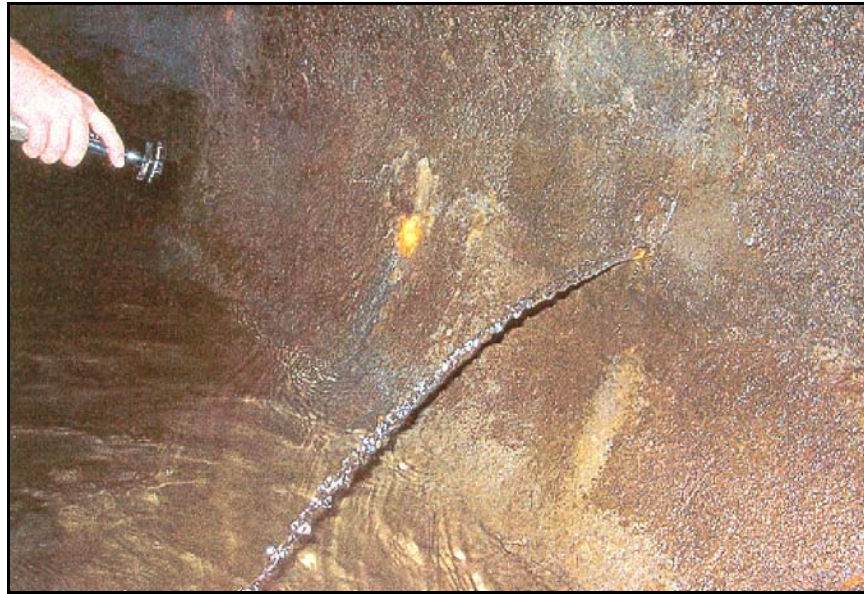
Figure B-72.—Seepage entering the downstream conduit.

the seepage into the conduit prior to installation of the tap. At this location, it was discovered that a void approximately 12 inches in depth existed behind the conduit wall. The concrete in this section of the conduit, which had previously been described as good, was determined to have 3 to 4 inches of somewhat sound concrete, backed by approximately 6 inches of loosely bonded aggregate or rubble. In subsequent explorations, it was determined that the void extended a minimum of 3 feet upstream and 4 feet downstream from the tap and was approximately 3 feet high.

A decision was made to perform concrete repairs on the poorest areas the downstream conduit. In preparation of the repair work in March 2001, a tap was inserted into a crack in the conduit approximately 190 feet upstream of the outlet portal in order to control seepage that was entering the conduit. Figure B-72 shows

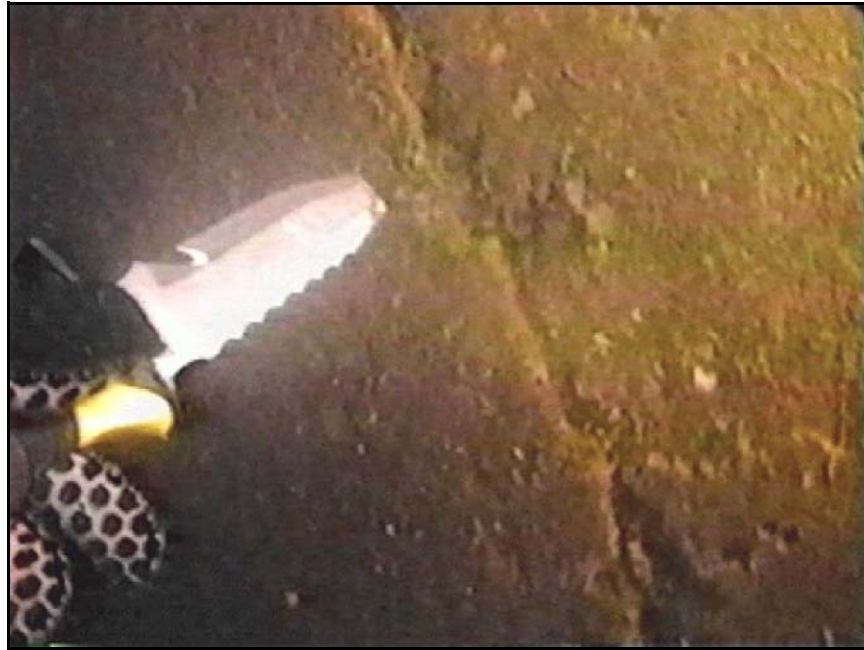
Figure B-73.—The diver used a knife to probe cracks in the concrete. Divers prefer knives with blunt ends in underwater inspection, since it is less likely that a hole could accidentally be poked into their dry suits.

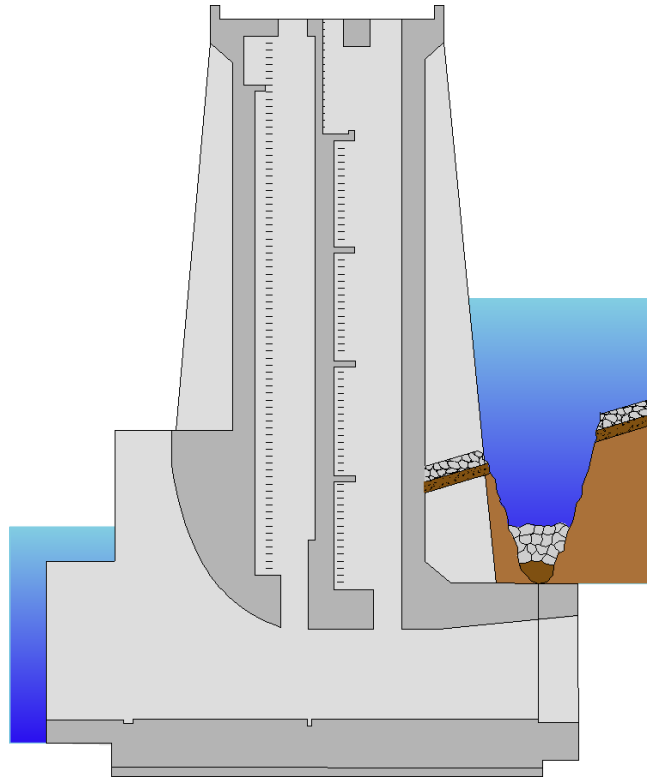
Figure B-74.—A sinkhole occurred above the monolith joint at the junction of the intake tower and the upstream end of the transition section.

The solution to this problem was to fill the sinkhole with impervious material and to drill grout holes in this monolith joint all the way through the concrete into the surrounding soil along the entire perimeter of the joint. The holes were drilled from inside the transition. Neat cement grout was then pumped through these holes to fill any voids outside the transition and to seal the waterstop as well as possible. Prior to grouting, the gates were closed and sealed with saw dust, air compressors and a grouting machine were set up in the backfill area of the stilling basin, and supply lines were run up the conduit to the transition monolith to be grouted. The lake stage was at its normal level for that time of the year, and the elevation of the lake was about 20 feet above the invert of the conduit. Twelve grout holes were drilled in the monolith joint, four in the invert, four in the crown, and two in each side wall. Each hole was installed as follows: (1) A hole about 2 inches in diameter was drilled

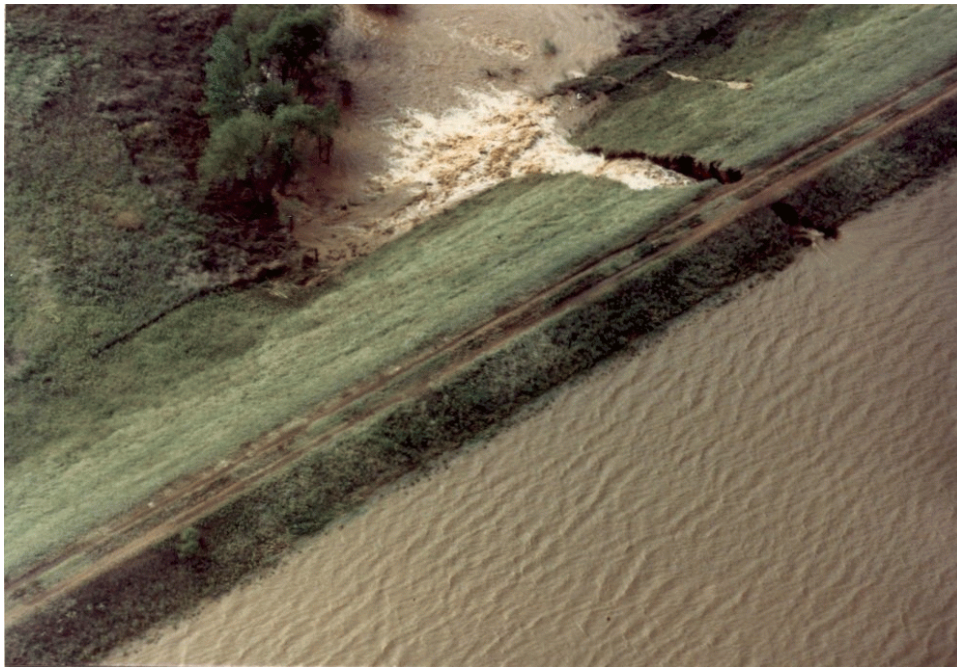
The failure of the embankment dam was observed as it occurred from an aerial survey of the site. Figure B-77 shows the failure of the embankment dam as it occurred. Water in the reservoir had risen to about 1.6 feet below the crest of the embankment dam following about 19 inches of rainfall which had occurred over several days. Water had flowed over the crest of the auxiliary spillway, but had not overtopped the embankment dam. Water was observed to be flowing through a tunnel developing in the embankment dam at about 40 feet to the side of the conduit location. Water entered the upstream slope of the embankment dam at about the maximum reservoir level in several locations and exited the downstream slope of the embankment dam through an erosion tunnel. Water exited the downstream slope about one-third of the way up from the toe of the embankment dam. The tunnel that developed in the embankment dam eroded quickly and drained the pool to about one-half of the embankment height.

Figure B-77.—Aerial view showing the failure of Upper Red Rock Site 20 Dam.

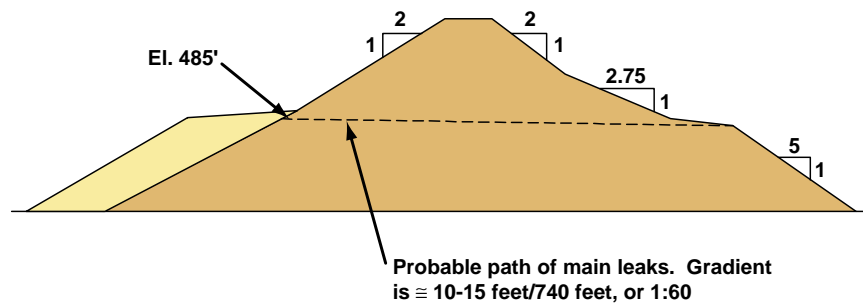
Figure B-81.—Cross section of Wister Dam showing probable path for internal erosion through embankment. The length of the flow path was about 740 feet, and the head on the entrance tunnels was less than 15 feet.

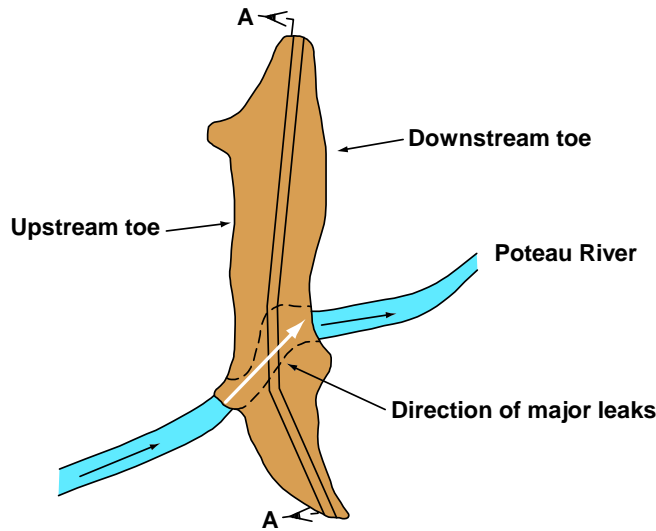
Figure B-82.—Plan View of Wister Dam showing flow path for internal erosion tunnels in fill.
