Report on Fire Boom Tests at Ohmsett in October, 2000

**U.S. Department of the Interior
Minerals Management Service
Herndon, VA**

**SL Ross Environmental Research
Ottawa, ON**

January 31, 2002

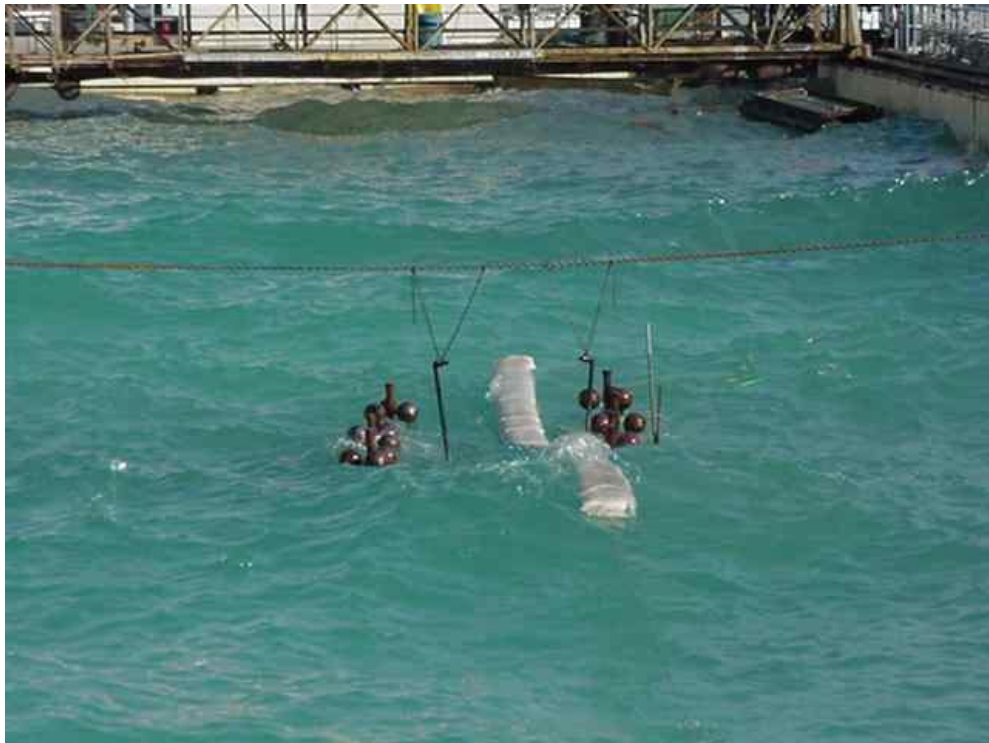
Figures 16 and 17 show the SWEPI fire boom in place over the bubbler frame during the two-hour pre-burn wave stress test on the morning of October 19, 2000. It is clear that the boom was considerably flexed in the harbor chop waves. Figure 17 illustrates how the boom was periodically over-washed by a wave. It should be remembered that this fire boom was designed for use in broken ice conditions, where wave action would be severely damped by the presence of the floes.

Figure 17 - Wave over-topping SWEPI boom.

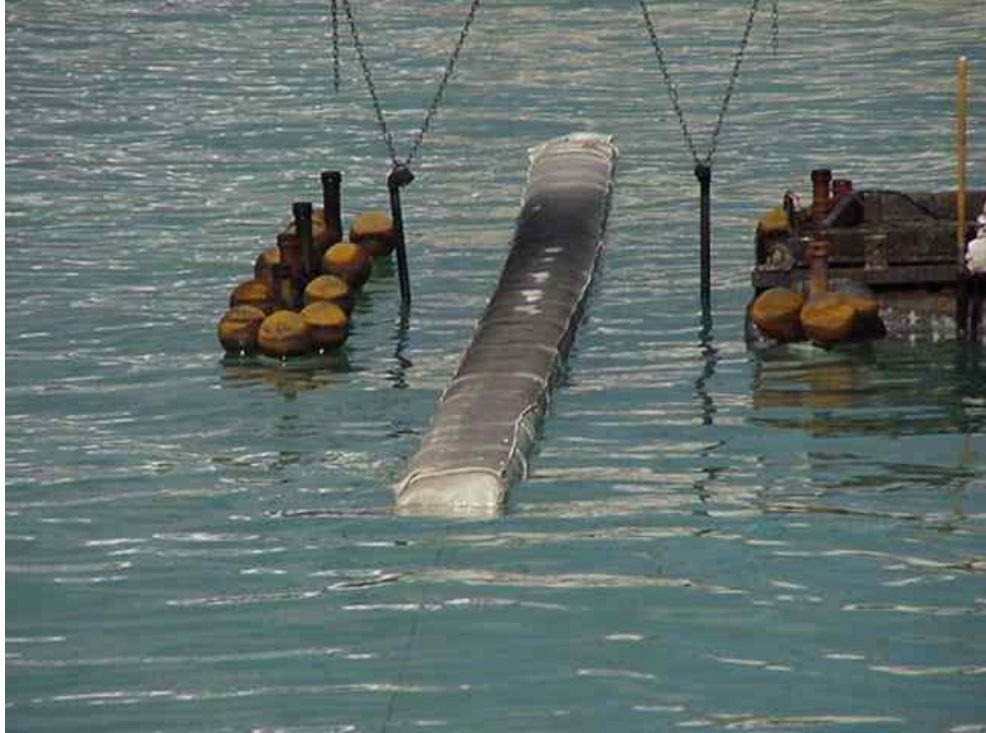
After the one-hour cool-down, the boom was inspected. Figures 28 and 29 show the condition of the boom. There was some staining of the refractory material with soot and some evidence of the beginning of abrasion cracking caused by flexure between flotation units, but the boom was judged to be in good, serviceable condition.

Figure 28 - SWEPI boom after first cool-down.

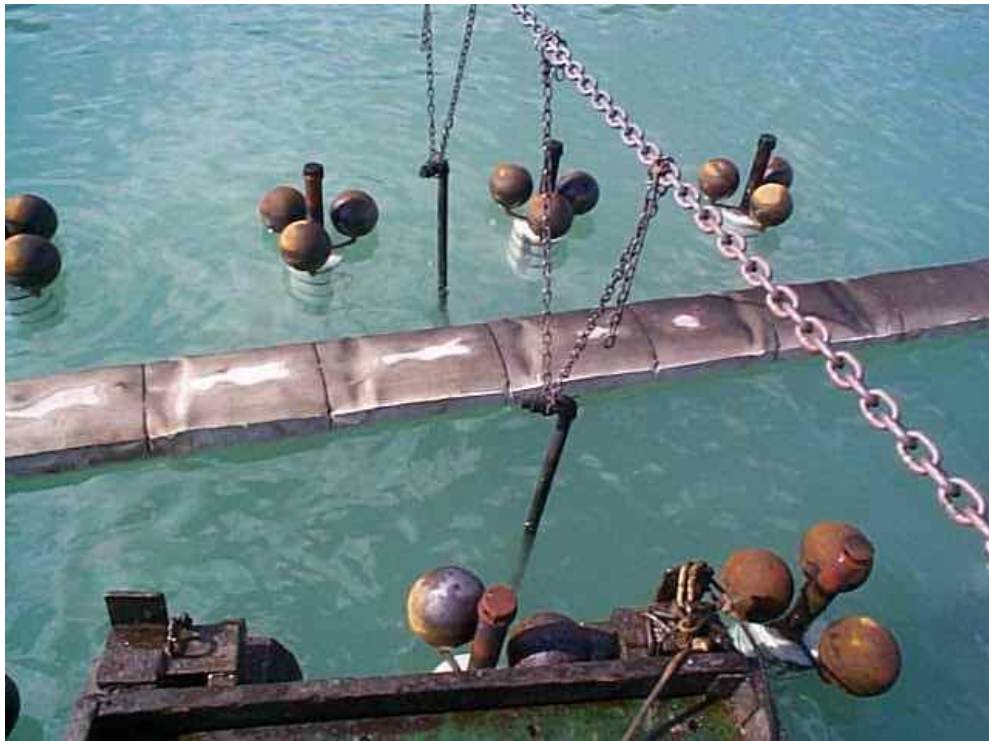
Figure 29 - Close-up of SWEPI boom after first cool-down.

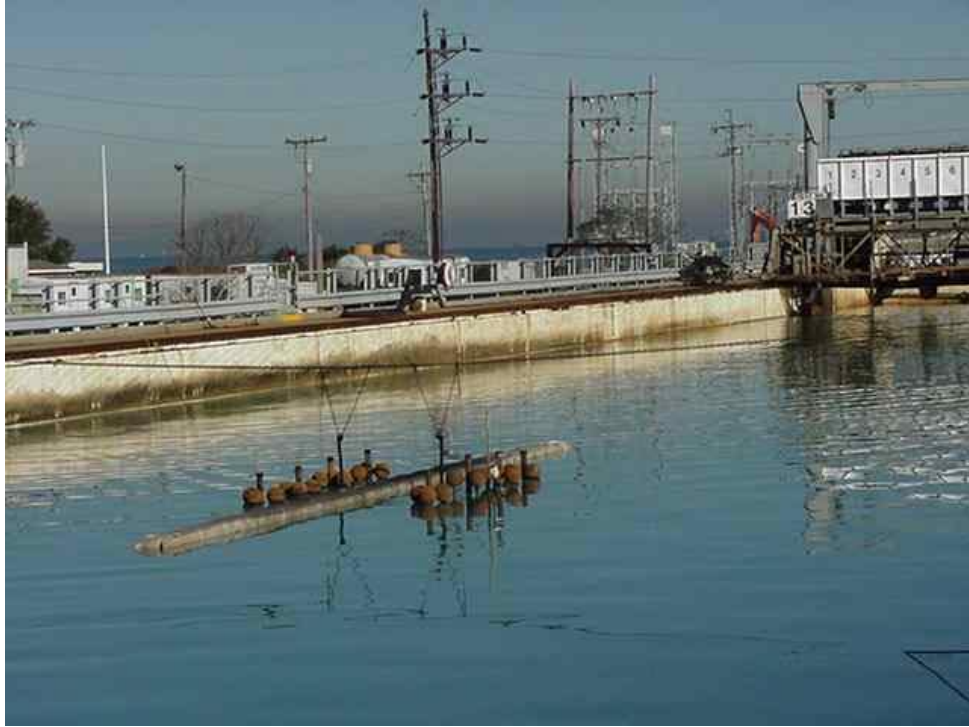
After the one-hour cool-down, the boom was inspected. Figures 34 and 35 show the condition of the boom. There was still some staining of the refractory material with soot apparent and some evidence of abrasion cracking caused by flexure between flotation units, but the boom was judged to still be in good, serviceable condition.

Figure 34 - SWEPI boom after second hour cool-down.

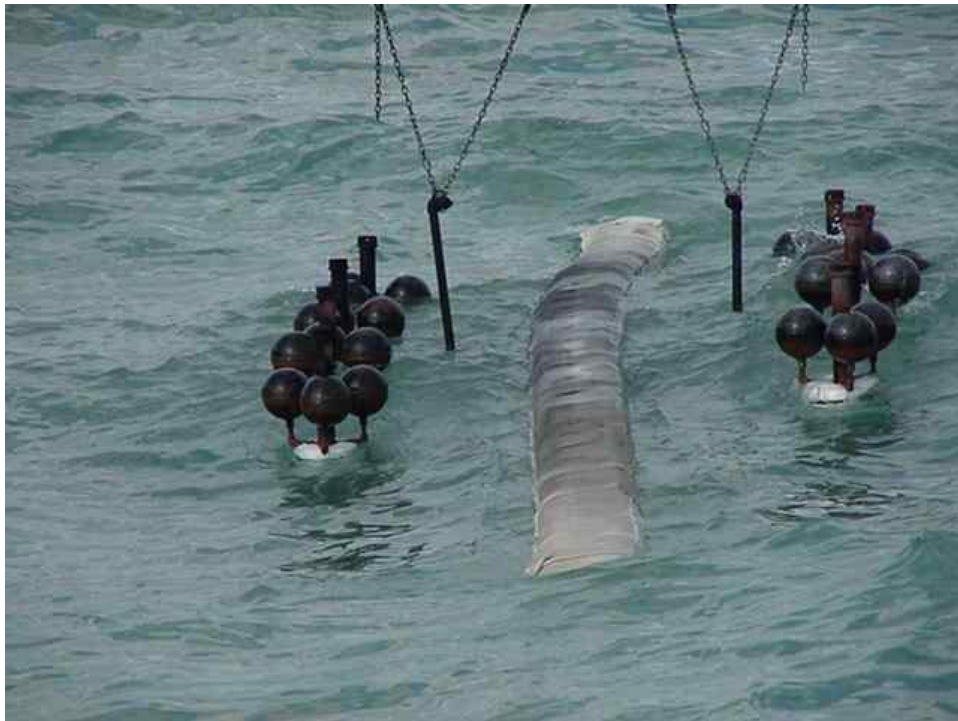
Figure 35 – Close-up of SWEPI boom during second hour cool-down.

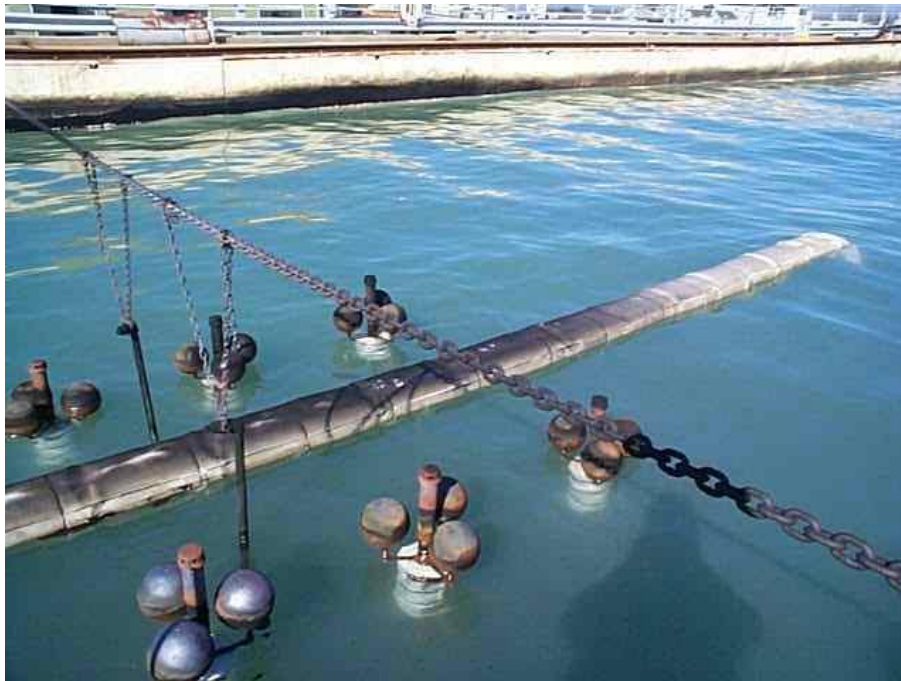
At the end of the third burn hour, the boom was inspected closely for damage. Figures 39 and 40 show the condition of the boom at that time. With the exception of some loss of refractory fabric in a few small locations on the top of the boom, it appeared to be perfectly serviceable.

Figure 39 - SWEPI boom at end of burn tests.

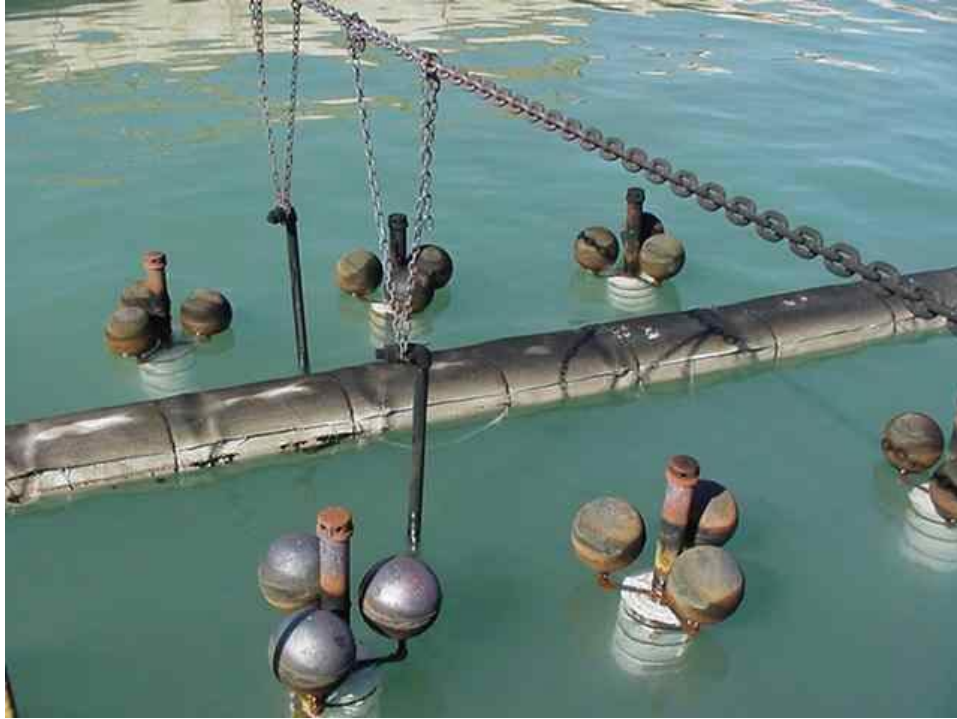
Figure 40 - SWEPI boom close-up at end of burn tests.

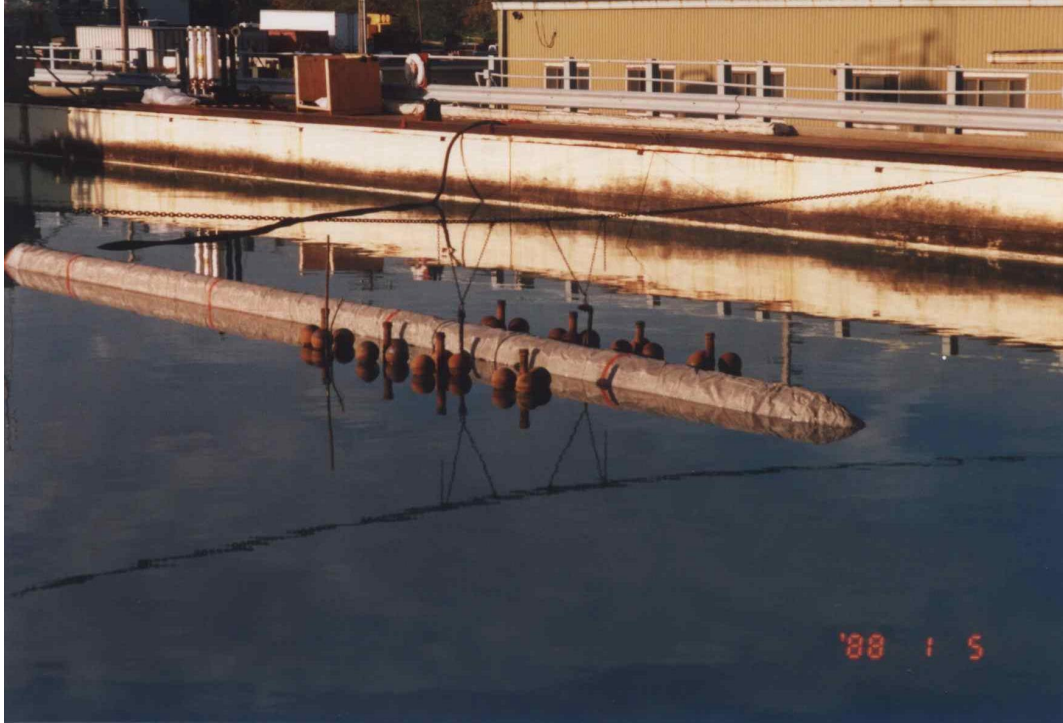
Figure 44 - Oil Stop Auto Boom after Pre-burn Wave Stress test.

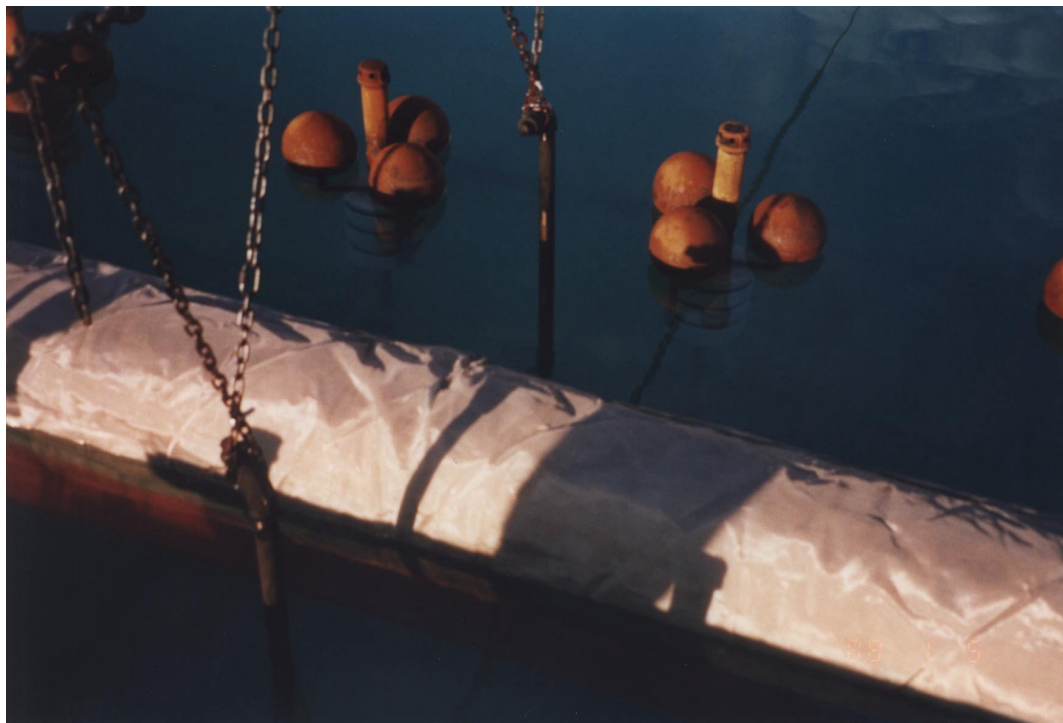
Figure 45 – Close-up of Oil Stop Auto Boom after Pre-burn Wave Stress test.

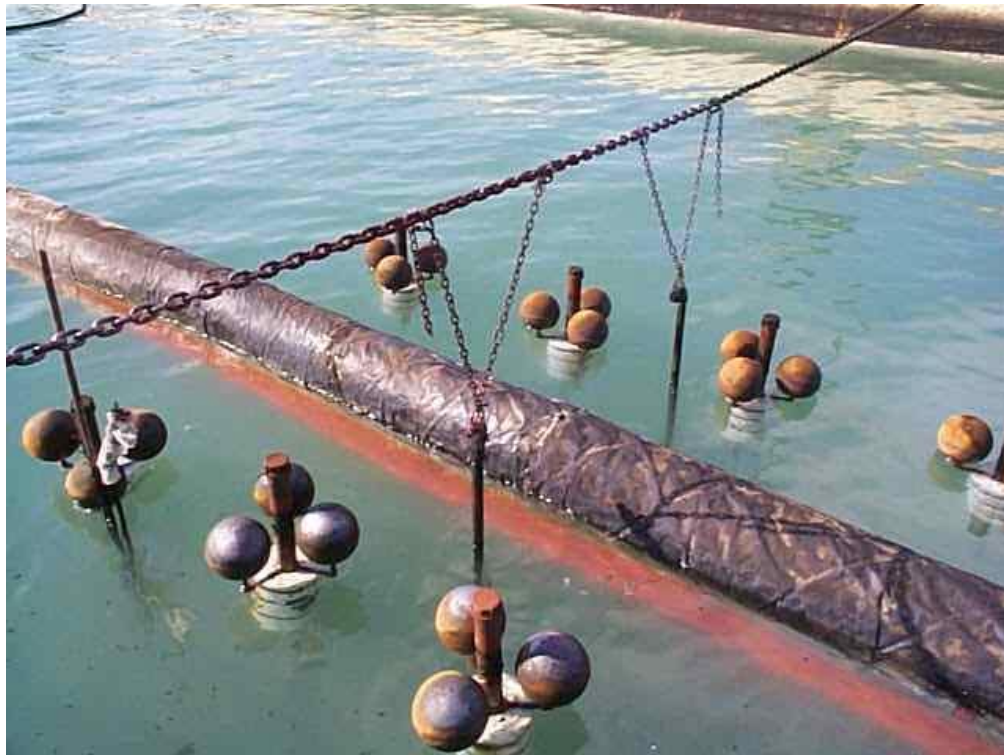
It had been necessary several times during the cool-down test to increase the air blower rate in order to keep the boom afloat. After the one-hour cool-down, the boom was inspected. No significant further degradation was noted in the section exposed to flames; however, it was observed that, at the north end of the boom, a bolt attaching the connector to the fabric layers had pulled out, causing an air leak. This was inspected, but deemed not crucial to the continued operation of the boom. It should be noted that, in more recent versions of this boom, the fabric used to make the air chambers has been changed to an unreinforced film. The coated glass fabric used in the boom model tested had been identified as susceptible to excessive wear where repeated flexing occurred. As well, the new film is much less likely to allow the bolt holes at the connectors to wallow.

Figure 52 - Oil Stop boom after first burn.

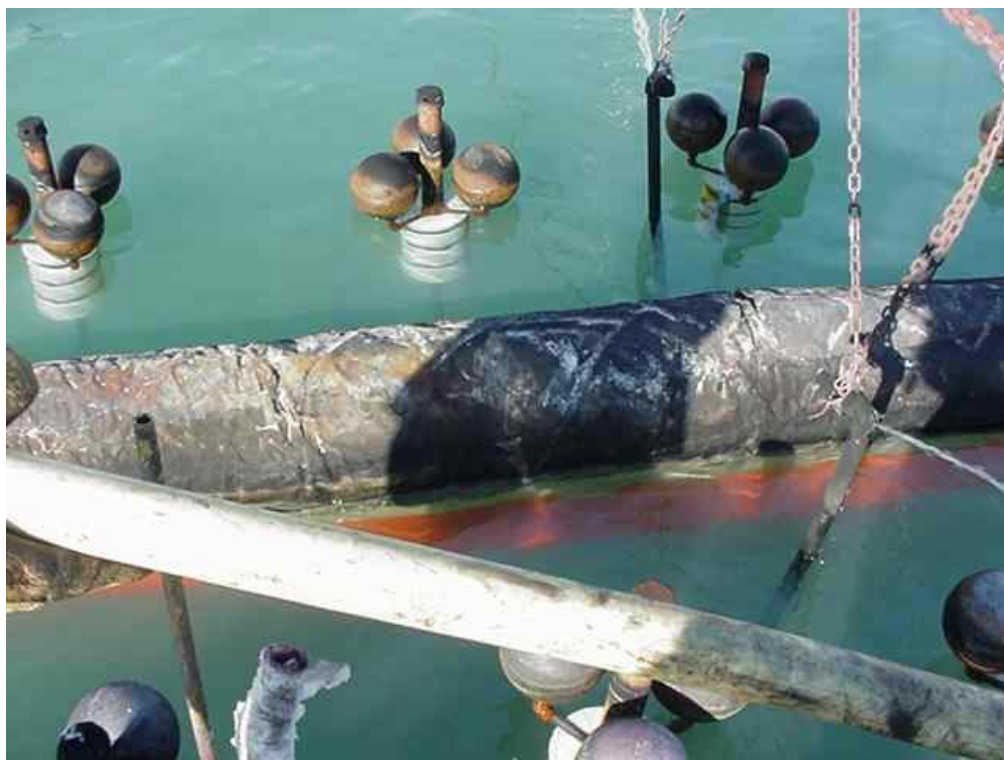
Figure 53 - Close-up of Oil Stop boom after first burn.

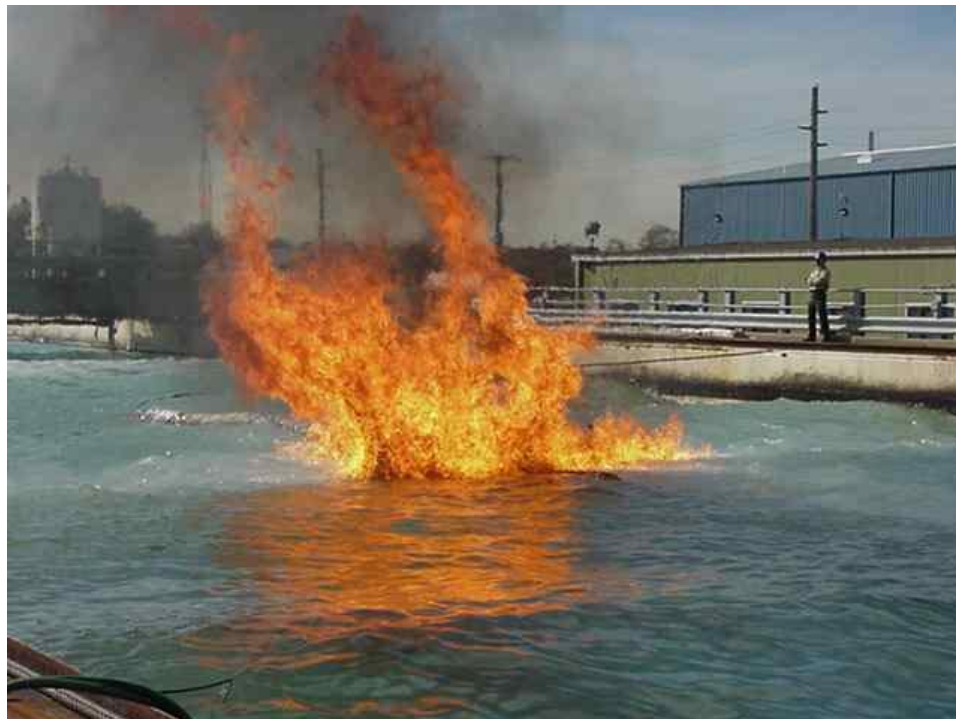
Figure 57 - North end of boom over washed by waves.

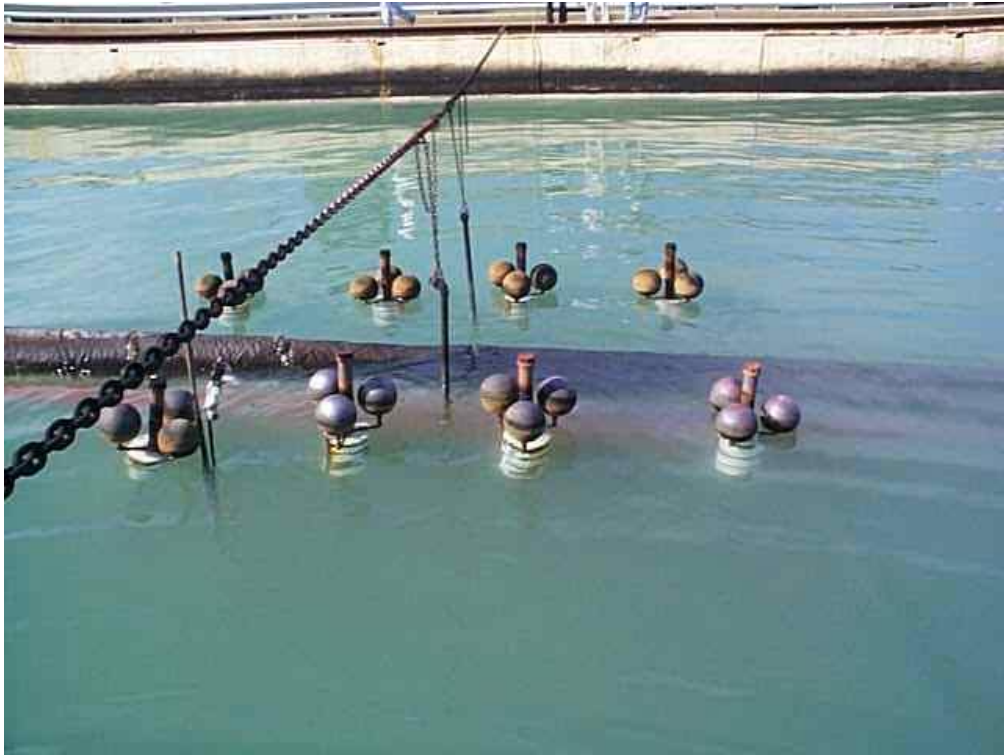
Figure 58 - Location of large hole in boom.

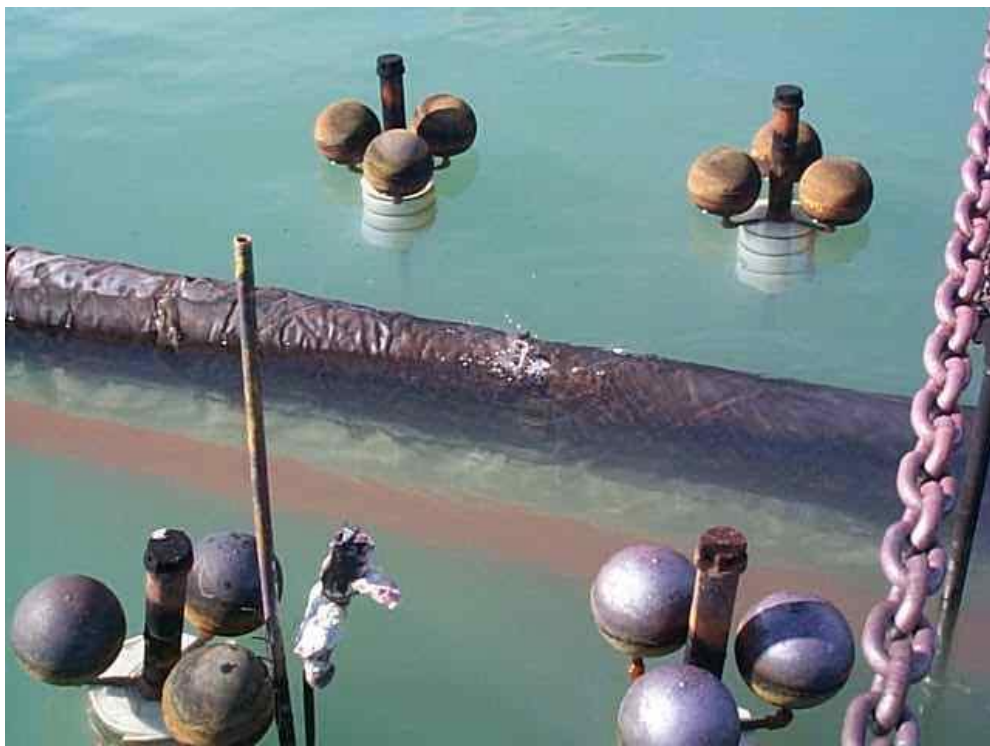
Figure 59 - Close-up of large hole.

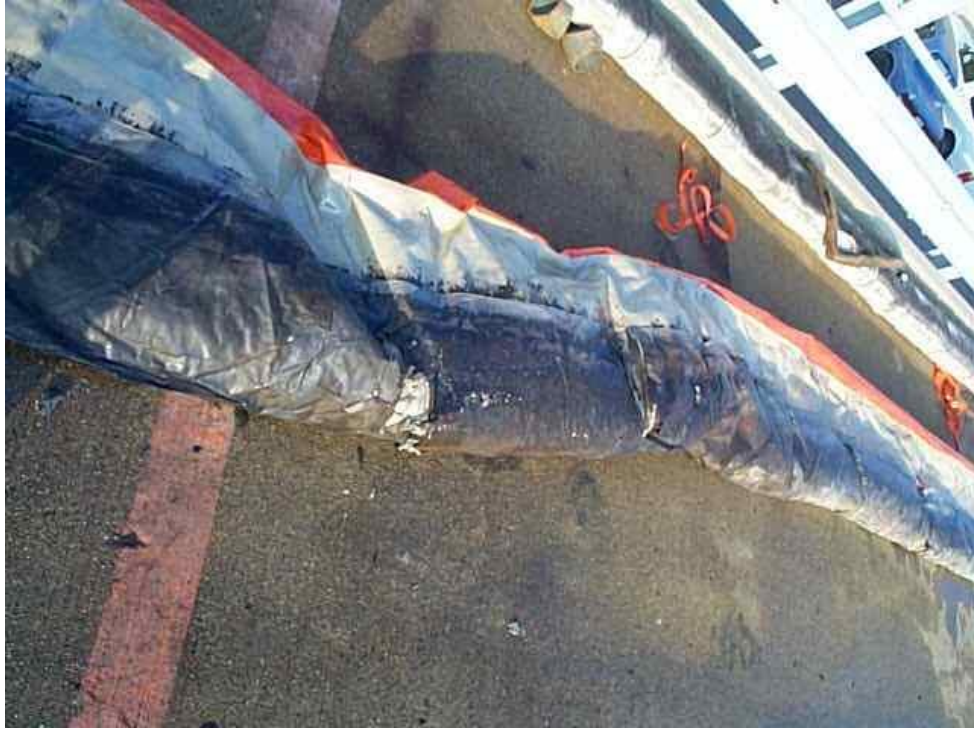
Figure 60 - Boom on deck showing exterior damage.

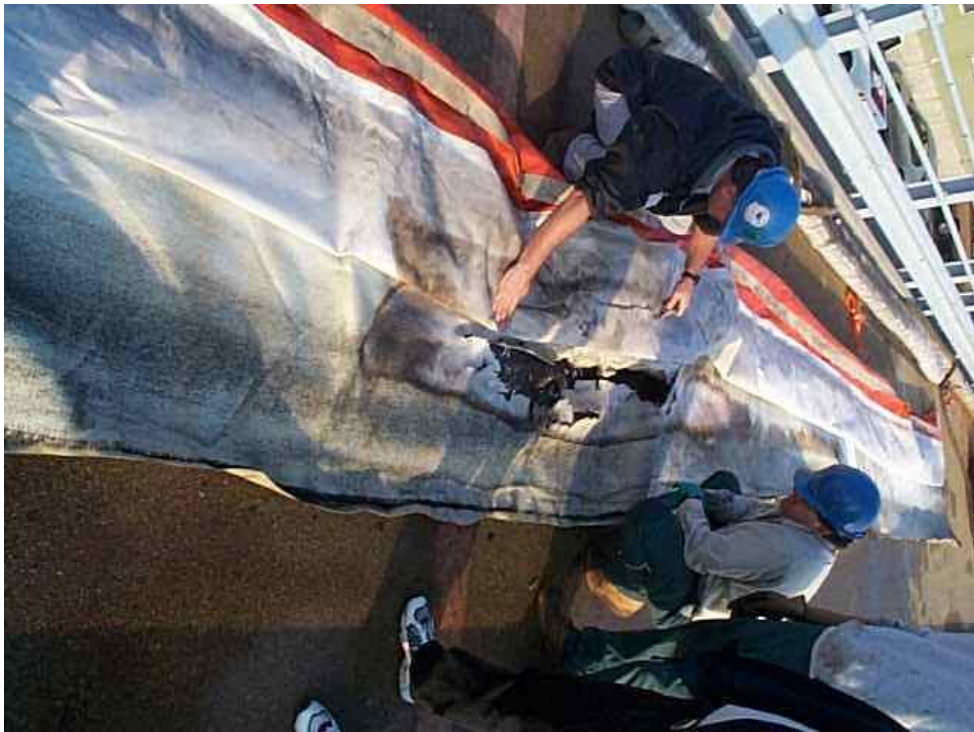
Figure 61 - Boom on deck showing damage to felt layer with stainless steel mesh peeled back.

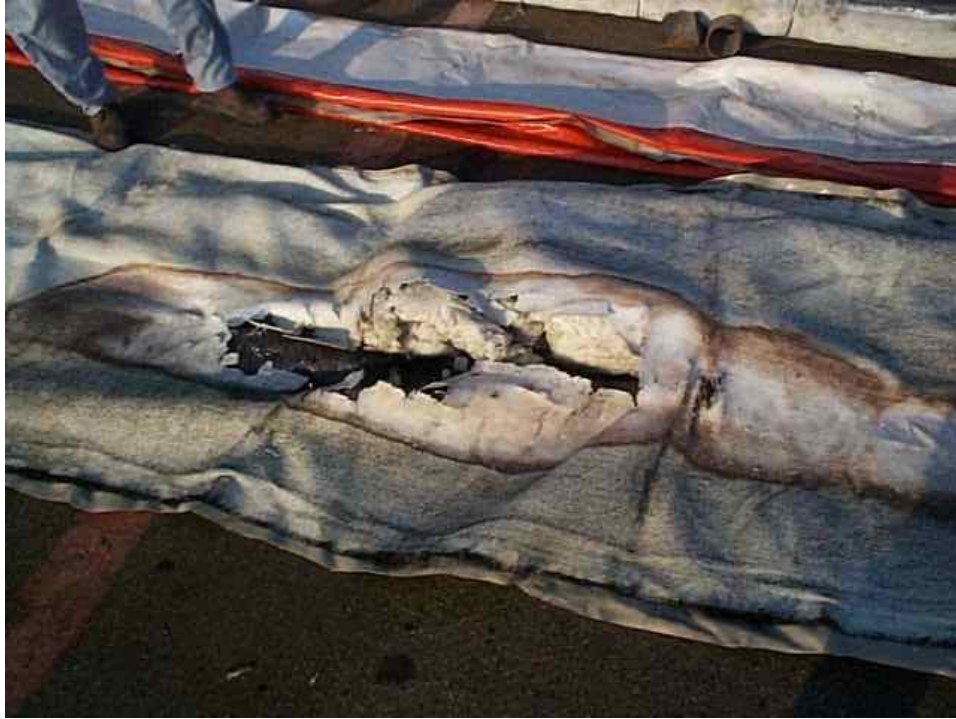
Figure 62 - Close-up of damage to felt layer with stainless steel mesh removed.

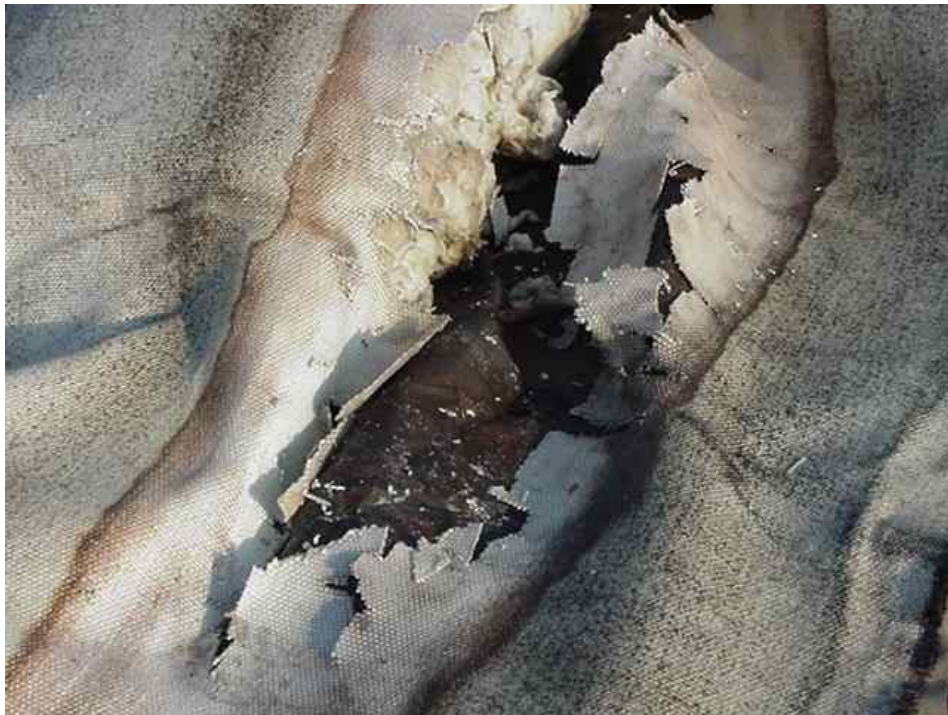
Figure 63 - Close-up of similar damage at another location on boom.
