## Fire Boom Testing at Ohmsett in 2000

### Abstract

One water-cooled blanket and one conventional fire boom failed the test protocol. Two versions of the reflective/insulating blankets proved effective in significantly reducing the heat insult to the underlying containment boom.

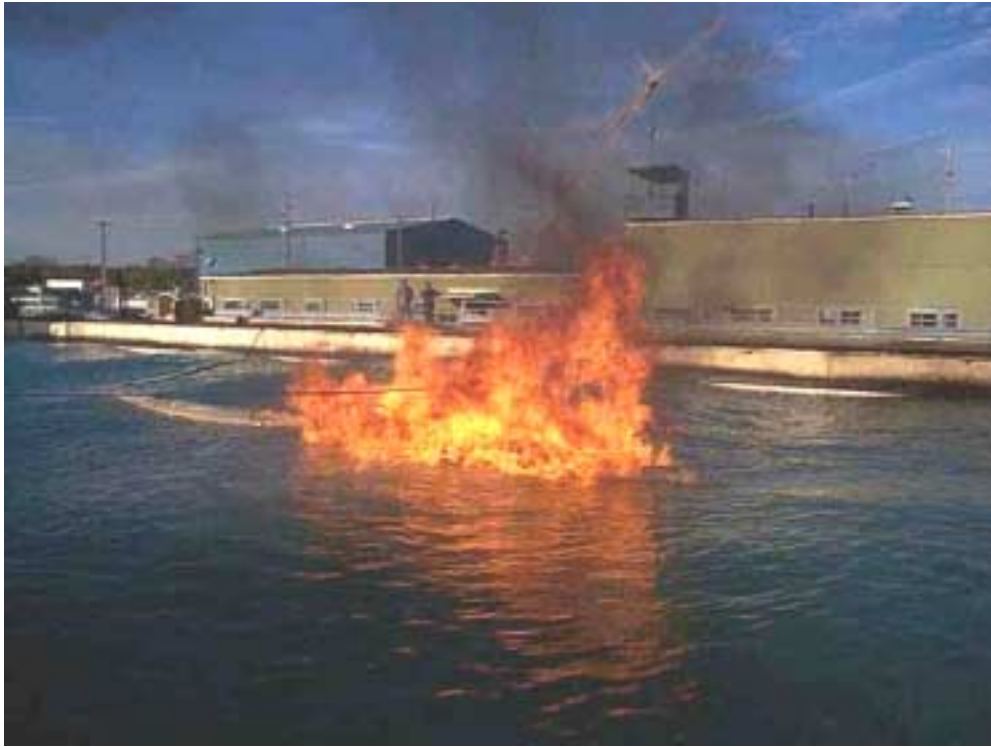
Figure 6 shows the first hour of burn tests with the Oil Stop boom. Note that the boom is not centered in the flame. This was done in an attempt to avoid propane bubbles entering an air chamber valve access slit in the skirt at the center of the test section. For these tests the wave beaches were raised, to produce regular waves. The boom rode the waves well. After initial adjustments a steady 26 kg/min (58 lb./min) propane flow was recorded. It was observed that the water entrained by the propane bubbles pushed on the skirt of the boom, forcing it over to rest against the air standpipe floats on the east side of the frame. After several attempted adjustments of the frame the propane was shut down, the frame was adjusted and the tension on the boom increased to 2200 N (500 lb<sub>f</sub>). The flames were then re-started with a steady flow of 25 kg/min (54 lb./min). On completion of the first burn hour, the boom was inspected. Numerous cracks in the outer steel mesh were noted and it was observed that the underlying refractory felt mat was beginning to degrade. It had been necessary during this burn test to increase the air blower rate in order to keep the boom inflated.

Figure 6 - Boom undergoing burn test in waves.

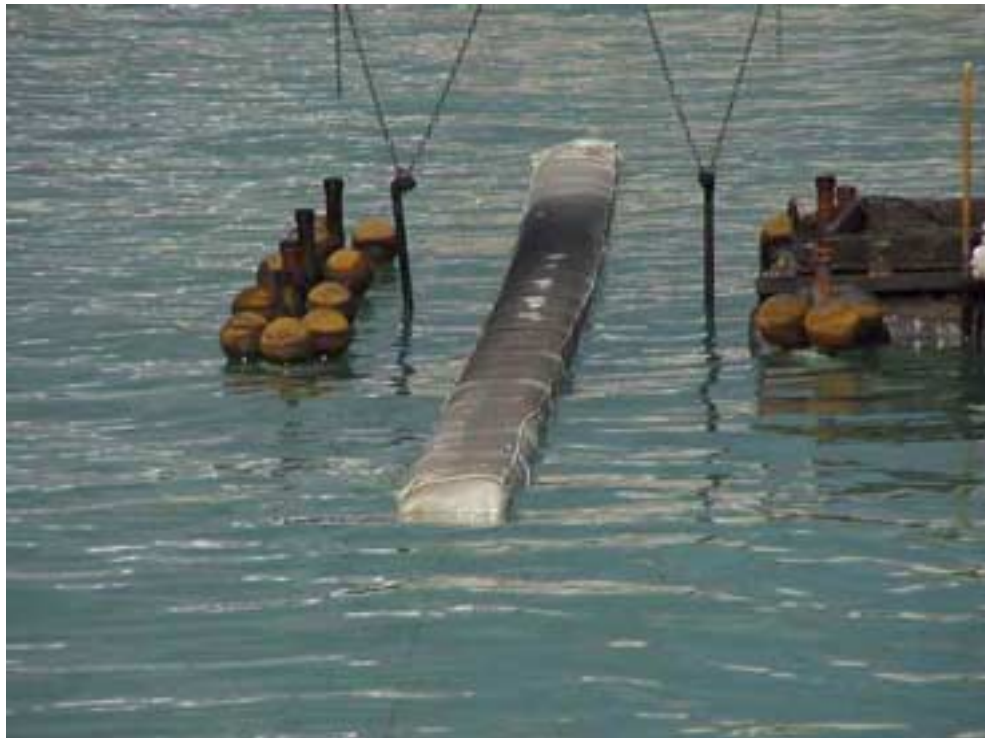
After the first hour of flame exposure, the propane flow was shut off and the SWEPI boom was allowed to cool down in waves for one hour. After the one-hour cool-down, the boom was inspected. There was some staining of the refractory material with soot and some evidence of the beginning of abrasion cracking caused by flexure between flotation units (see Figure 7), but the boom was judged to be in good, serviceable condition.

Figure 7 – SWEPI boom after first burn test.

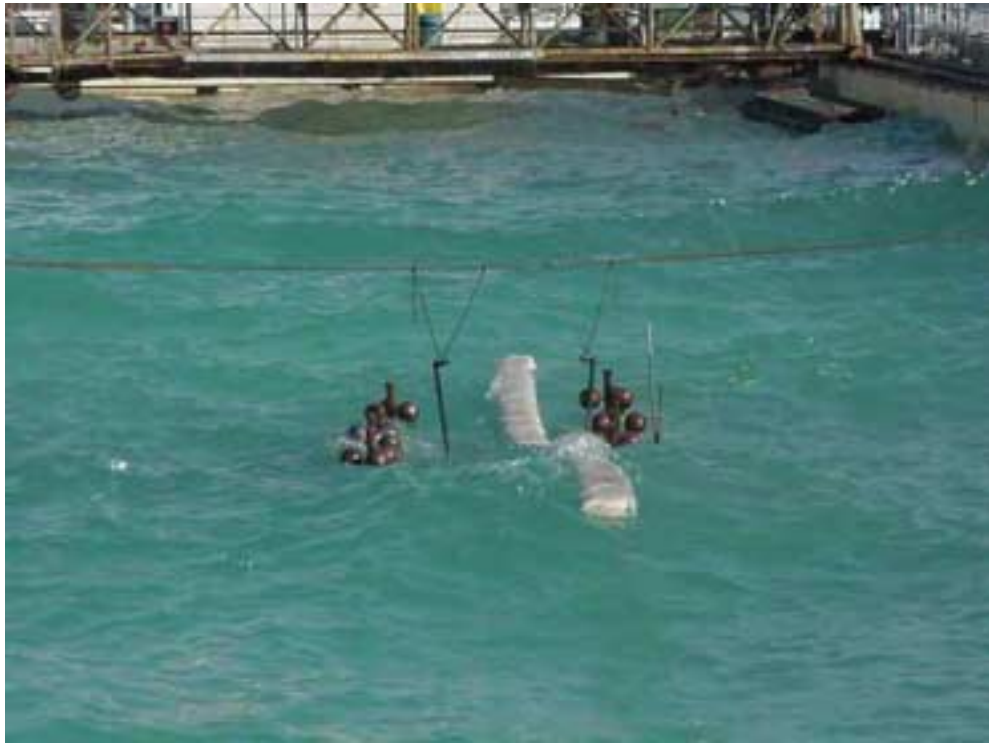
Figure 12 shows the SWEPI fire boom in place over the bubbler frame during the two-hour pre-burn wave stress test. It is clear that the boom was considerably flexed in the harbor chop waves. This photo also illustrates how the boom was periodically over-washed by a wave. It should be remembered that this fire boom was designed for use in broken ice conditions, where wave action would be severely damped by the presence of the floes. Inspection of the SWEPI boom after its 2-hr pre-burn wave stress test showed no visible damage to the exterior components.

For the burn tests with the SWEPI boom the wave beaches were raised, to produce regular waves. These waves also regularly over-washed the entire length of the boom and periodically soaked it with water during the tests. This behavior would not be expected in the boom's intended operating environment (broken ice conditions) and is an artifact of the test protocol that should perhaps be changed for future tests of booms intended for use in ice-covered environments.

Figure 12 - Wave over-topping SWEPI boom.

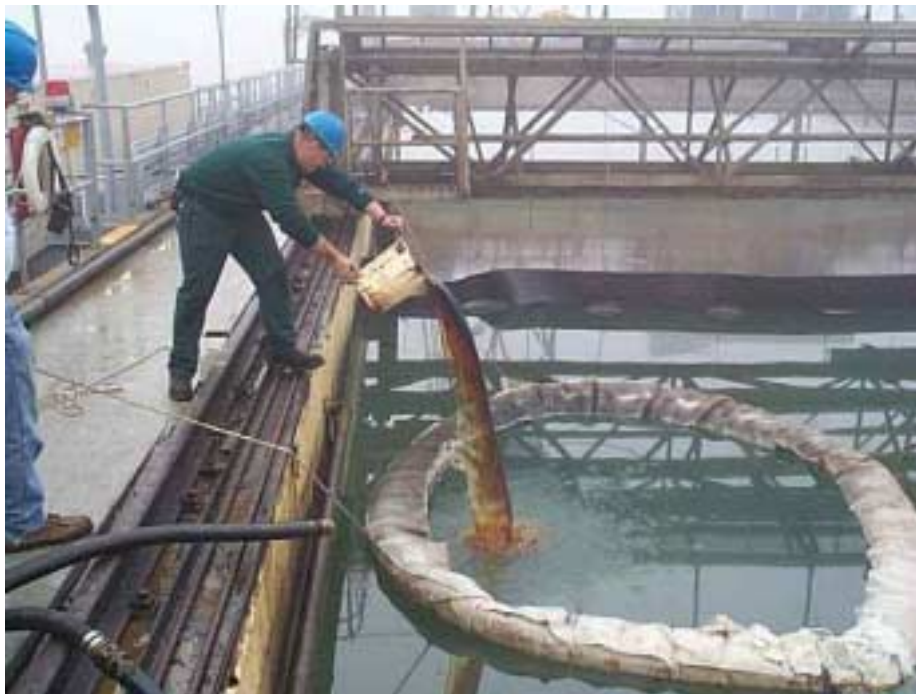
The SWEPI fire boom test section was subsequently connected in a circle and placed in the north end of the Ohmsett tank. Measured volumes of a mixture of diesel and JP-5 were added to the inside of the boom circle to determine its ability to contain thick, low-viscosity oil slicks (Figure 15). The viscosity of the mixture at the tank water temperature ( $15^\circ\text{C} = 60^\circ\text{F}$ ) was  $10 \text{ mPas}$  (cP). The boom failed, by drainage, after approximately  $56 \text{ mm}$  (2.2 inches) of the oil had been added. It was clear that this was the operational, calm-water draft of the Shell boom. There was no visually detectable leakage of the oil through the boom fabric prior to the drainage failure.

Figure 15 – SWEPI boom undergoing thick oil containment test.

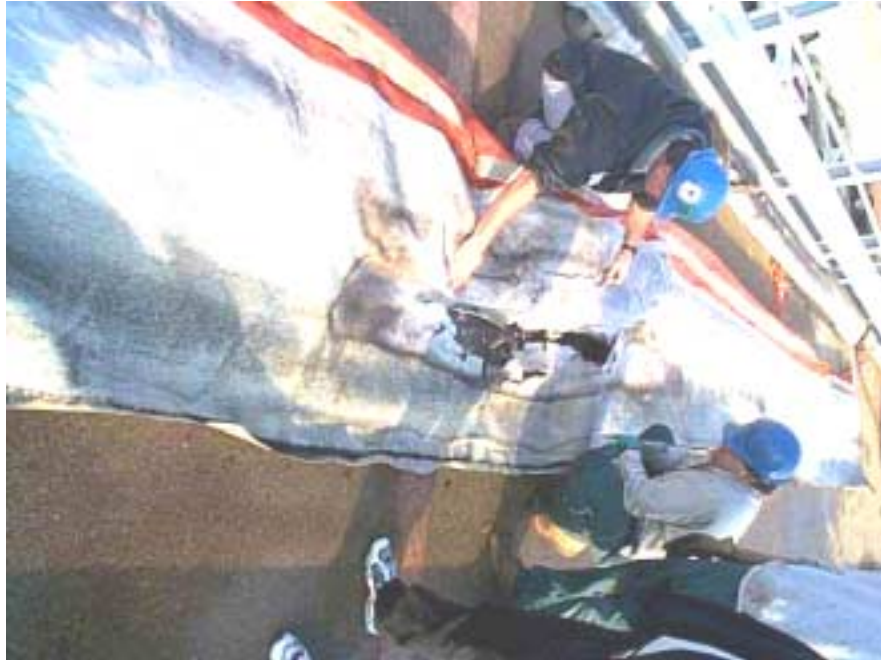
The boom was then allowed to cool down in the waves for one hour. It was necessary several times during the cool-down period to increase the air blower rate in order to keep the boom afloat. After the one-hour cool-down, the boom was inspected. No significant further degradation was noted in the section exposed to flames; however, it was observed that, at the north end of the boom, a bolt attaching the connector to the fabric layers had pulled out, causing an air leak. This was inspected, but deemed not crucial to the continued operation of the boom. It should be noted that, in more recent versions of this boom, the fabric used to make the air chambers has been changed to an unreinforced film. The coated glass fabric used in the boom model tested had been identified as susceptible to excessive wear where repeated flexing occurred. The new film is reportedly also much less likely to allow the bolts at the connectors to move around and stretch the fabric.

Inspection of the boom revealed that there was a large hole in the top of the boom at the south end of the flame zone. Too much air was escaping from this hole to maintain flotation in the portion of the boom north of the hole. The boom was subsequently removed from the tank and laid out on the deck for inspection. Figure 16 shows the damage to the underlying felt layer, with the stainless steel mesh outer cover peeled back. It was apparent that the combination of heat from the flames and loss of insulation to abrasion from flexing in waves had caused the coated glass fabric forming the wall of the flotation chamber to melt.

Figure 16 – Oil Stop, Inc. Auto Boom on deck showing damage to felt layer with stainless steel mesh peeled back.

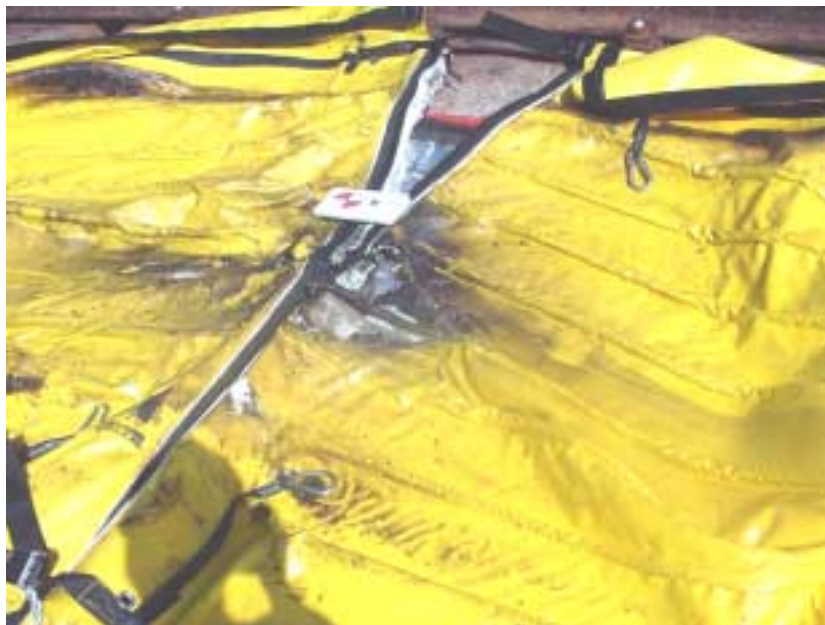
Figure 17 shows the underside of the blanket after its removal from the boom and placement on the deck: the hole at the zipper is apparent (the field book in the background for scale is approximately 7" x 4"). Melting and charring of the plastic occurred, and a water distribution hose had been exposed.

The Elastec/American Marine water-cooled fire protection blanket failed, after 2 hours and 46 minutes exposure to flames, at the blanket connector, by allowing the underlying boom flotation chamber material to melt.

Figure 17 – Close-up of underside of Elastec/American Marine blanket showing damage at zipper.
