## Coal Mine Fatal Accident 2006-26

Operator:	Lone Mountain Processing Inc.
Mine:	Huff Creek No. 1
Accident Date:	April 21, 2006
Classification:	Machinery
Location:	Dist. 7, Harlan County, Kentucky
Mine Type:	Underground Coal Mine
Employment:	135
Production:	12,000 Tons/Day

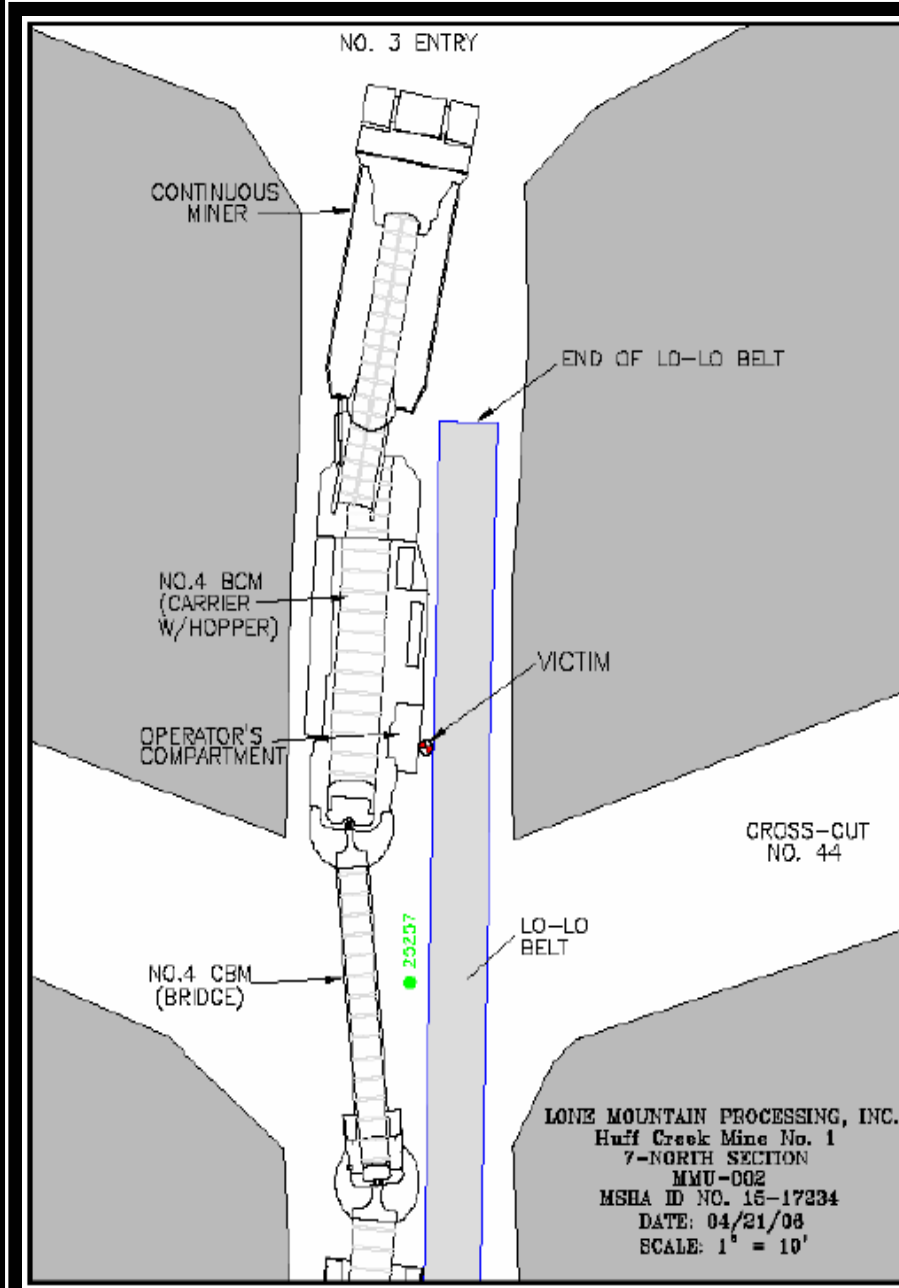
At approximately 4:30 a.m. on Friday, April 21, 2006, a 45 year-old Electrician was found fatally injured at Lone Mountain Processing Inc.'s Huff Creek No. 1 mine. The accident occurred while the victim was checking the hydraulic pressure on the left side tram of the No. 4 Breaker Car Module (BCM) while outside the operator's compartment. During this process, the No. 4 BCM tram control was bumped or struck by the victim, causing the machine to move, pinning him between the operator's compartment and the lo-lo conveyor belt structure.

Causal Factor: The mine operator did not have written procedures or policies in place to require blocking machinery against motion before performing repairs or maintenance. The victim was fatally injured when the BCM moved due the BCM not being blocked from motion. The victim's position, being located in a pinch point area, exposed him to hazardous conditions when the No. 4 BCM was started up and the left tram was engaged in reverse.

On April 21, 2006, maintenance was being performed on the No. 4 Breaker Car Module (BCM), located on the 002 MMU. The BCM was positioned in the No. 3 entry beside the lo-lo structure to permit scheduled maintenance. The machine was not deenergized and blocked against motion. The victim received fatal injuries when the left tram control lever of the BCM engaged, causing the BCM to pivot, crushing him against the adjacent lo-lo belt structure.

Corrective Action: The operator developed and implemented an action plan that was added to the training plan to require safety procedures to be followed when operating or performing maintenance on equipment.

- Ensure that machinery is blocked against motion before performing maintenance or repairs, and work from the safest location possible.
- Install and maintain "position occupied" switches or devices designed to prevent all system movement when any operator leaves their cab. For more info, click:  
[http://www.msha.gov/Accident\\_Prevention/ideas/pinch.htm](http://www.msha.gov/Accident_Prevention/ideas/pinch.htm)
- Develop and implement a Standard Operating Procedure (SOP) for conducting repair work on bridge carriers.
- Develop processes, involving all miners, designed to proactively identify and eliminate hazards and unacceptable risks.
