Historic Preservation Assessment and Recommendation Report for the Gun Site Restoration Project

LA-UR-08-05177

Historic Building Report No. 281

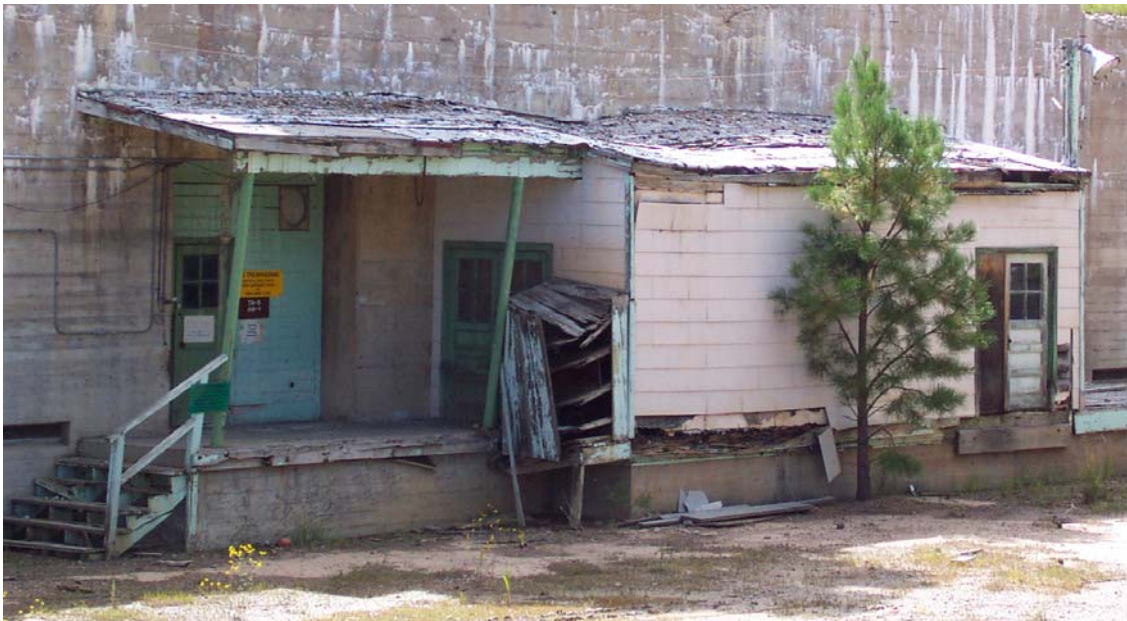
Loading Dock Steps: The wood frame loading dock steps are rotten and deteriorated. These steps should be documented then removed. Temporary steps should be constructed until a permanent replacement can be built following the completion of concrete work in Phase II.

Loading Dock Addition: The 1948 addition to the exterior face of the loading dock (canopy and dock addition) is not structurally stable and is non-contributing to the historic status of the facility (ENG4-C 494 October 14, 1948) (Figure 9). This addition should be removed. However, because removal of these elements will result in increased exterior exposure of the original historic doors and woodwork now protected by the addition, measures should be taken to protect the original wooden elements until restoration efforts are made. If safety concerns are met, all concrete foundations should remain to document historic foundation sections. Any non-contributing concrete work associated with the loading dock addition should be removed.

Figure 9. TA-8-1 (entrance steps and wooden canopy to be replaced at left; deteriorated dock addition, storage bins, and tree to be removed at right)

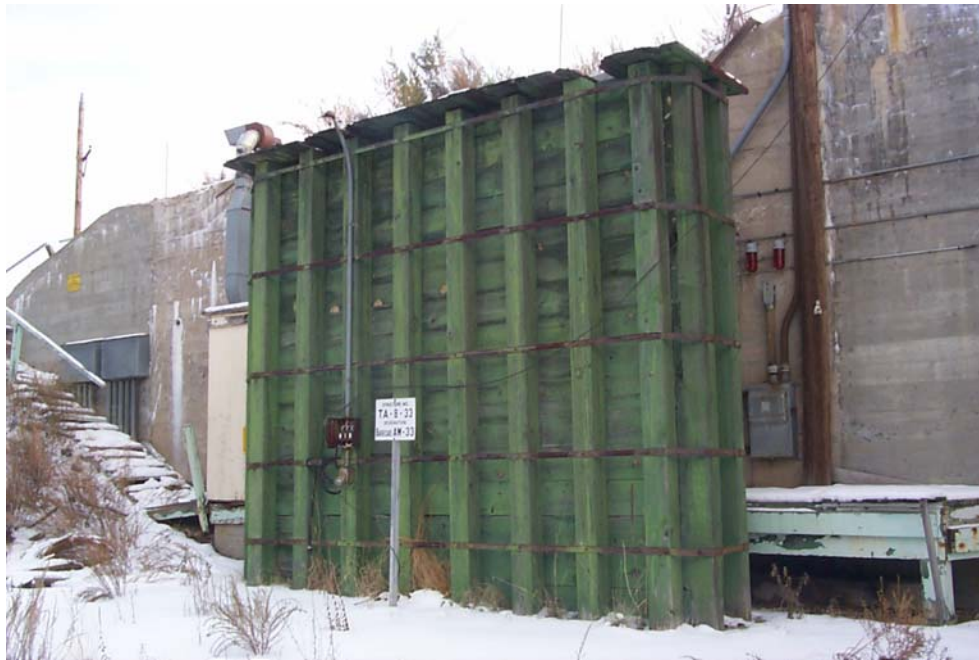
Additions: As recommended on Building 1, all non-historic additions addressed earlier should be removed. These include the barricade, the dock enclosure, the existing platform with the exception of the foundation, and the wooden steps leading up to the east (Figure 10).

Figure 10. TA-8-3 (green barricade and stairs to be removed)

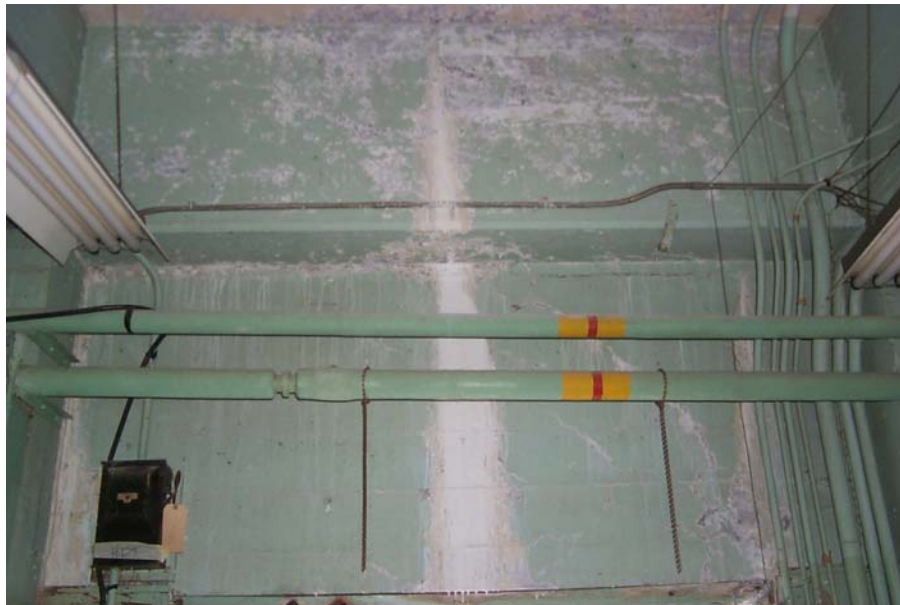
Interior: Several areas on the interior of the building show evidence of moisture intrusion from the surrounding soils (Figure 12). Most of these areas run along the top of the north wall, where cracking and moisture seepage are visible. The severely deteriorated or spalled areas should be consolidated and new cast concrete applied. Smaller areas of deterioration should be cleaned and allowed to remain in their current state as an acceptable characterization of the materials used at the time. Patched areas will most likely be visibly distinguishable from the original concrete, a beneficial outcome for interpretation.

Figure 12. TA-8-1 interior water damage

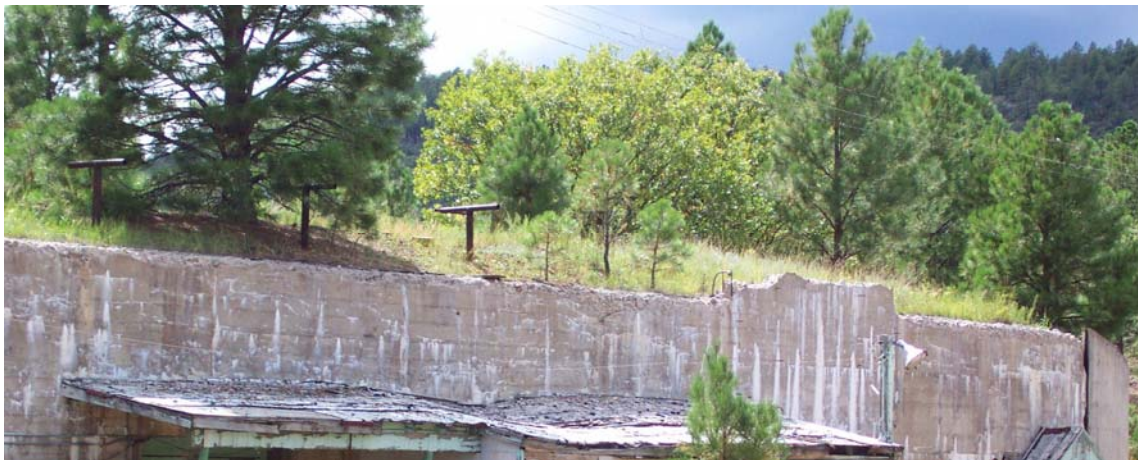
Concrete: The primary structural concern with the entire compound is the decay of the concrete because of moisture infiltration, both at the top parapet and in general. Severe spalling along the top section, within contraction cracks, and at cold joints is a common observation (Figure 13a–b).

Figure 13a. TA-8-1, concrete spalling at parapet, looking southwest

For much of the concrete that forms the vertical north face, the mix had a high alkali content (based on its sensitivity to moisture and the high levels of efflorescent deposits), as well as extremely large aggregate. There are some sections of concrete retaining walls—sections not structurally tied to the buildings—that appear to be much more stable than others. These sections were likely poured separately from the buildings. The structural walls appear to have been poured monolithically using the high alkali, large aggregate concrete mix. This observation lifts the overall protection and waterproofing of the buildings to an elevated priority, because one may assume that the visible damage along the face of the wall is also occurring within non-visible areas. However, the spalling should have been minimized by the reduced freeze/thaw cycles below the frost line.

The concrete buildings should be waterproofed. All soil on top of the buildings would be removed and modern waterproofing installed. The specific type and technique to be used will depend on engineered specifications and field conditions. The finished grade should provide for positive drainage away from the back of the concrete retaining wall for at least 12 feet. Original architectural plans indicate that two 2,000-gallon diesel fuel oil tanks are buried in the hillside. One is buried six feet to the east of Building 1 with six feet of cover, and the other is approximately six feet directly behind Building 3 with 10 feet of cover.

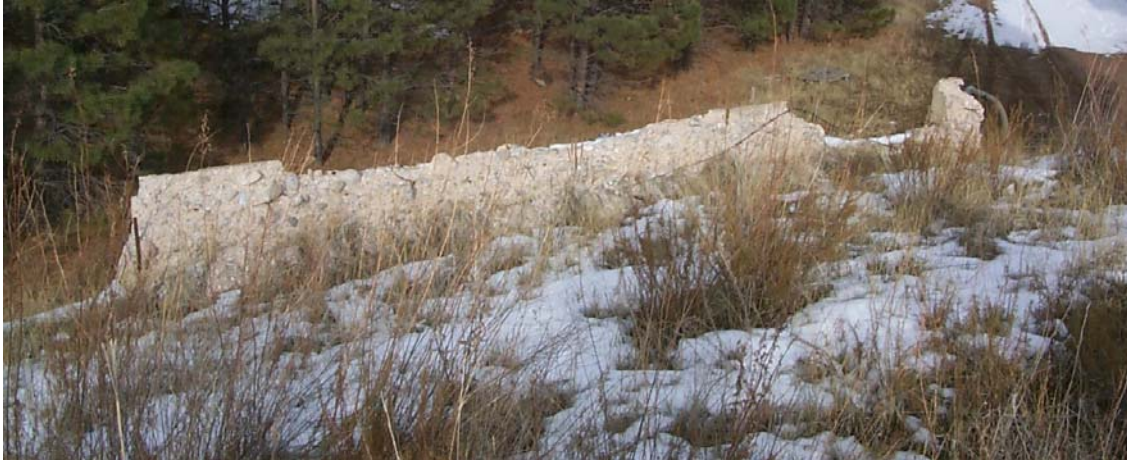
Figure 13b. TA-8-1, concrete spalling at parapet, looking northeast
