**Composite Repair Methods for Steel Pipes**  
Research Activities Summary Report

**Supplemental Project Report**  
**Prepared for the Minerals Management Service**  
**Under the MMS/OTRC Cooperative Research Agreement**  
**1435-01-04-CA-35515**  
**Task Order 39300**  
**MMS Project Number 558**

**June, 2007**

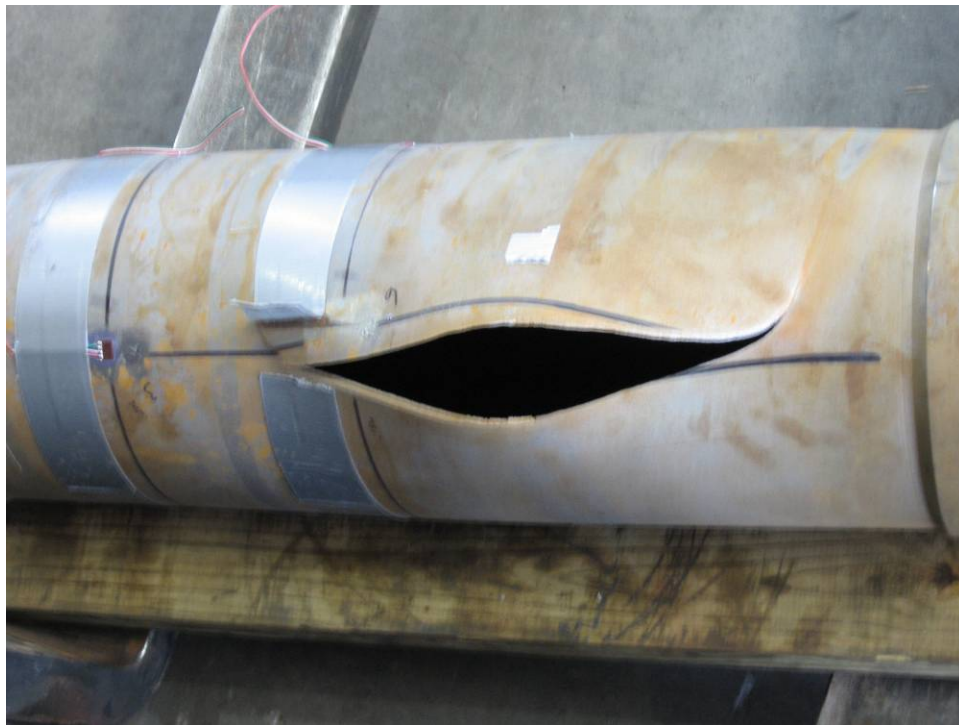
**Figure 7 – Failure in unrepaired test sample**

- The unrepaired sample failed at a pressure of 3,694 psi. The failure pressures for the four repaired samples are listed below. Failures in the test samples involving Products A, C, and D occurred in the steel away from the repaired region. **Figure 7** shows the failure in the unrepaired sample, while **Figure 8** shows the failure in the Product C repaired sample outside of the repaired region in the base pipe.
  - Unrepaired – 3,694 psi
  - Product A – 6,921 psi
  - Product B – data not reported
  - Product C – 7,502 psi
  - Product D – 7,641 psi

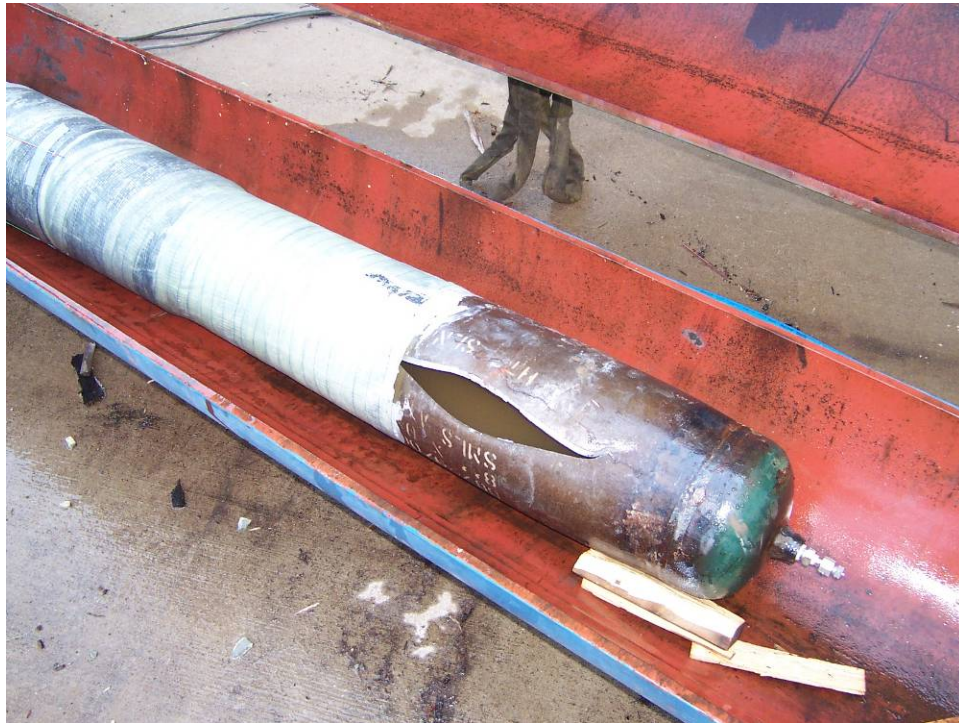
**Figure 8 – Failure in burst sample using Product C**

- The strain gage results provide measurements of the strains in the pipe during pressurization. The measurements of greatest significance are those that demonstrate behavior once yielding initiates in the steel and the point at which load is transferred from the steel into the composite material. This latter observation is the best indicator for determining how much reinforcement is provided by the composite material. Product C provides the greatest continuous reinforcement, while Product A provides similar results up to 2,500 microstrain. Although Product D did not provide the same level of strain reduction beneath the repair as the other two systems, this system generated the largest burst pressure of all the test samples.

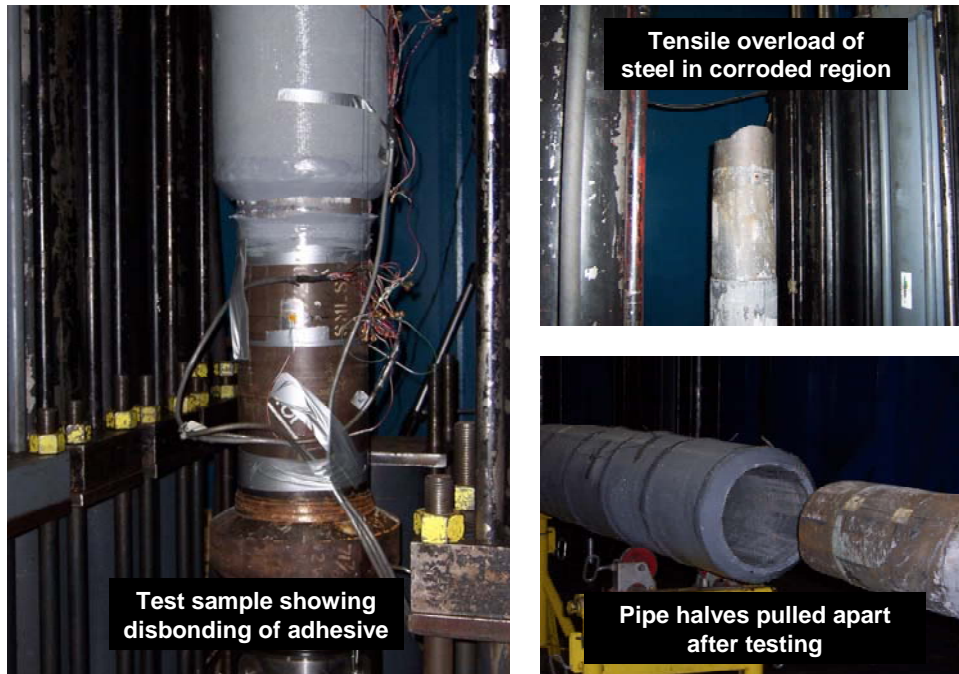
**Figure 10 – Post-failure photos of Product D pressure-tension test**

**Figure 10** provides several photos showing the post-failure surface of the pressure-tension sample for Product D. As shown, the inner steel in the corroded region failed due to tensile overload. From a mechanics standpoint, the adhesive at the interface between the composite and steel transfers load into the composite material. At some point during loading, the strength in this bond is exceeded and the composite is no longer able to carry the tensile load. As shown in **Figure 10** (lower right hand side photo), the composite material remains intact so that the repair system mimics a pipe-in-pipe repair where the strength of the repair is dependent on the interface bond between the two pipes.
