NIOSH
Fire Fighter Fatality Investigation
and Prevention Program

A Summary of a NIOSH fire fighter fatality investigation

Fire Fighter/SCUBA Diver Dies During Training Evolution—Indiana

Fatality Assessment and Control Evaluation Investigative Report #F2000-38

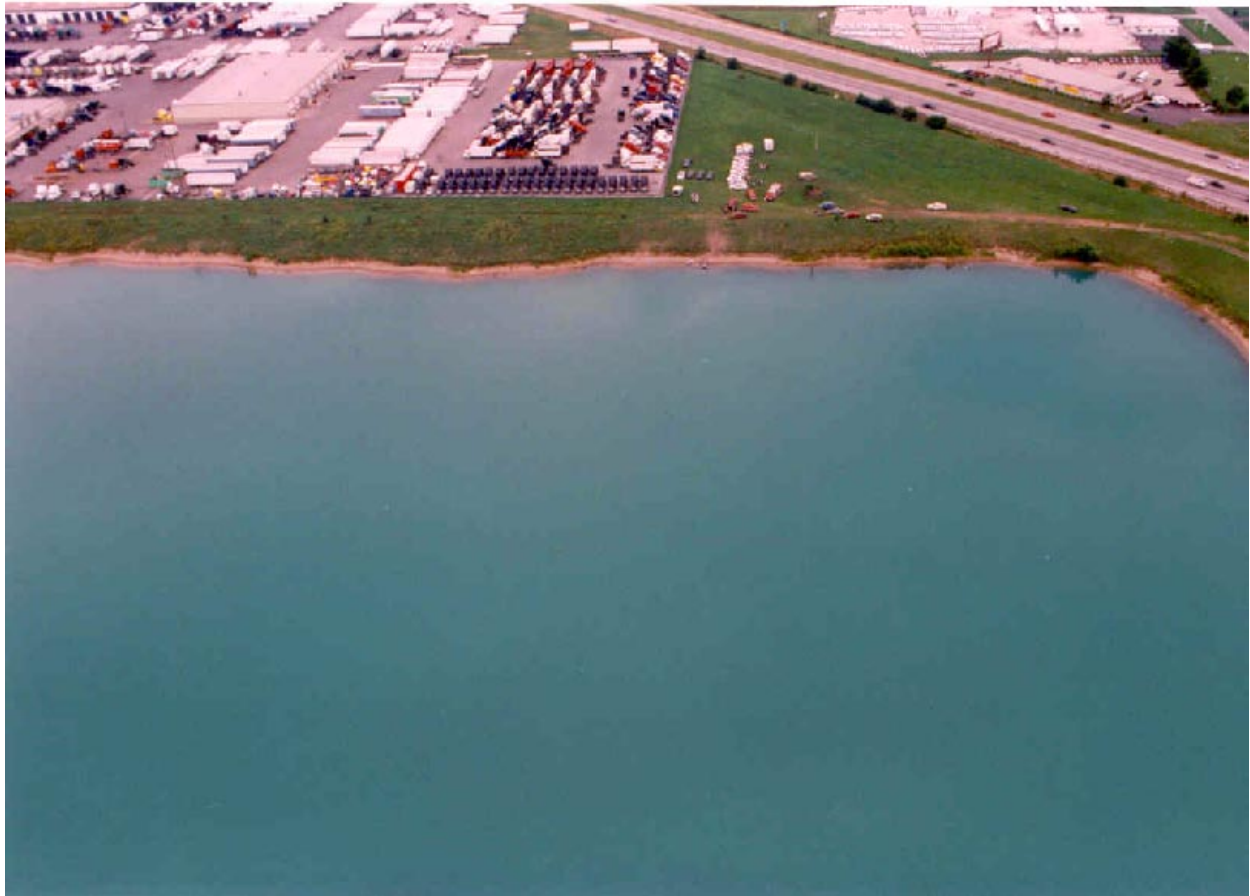
Photo. Incident Site

complete Fire Fighter Level I and Level II certification. Upon entering the department, all fire fighters must pass an annual physical examination which consists of medical screening, psychological evaluation, personal fitness evaluation, blood work, physiologic evaluations, random drug testing, and a flexibility test. Fire fighters on the Dive and Rescue team must pass the above evaluations, along with additional evaluations which include endurance tests, body fat analysis, ear checks, blood pressure, and other general medical checks to obtain their SCUBA dive team membership. The fire department requires all fire fighters who are on the SCUBA Dive and Rescue team to achieve Basic and Advanced National Association of Underwater Instructors (NAUI) certification. The fire fighters are required to complete six dives a year of which three of the dives must be completed with the dive instructor to maintain their certification. The victim was certified as a Basic and Advanced SCUBA diver. The victim's training records were reviewed by NIOSH investigators and appeared to be sufficient. The victim's dive log was reviewed and the last dive logged by the victim was on May 28, 1998, with no apparent problems noted. All comments and notes recorded in the victim's dive log were positive, with encouraging remarks by the victim's instructor. Although his last dive was logged on May 28, 1998, he had completed additional training and was an active diver in the department. *Note: According to one of the dive instructors, since May 28, 1998, the victim completed the once a month dives to retain his diving certification. However, these dives, along with others, were not recorded by the victim in his dive log.* The Standard Operating Procedures for the departments' SCUBA Dive and Rescue team were reviewed and appeared to be up to date and complete. The body of water in which the incident took place was a large, open lake with depths near 100 feet (see Photo). The

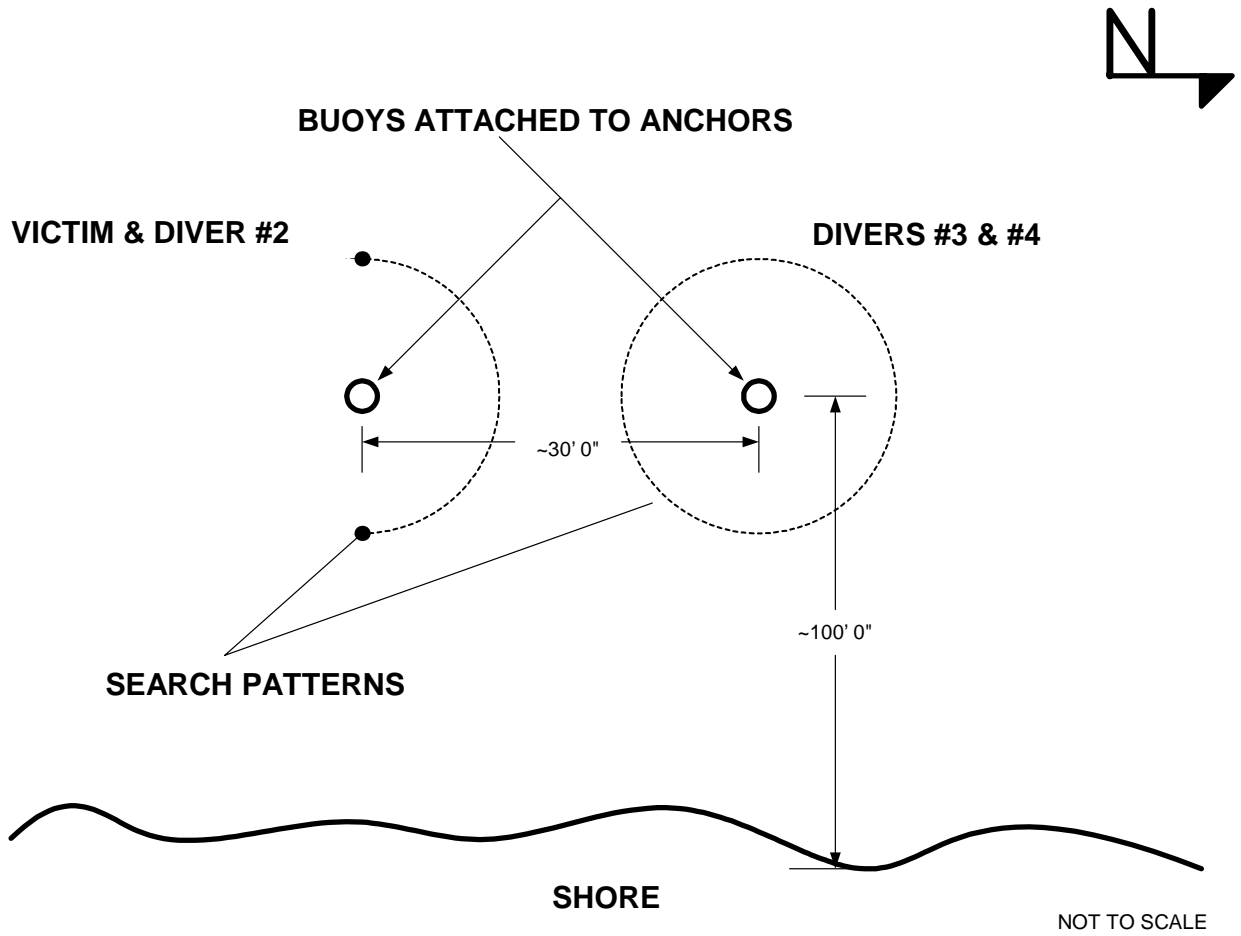
Diagram. Search Patterns

Any time rope lines are used underwater during SCUBA activity, the risk of entanglement is present. Rope lines used underwater should be kept at a minimum to avoid possible entanglement. When two different search patterns are being performed in close proximity, it is possible that the search patterns can overlap one another and cause the ropes to become entangled. If two different searches take place, they should be at a safe distance from each other and the proper staff should be assigned to oversee each individual dive operation. It is unclear that the search patterns were overlapped in this incident. However, Diver #3 located the victim underwater on his (Diver #3's) search line, which indicates that they had become entangled at some point underwater. Diver #3 recalled releasing approximately 40 feet of rope line during their circular sweeps. The

buoys were set up approximately 30 feet from each other. Additionally, it was stated that the buoys were dragged from their original placement closer together during the operations, which also indicates entanglement of the two lines.

Recommendation #2: Fire departments should ensure that underwater searches are completed individually to avoid possible rope entanglement.
