Career Fire Fighter Drowns During Final Dive of Training Course - Indiana

On June 14, 2002, at approximately 1243 hours, a 37-year-old male career fire fighter (the victim) drowned during the final dive of a diver training course. The victim and his partner were attempting to locate and bring an object to the surface. They were using a lifting device in zero visibility at a depth of approximately 50 feet. The victim's partner was in a kneeling position on the bottom of the lake attaching his line to the object when the victim knocked him over on his side and attempted to remove his mask. The victim's weight belt landed on top of his partner. The partner surfaced and informed the personnel in the safety boat that the victim was in trouble. The safety diver immediately entered the water and began searching for the victim. Additional divers were shuttled to the site by the safety boat to continue searching for the victim. The victim was recovered over 2 hours later using a sonar device. Advanced life support was initiated en route to a local hospital where he was pronounced dead. NIOSH investigators concluded that, to minimize the risk of similar occurrences, fire departments should

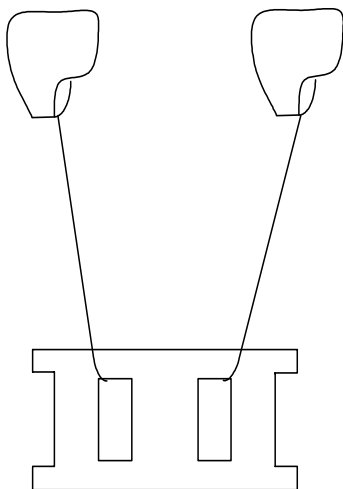
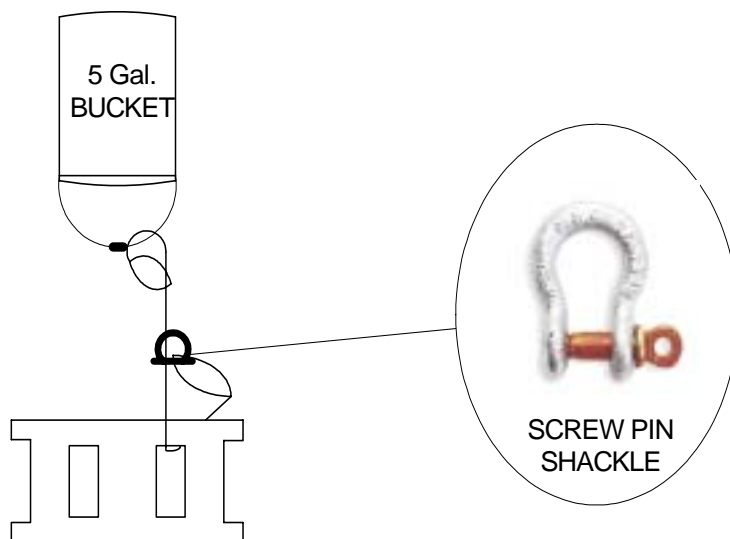
Diagram 1. Block assemblies

the lanyard to a 5-gallon bucket. The bucket would then be turned upside down so that the divers could expel air into it and lift the cinder block with both lines (Diagram 1).

In this incident the victim transported his 5-foot lanyard by attaching it to his vest with a D-ring. He attached one end of the lanyard to the cinder block, while the other end was still attached to his D-ring on his vest. For an unknown reason, the victim attempted to contact his partner. The victim removed his weight belt signifying distress in an attempt to reach the surface. When the victim was recovered, he was found attached to the cinder block by his lanyard. Practicing the specific steps that will be used in open water training dives in a controlled environment (e.g. swimming pool) under close supervision could assist in dealing with factors in a real environment.

A. Milk jugs attached to cement block with nylon rope.

B. Example of the components used to lift the cement block.

Recommendation #2: Fire Departments should ensure that all participants in diver training have practiced the specific evolution in a controlled environment such as a swimming pool before attempting the evolution in open water.³

Discussion: The complexity of public safety diving cannot be understated. Whenever new skills and/or equipment are introduced, it is important to gradually increase the level of complexity the diver is expected to master. Pool sessions that gradually increase the level of complexity would allow the diver to master the tasks and skills expected in a controlled situation, thus improving the chance of a positive outcome when the evolution is replicated in an open-water environment. A diver's skills should be evaluated with the diver wearing the full complement of equipment that would be worn while performing in actual rescue situations. This skill evaluation should include underwater emergency procedures as well as the other skills needed to deliver public safety diving services.

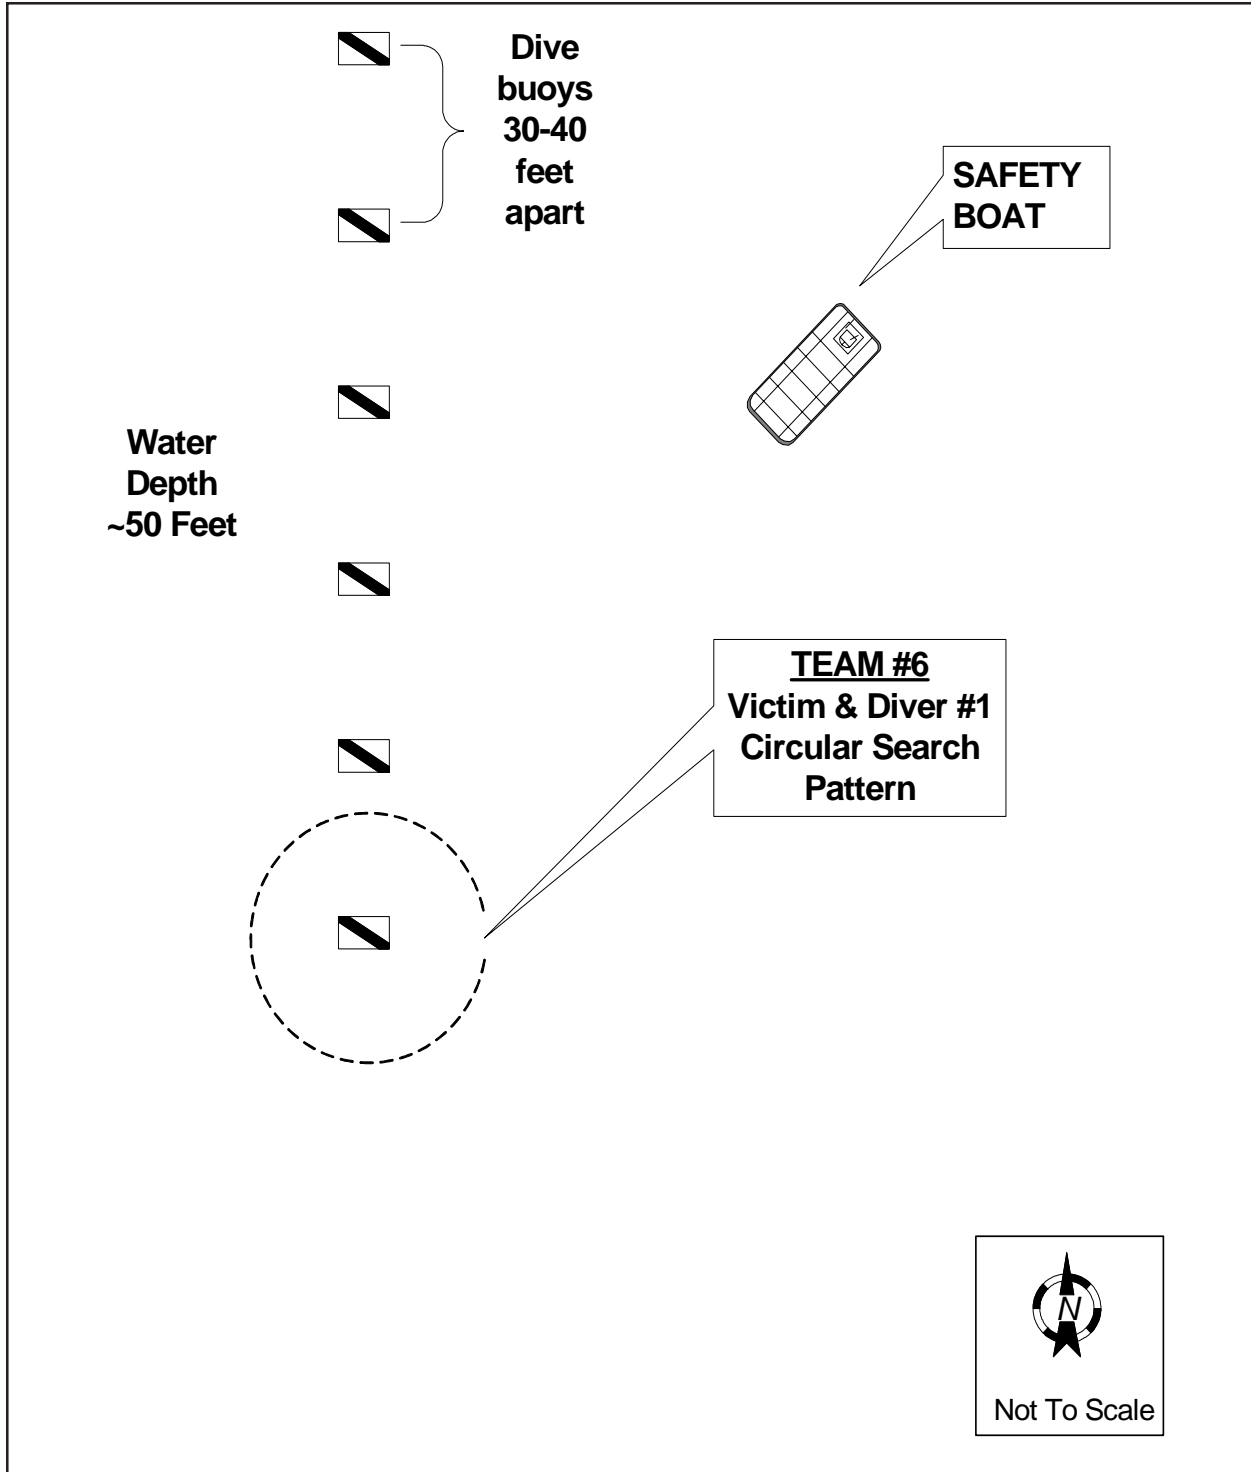
Diagram 2. Aerial view, dive team setup

The staging area where the class was operating from included the dock, a beach, and a loading ramp where individuals were waiting to participate in the class (Photo 1). One instructor and a dive master in the safety boat placed buoy markers 30 to 40 feet apart in a straight line using the safety boat. The lines for the marker buoys were 50 feet long and were counter weighted so that the depth could be adjusted. The marker buoys were placed at a depth of approximately 50 feet (Photo 1 and Diagram 2). The crew then sank each block assembly within 5 to 10 feet of the marker buoys and returned to shore.

In this event, the safety diver had all three components available to begin the rescue operation. He immediately entered the water after obtaining information from the victim's partner and used the buoy line as his reference point. During the fourth search pattern, the crew on the safety boat raised the buoy line, eliminating the reference point for future searches.

Recommendation #3: Fire departments should ensure that search-and-rescue operations establish and use reference points to conduct searches.⁴

Discussion: The establishment of a last-seen reference point should be a dive rescue team's primary objective when beginning search-and-rescue operations. The last-seen point can eliminate a great deal of uncertainty when conducting underwater searches. Establishing a last-seen point consists of three components:

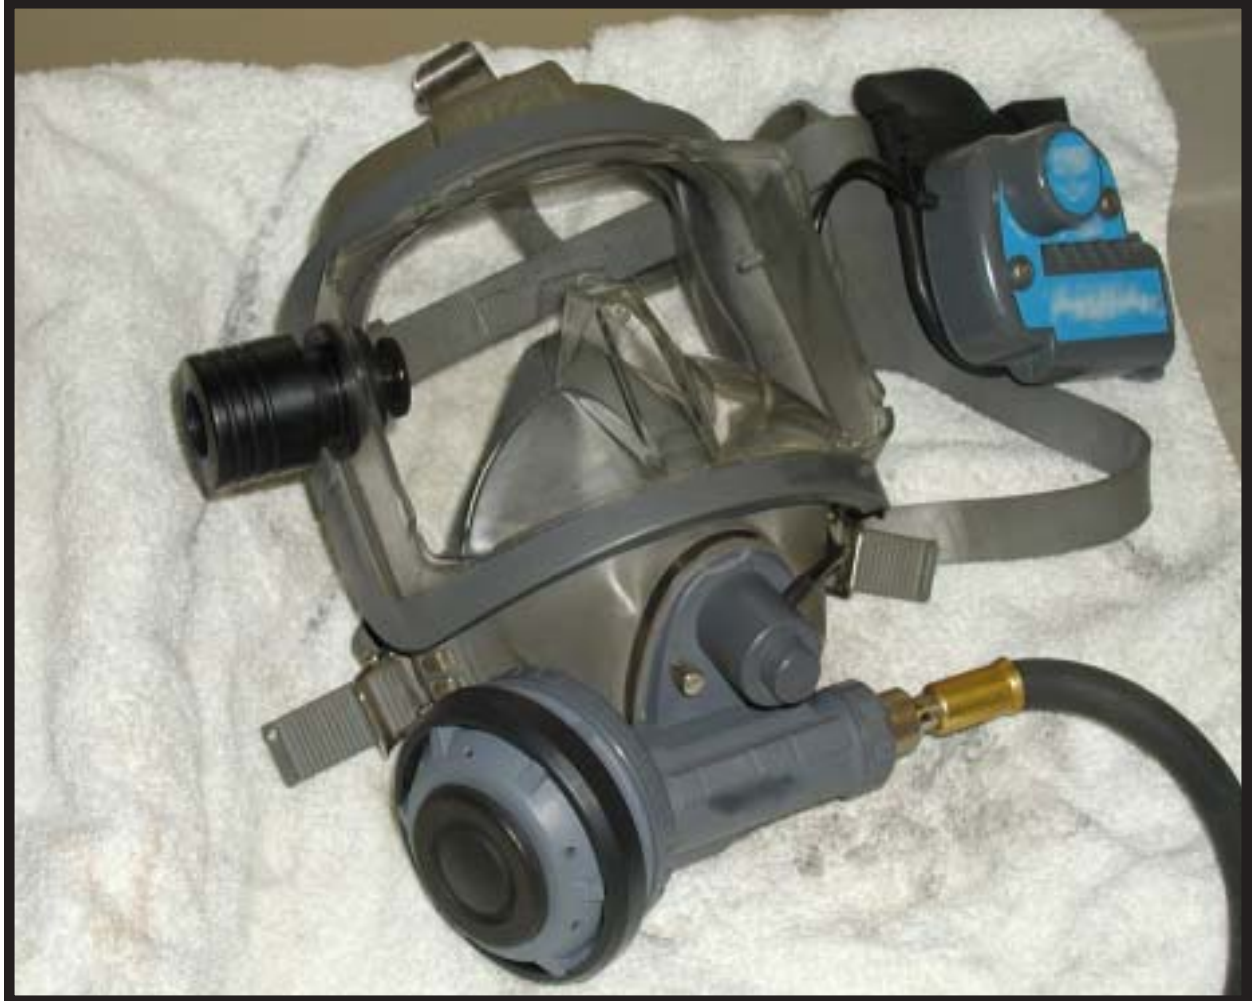
Photo2. Example of dive mask used by the victim

personnel that they had found the block and had begun working on their objective. Diver #1 was in a kneeling position on the bottom and began to attach his 5-foot nylon line to the cinder block using a shackle. As Diver #1 was screwing the pin back into the shackle, the victim attempted to remove Diver #1's facepiece. The force from the victim pushed Diver #1 over on his side, and the victim's weight belt landed on the arm of Diver #1. The victim may have released his weight belt in an attempt to reach the surface.

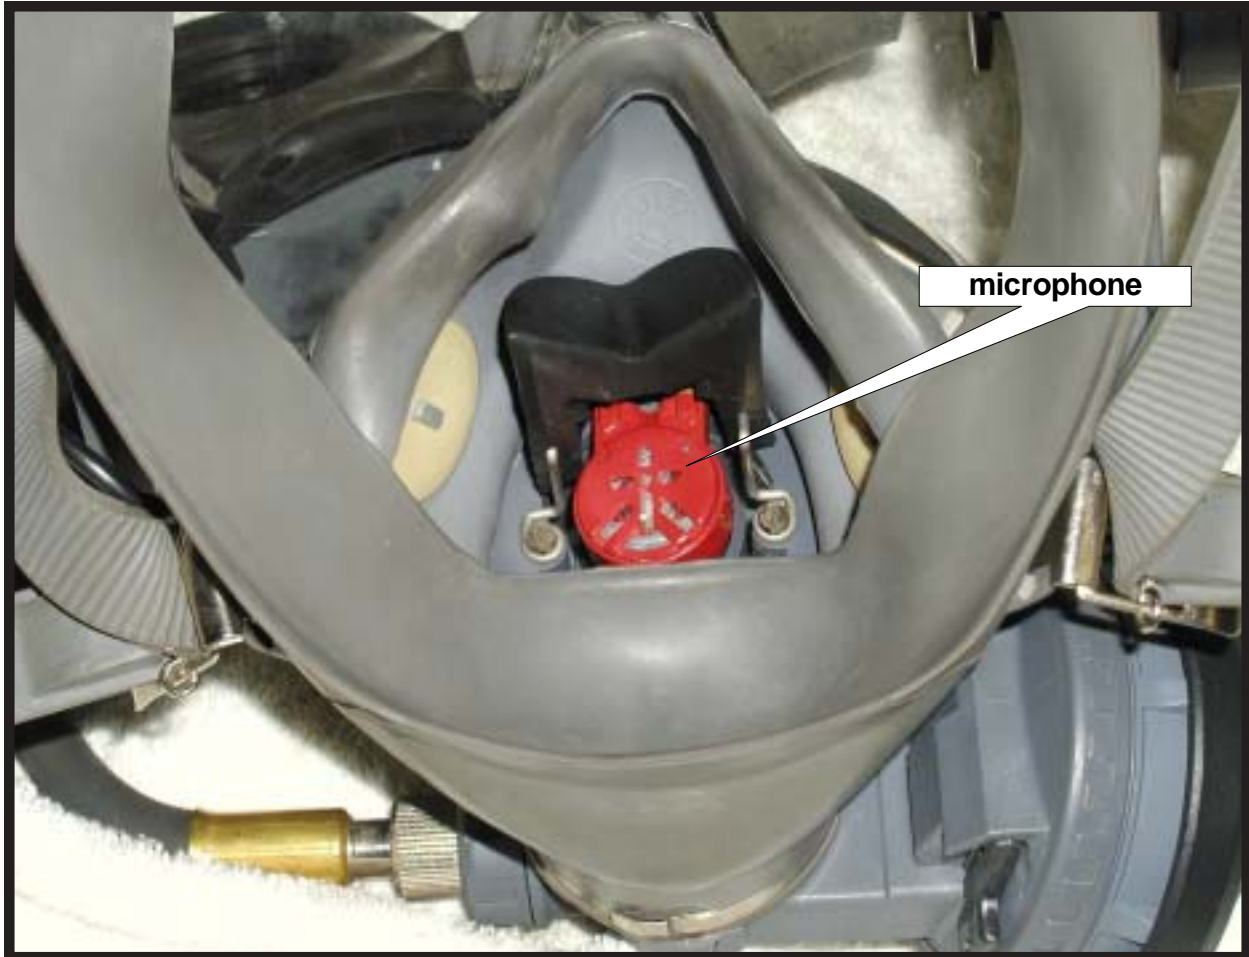
Photo 3. Example of microphone that was not working

The victim made two circles and gave two tugs on the line to indicate to Diver #1 that he had found the buoys attached to the cinder block. Diver #1 followed the pivot line to the victim and was talking to the victim as he swam toward his location. *Note: The victim's underwater communication system was not working properly at the time of the incident. He could hear but could not send transmissions (Photo 2 & Photo 3).* Diver #1 gave the victim two squeezes on his arm, and the victim returned the two squeezes, which indicated that everything was alright.

Recommendation #1: Fire departments should ensure that equipment checks are performed before each dive and defective equipment is repaired or replaced before the dive takes place.²

Discussion: Using the buddy system, divers should develop the habit of inspecting each others equipment for correct positioning, adjustment, air pressures, and function before entering the water. Whenever divers are using underwater electronic communication devices, all divers should ensure that the devices are working properly and have fully charged batteries. Divers should test communication equipment on the shore before diving and remain in contact with one another throughout the dive. In addition, personnel on the shore should be able to monitor communication among divers both above and below water through an electronic surface monitor. Any problems (e.g., low air, broken weight belt, malfunctioning communication equipment, etc.) should be reported to the dive instructor, logged, and repaired or replaced before the dive takes place.
