Volunteer Assistant Chief Dies in Tanker Rollover - New Mexico

Fatality Assessment and Control Evaluation Investigative Report #F2003-23

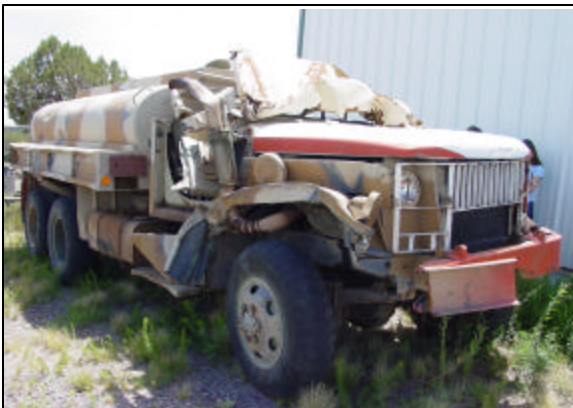
Tanker involved in incident

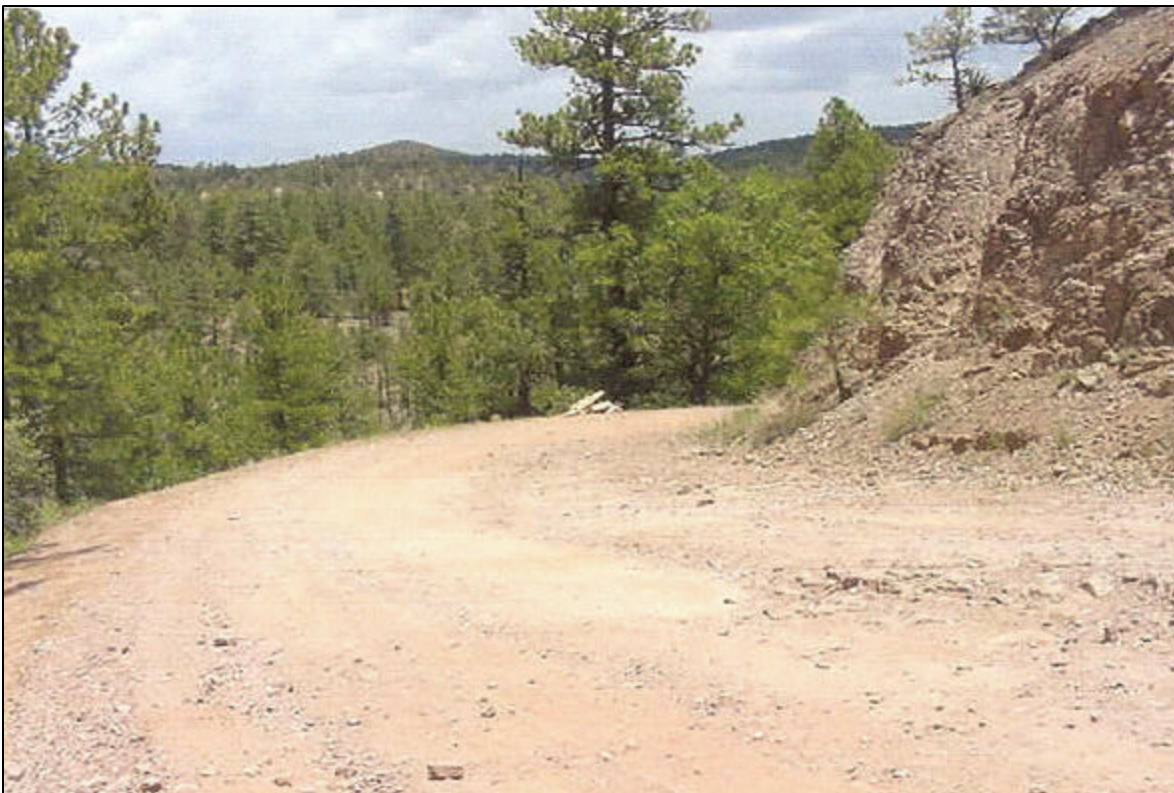
This incident occurred on a 45-degree curve on an unpaved mountainous road, with an approximate 8 to 10 degrees downgrade, within a National Forest (see Photo 1). The road had a steep drop-off to a canyon, approximately 150 feet below. The road was approximately 27 feet wide and did not have a shoulder, guardrails or a posted speed limit. The State police report estimated 15 mph as the safest speed on this road. The road surface was gravel and dry at the time of the incident. According to the State police accident report, there were no adverse weather conditions on the day of the incident. The tanker was still several miles from the fire at the time of the incident and no smoke was present. The weather was sunny, with temperatures about 90°F.

Photo 1. Incident site in national forest

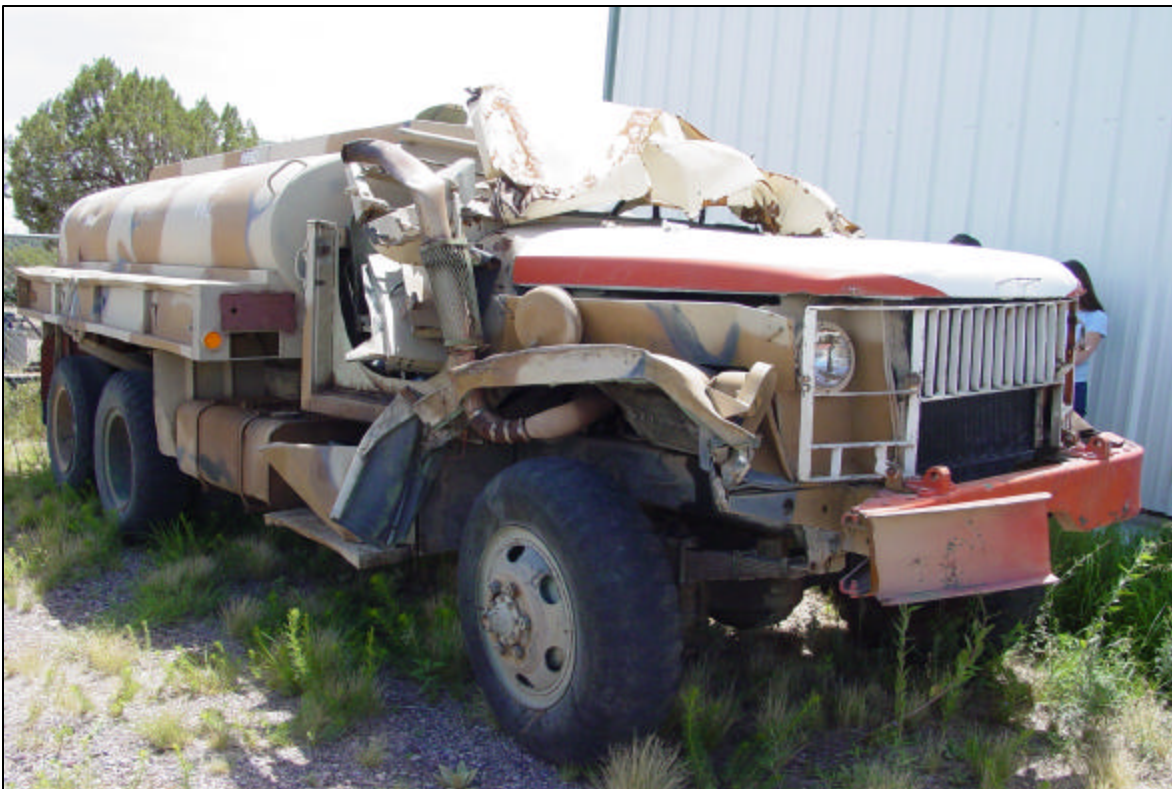
The apparatus involved in this incident was a surplus 1954 2½-ton military fuel servicing truck with a multi-fuel engine (see Photo 2). The truck had a rectangular 1,200-gallon tank with one central side-to-side internal baffle. The tank was originally used to transport diesel fuel. In the rear, the truck was equipped with a small gasoline-powered pump and piping for water transfer. The overall vehicle length was 22 feet, vehicle width was 6.7 feet, and the wheelbase was 15 feet. The vehicle's empty weight was 14,970 lbs; the vehicle weight with a full tank of water was 24,930 lbs.

traveling off-road and 7,500 lbs (3¾-tons) when traveling on the highway. Since water weighs 8.3 pounds per gallon, 5,000 lbs of water is about 600 gallons. The vehicle involved in this incident had a 1,200 gallon tank and the water weight alone from a full tank would be 9,960 lbs, thus exceeding the vehicle's payload capacity when traveling either on the highway or off-road.

In the post crash investigation, the State police reported that the tanker “probably had brake failure prior to the accident” and noted that the master cylinder was leaking brake fluid and the emergency brake was inoperable. The State police further reported that both front shock absorbers were defective and that three tires had a tread depth of less than 1/32 of an inch.

Photo 2. Tanker involved in rollover after recovery from the canyon

Recommendation #1: Fire departments should determine a safe operating weight for water tankers based on vehicle characteristics and remove overweight vehicles from service.²

Recommendation #2: Fire departments should develop comprehensive apparatus maintenance programs and guidelines that include regularly scheduled inspections, documentation, and procedures for removing apparatus from service until major defects are repaired.^{3,4}

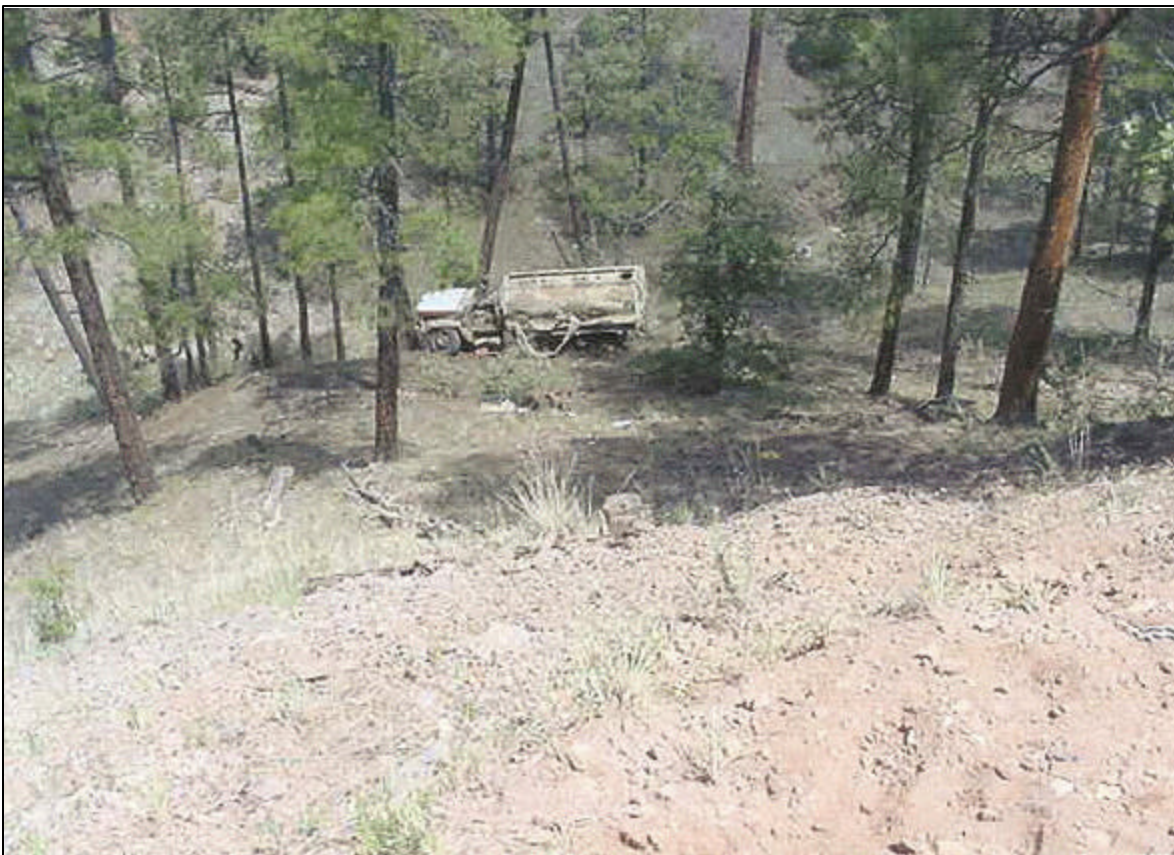
They drove approximately 135 miles on State and interstate highways prior to reaching the National Forest. At approximately 1945 hours, on a mountainous road within the National Forest, around a downward sloping curve, the victim’s truck rolled over and left the road (see Photo 3). According to the State police accident report, the tanker rolled over 4 times prior to coming to rest 123 feet down the canyon. The victim was ejected from the cab landing in front of the tanker on the second rollover. The State police reported that the tanker had rolled over the victim prior to coming to a stop. His body was found in the canyon approximately 100 feet from the road.

Photo 3. Location of tanker after incident
