A Summary of a NIOSH fire fighter fatality investigation

March 31, 2005

# Career Fire Fighter Dies of Carbon Monoxide Poisoning after Becoming Lost While Searching for the Seat of a Fire in Warehouse - New York

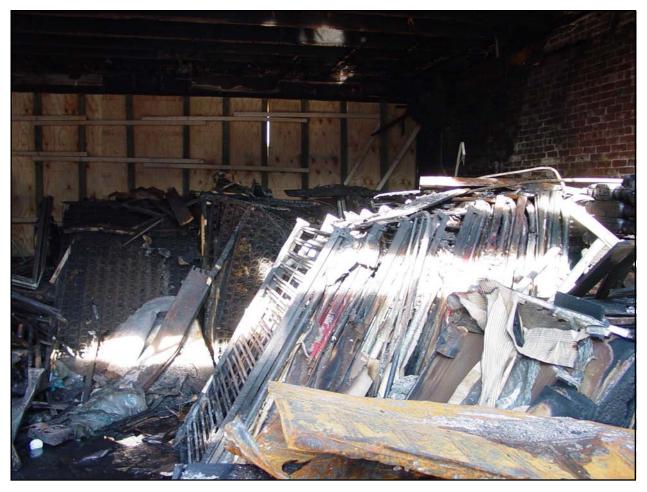
already limited aisle space and produced a mazelike condition (Diagram 1; Photo 1). The building had no sprinkler system, smoke detectors, or fire doors. Fire escapes were present and operational. Bars were present on all windows and the rear door was heavily secured with locking devices and steel bars. The front door leading to the second floor had a pull-down gate that was locked when fire fighters arrived.

Photo 1. Interior of structure showing contents after fire suppression

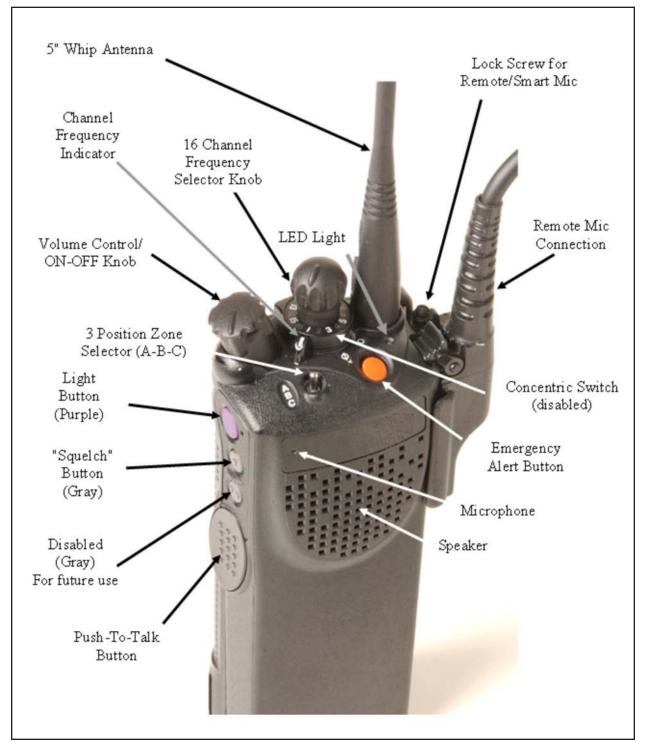
Radio: Every unit and riding position has a handheld radio (Photo 2). Most fire fighters have the model shown in the photo which is programmed with one 16-channel zone. The radio model used by chief officers has a liquid crystal display (LCD) and three 16-channel zones. Radios have an emergency alert button on top of the radio that switches the radio to high power (2 watts to 5 watts) and maximum receive volume, and which causes tones to be heard on receiving radios and the transmitting radio on whatever channel is being used. The emergency function also transmits an electronic designator indicating the user's unit and riding position. The latter information appears on the LCD of receiving radios. Radios are carried in a holster under the bunker gear; remote microphones are clipped to the jacket. The victim had a simple remote microphone with a push-to-talk (PTT) button.

Photo 2. Type of hand-held radio used by victim

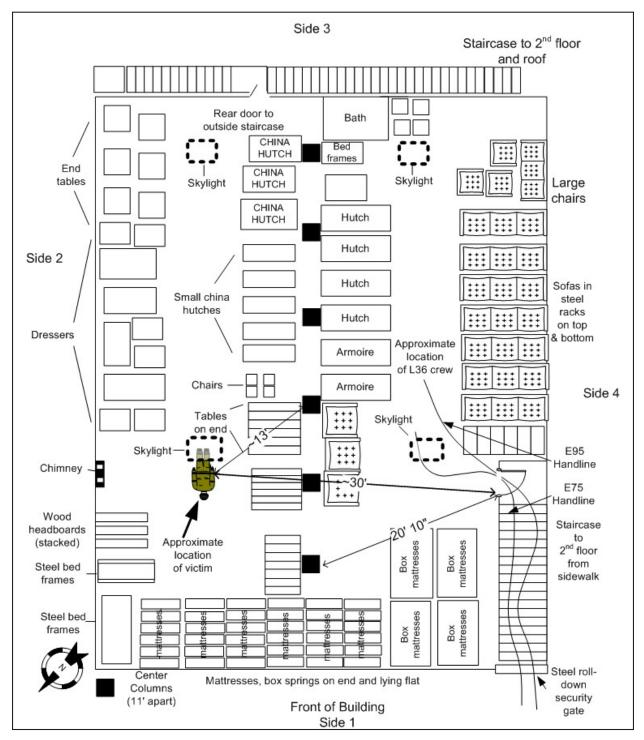
The warehouse was one large room, approximately 53-ft wide by 87-ft deep, with columns down the center (Diagram 1). It contained mattresses, mattress springs, upholstered sofas and chairs, and other household furniture often stacked to the ceiling. Furniture was stacked on both sides of the center columns and along the walls, some in racks. On Side 1 (northwest wall) mattresses and box springs were stacked on end against the front windows. According to the state fire marshal's report, the warehouse was at maximum capacity the day of the incident due to a stock delivery several hours before the fire. This reduced the on either side of the air cylinder posteriorly; no

At 1313 hours, R3 located the victim who was about 30 feet from the stairs near the center columns (Diagram 1). He was lying beneath a skylight, face down in a pool of water with his head in the direction of the front windows. Two pieces of the tin ceiling were covering him. His face piece was off and the manual shut off switch on the regulator was depressed. The PASS alarm was not audible. When the victim was turned over, the PASS device emitted a faint, monotonous sound. Note: According to the manufacturer (as communicated to the department), this sound indicates a dead-short in the electronics of the PASS. The victim's radio was on and his left glove was off. The rescue team administered cardio-pulmonary resuscitation (CPR) and then removed the victim from the structure via a rescue basket. He was taken by ambulance to a nearby hospital where he was pronounced dead at 1349 hours. The total time the victim was in *fire fighters to an interior operation, and* the structure from the time he was noted to be missing to when he was found was estimated to *the operation*. be approximately 30 minutes.

Diagram 1. Interior of building

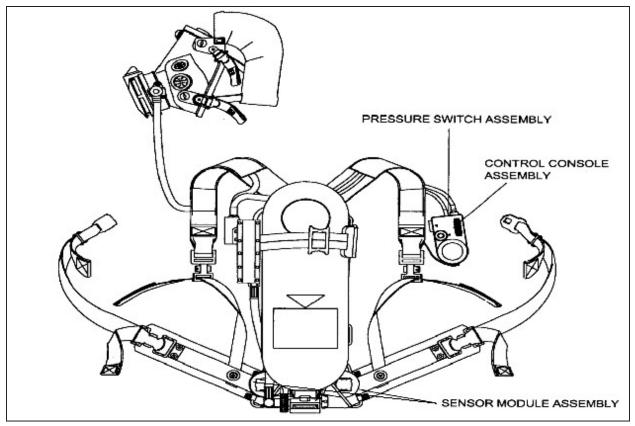
SCBA, which was less than 2 years old, passed post-incident functional tests done by a private company at the request of the fire department prior to the arrival of the NIOSH team. The same company inspected the PASS device and found that although a continuous tone was emitting, the alarm would not activate. According to the test report, water was present in the battery compartment. Based on a conversation with the chief of safety, the battery cover did not appear damaged or incorrectly fastened.

Diagram 2. Integrated PASS device

high temperatures affected the performance of the PASS device in this incident, NIOSH suggests that researchers, manufacturers, and committee members of NFPA 1982 review the temperature resistance testing requirements for PASS devices to ensure that these temperatures are representative of levels encountered under actual fire conditions.<sup>20,21</sup>
