Career Fire Fighter Dies and Two Career Captains are Injured While Fighting Night Club Arson Fire - Texas

SUMMARY

**Status Investigation Report of One
Self-Contained Breathing Apparatus
NIOSH Task No. 13617**

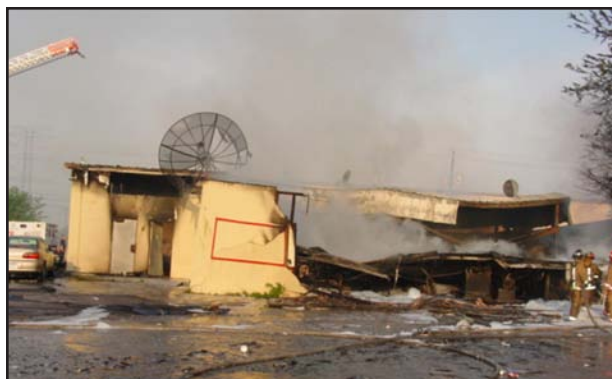
Incident scene

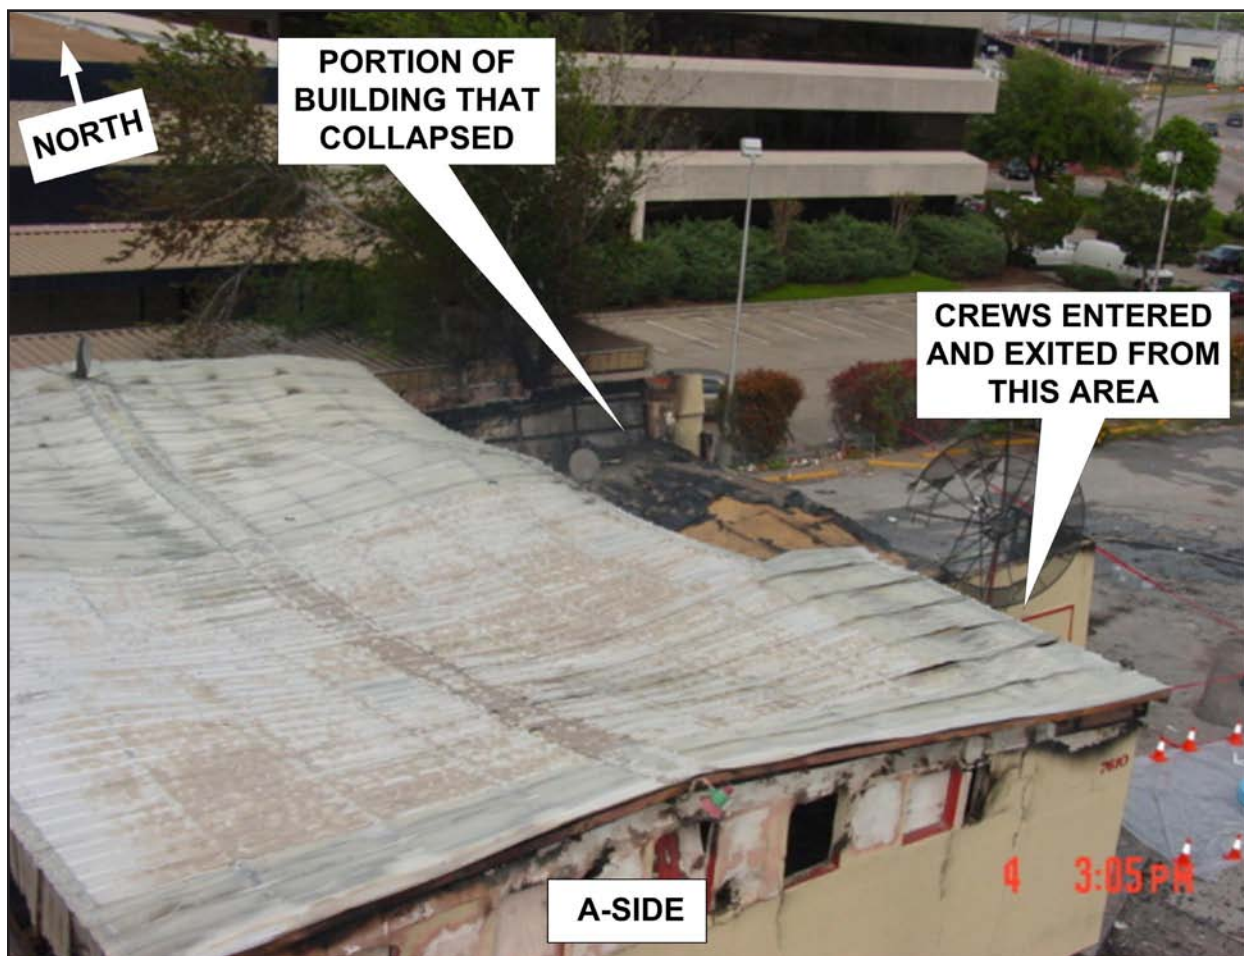
Photo. Aerial view of incident site

second search was initiated. At approximately 0722 hours, a radio transmission was made that an alarming PASS device could be heard. The IC then ordered all companies to shut down their operations and their engines. Approximately three minutes later the IC was informed that the victim had been found in the debris (Diagram 2 and Photo).

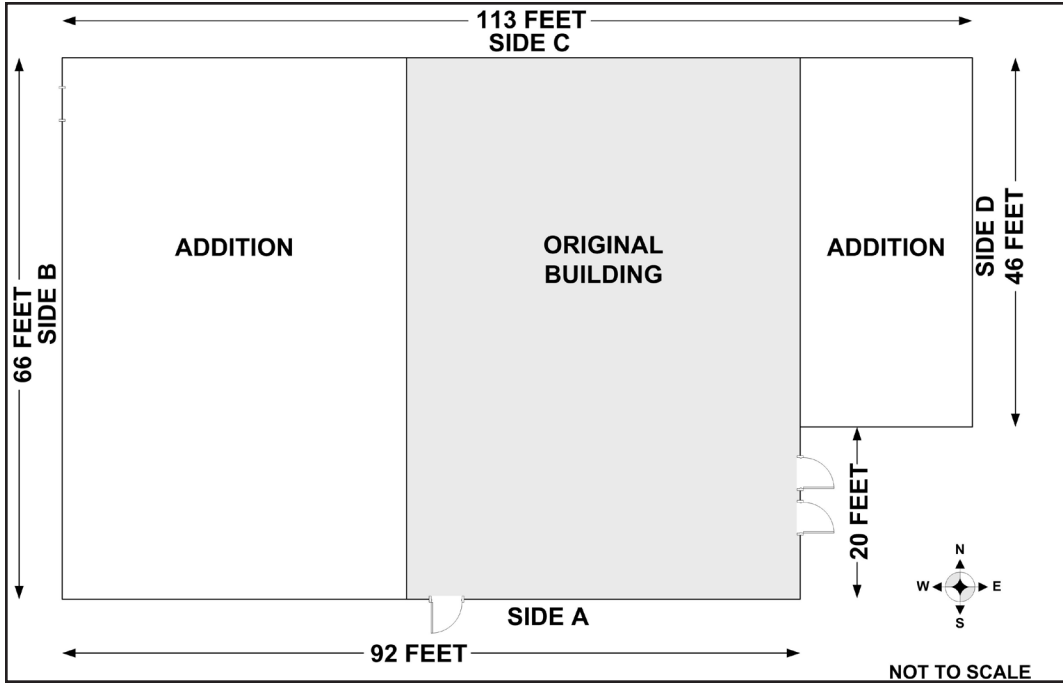
Diagram 1. Dimensions of night club

This structure had various construction methods and materials. The walls, ceilings and known interior finishes varied throughout the structure and a significant portion could not be determined due to the extent of fire damage. The structure had three sections, with the middle section being the original building, and the west and east sections added on at later dates (Diagram 1).

At 0605 hours, the Engine 50 crew stretched 200-feet of 1 ¾-inch pre-connect handline and positioned themselves at the main entrance (A/D corner, Diagram 1). Captain #1 conducted a partial size-up as he walked through a crowd of people that had gathered in the parking lot on the east end of the building (Side D). There was no visible fire observed on the exterior of the building by the first arriving units. Officers and fire fighters reported to NIOSH investigators that they observed heavy dark smoke emitting from the northwest corner of the structure upon their arrival.

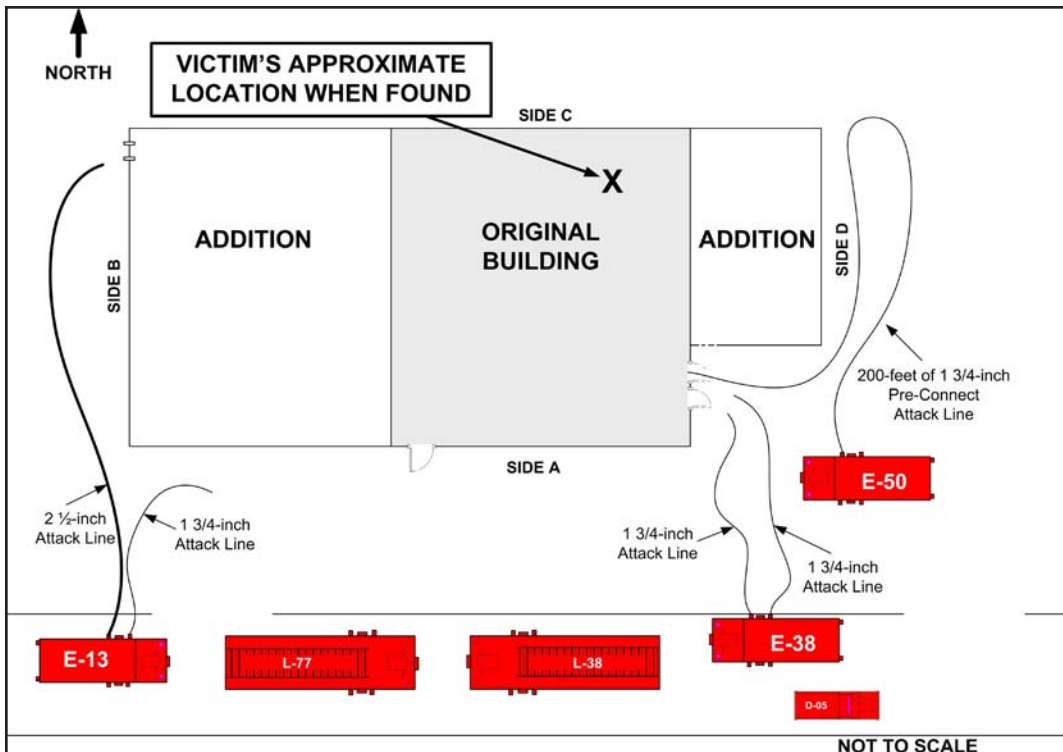
Diagram 2. Aerial view of incident site

The construction material of the walls of the two additions varied, with portions consisting of concrete blocks, while other sections had wood framing (2x4 construction). The addition on the east end of the building had a roof constructed of wood and was overlaid with asphalt shingles. The pitch of the roof was not significant enough to ensure proper water runoff. The construction of the walls of the west end of the building was very similar to the addition made to the east end of the building. The roof was constructed of wood and was overlaid with a built-up tar and gravel roof. The pitch of the roof at the west end of the building was also not significant enough to ensure proper water runoff. *Note: The two additions collapsed prior to recovering the victim. However, the victim was found in the original (middle section) building that had not collapsed (Diagram 2).*
