Career Fire Fighter Dies After Falling From Tailboard and Being Backed Over by Engine - California

SUMMARY

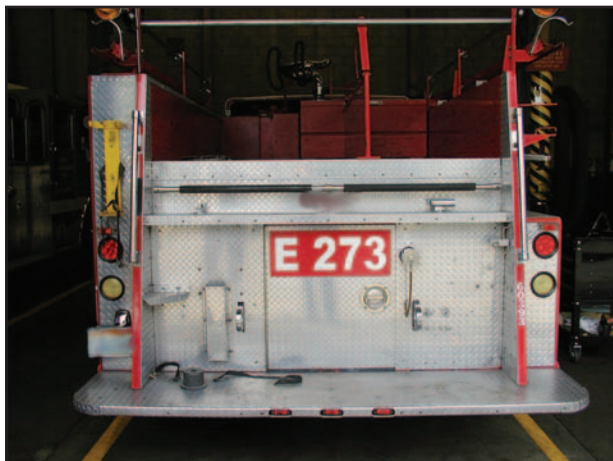
Tailboard of Engine 273

provide any means of protection from a collision or a fall from the apparatus. For an unknown reason, the victim fell from the apparatus and was run over.

Recommendation #1: Fire departments should modify existing policies to prohibit members from riding on the tailboard or any exposed position when the vehicle is in motion.

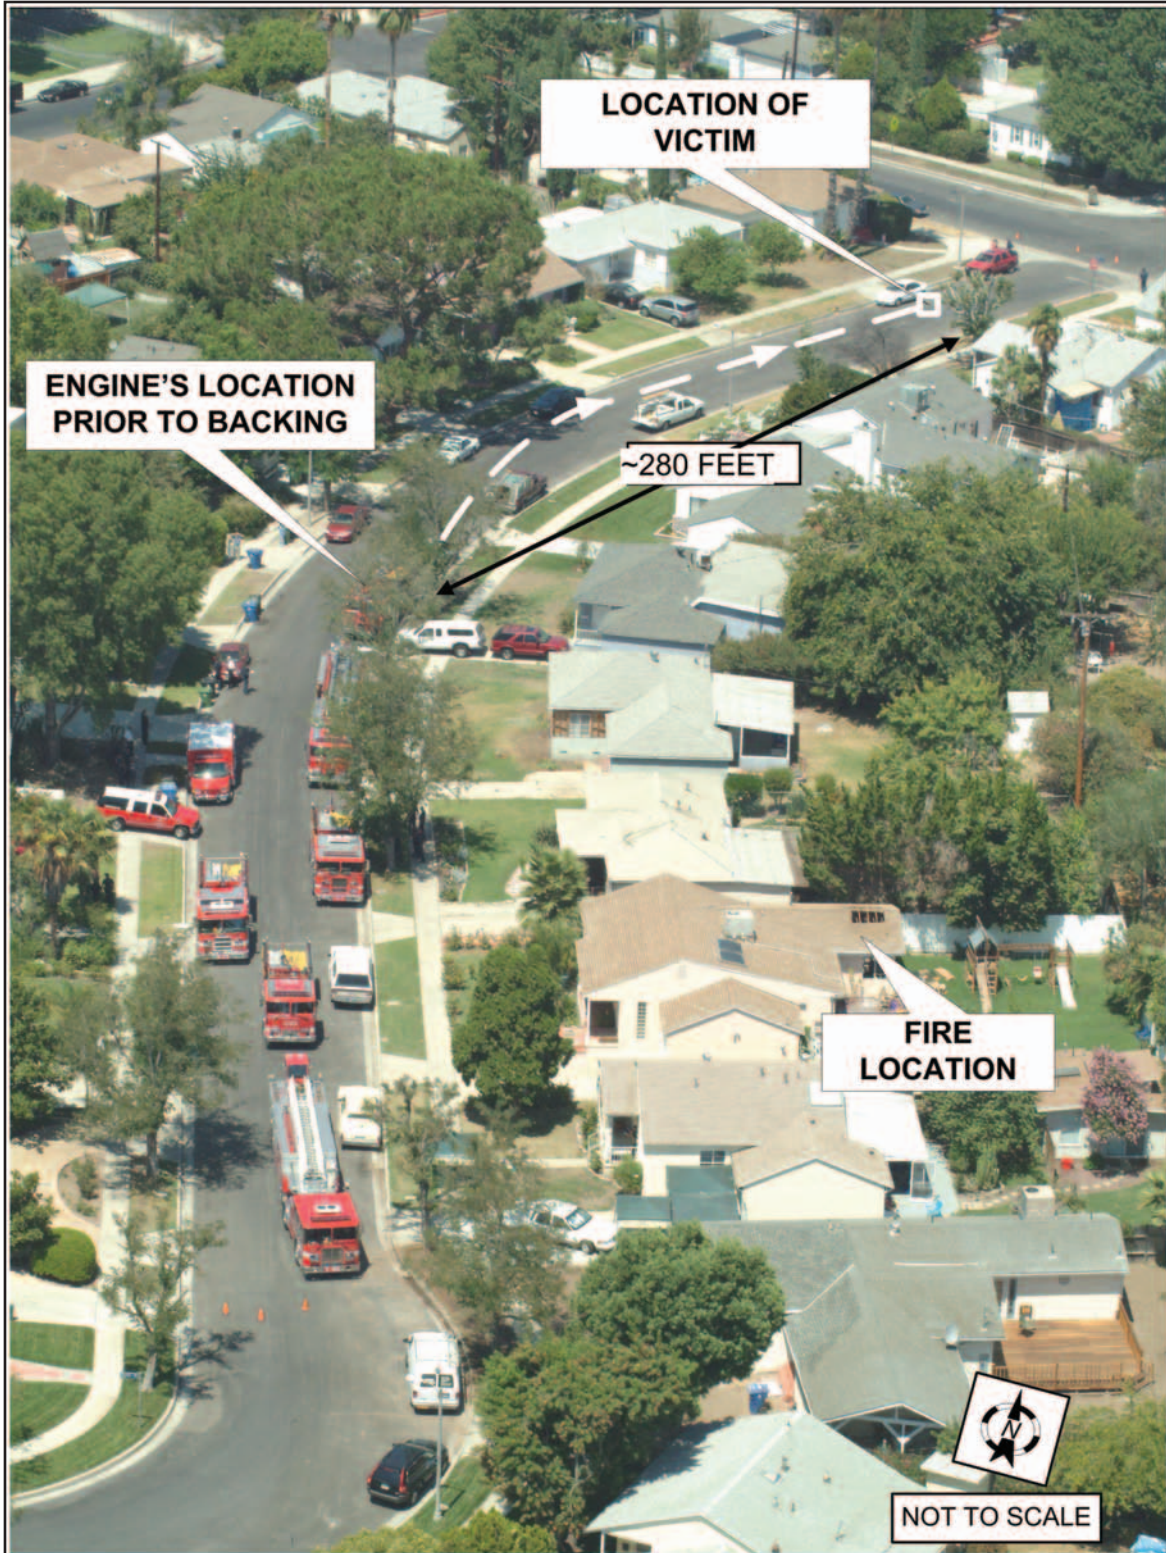
The crew returned to their apparatus, removed their gear, and rested for a few minutes as they drank water. The Incident Commander released the victim's crew from the incident at approximately 1330 hours, and because of other apparatus blocking the road, they were forced to back up to leave the fireground (see Photo #1).

Photo 1. Recreated incident scene

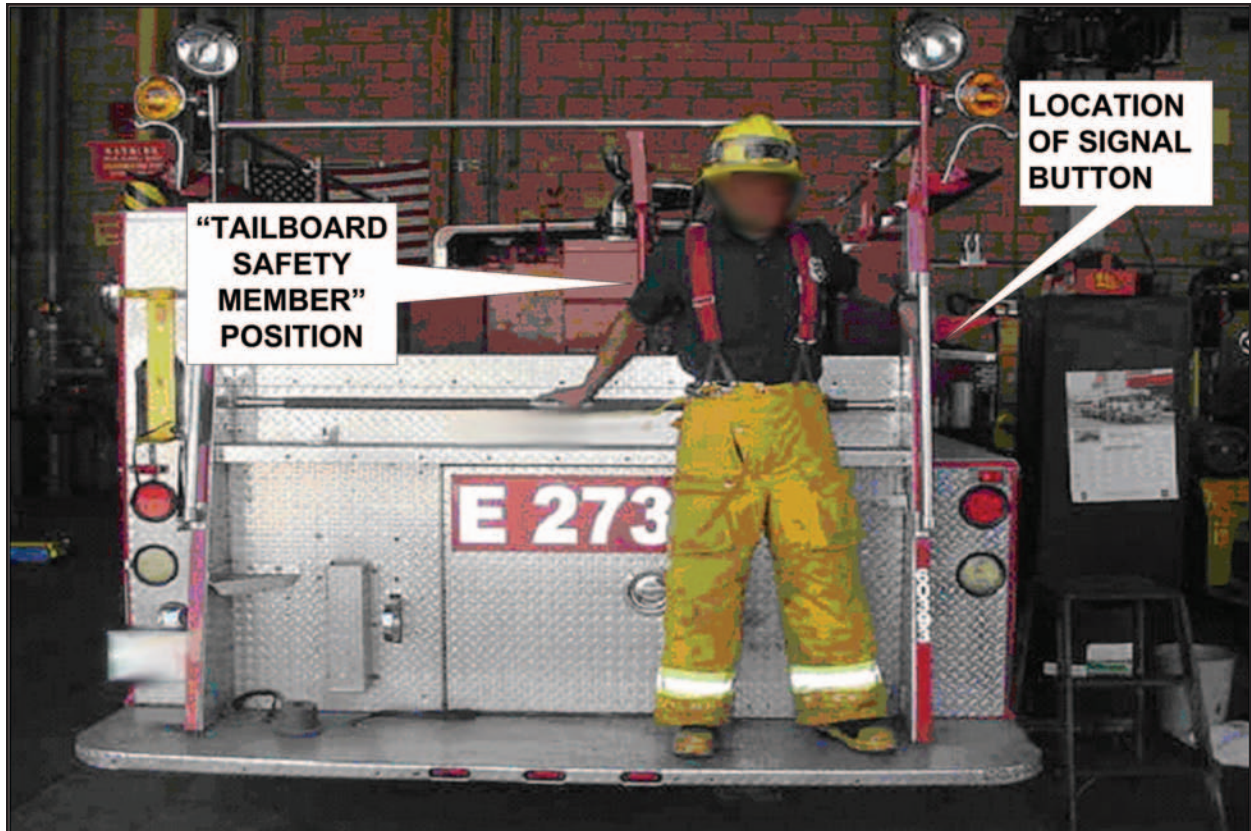
The victim took her position standing on the tailboard as the "Tailboard Safety Member," and as directed by department policy, notified the driver to begin backing up by pushing an electronic signaling button located on the rear panel of the engine. *Note: The fire department policy is for a fire fighter to ride on the tailboard and guide the driver whenever the apparatus is backing by pressing a signal button located on the rear engine panel. The "Tailboard Safety Member" would push the button once to stop, twice to go, and three times to back-up (see Photo #2 and Photo #3). The signal button would sound a bell in the cab and a red light would also flash correspondingly on the dash (see Photo #4).* A Captain, as directed by department policy, acted as the "Traffic Control Officer" and guided the backing operation from behind the apparatus, in the road on the driver's side, by using hand signals.

The department involved in this incident had a policy that required a member titled the "Tailboard Safety Member," to ride on the tailboard and act as a spotter whenever the apparatus was backing. The spotter would face toward the rear while backing and communicate to the driver with an electronic signaling button located on the rear panel. A member riding in a standing position on the outside of the apparatus cannot be secured to

Photo 2. Demonstration of victim's position and function just prior to incident

Recommendation #2: Fire departments should develop, implement, and periodically review standard operating procedures for backing fire apparatus.

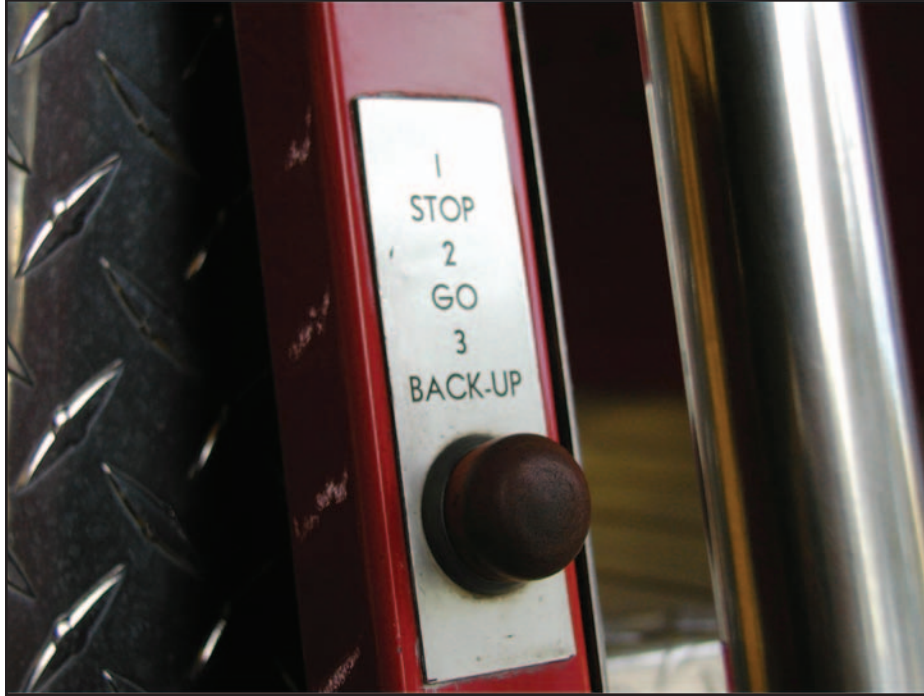
Photo 3. Push button on rear panel of engine with operating instructions

Recommendation #3: Fire departments should consider equipping apparatus with safety equipment such as additional mirrors, automatic sensing devices, and/or video cameras to assist with backing operations.

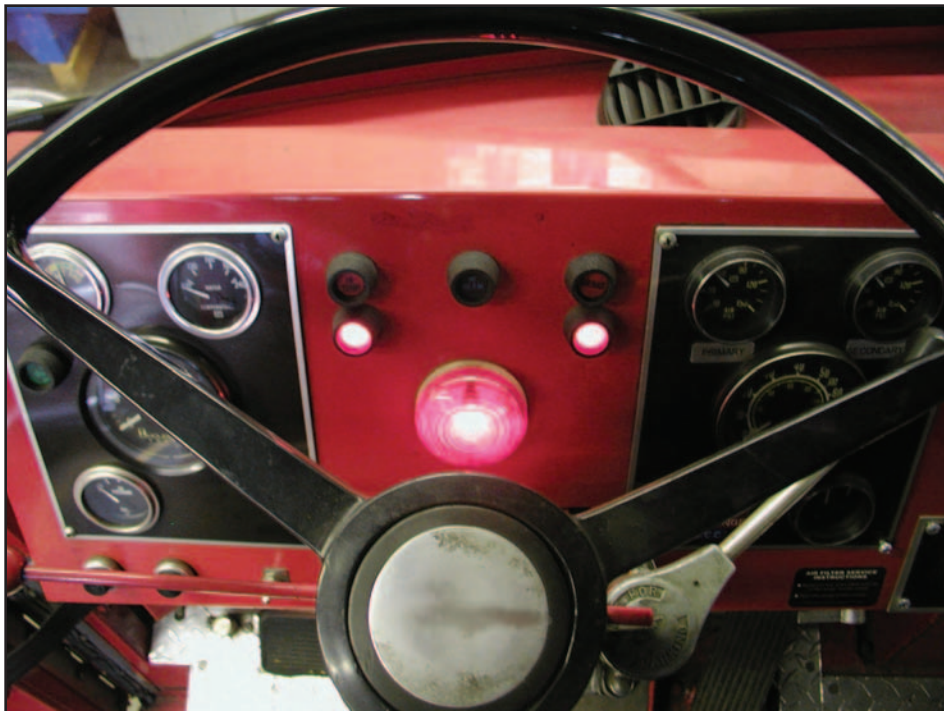
Photo 4. Red light on dash that flashes when the electronic signal button is pushed
