Two Volunteer Fire Fighters Die When Struck by Exterior Wall Collapse at a Commercial Building Fire Overhaul - Alabama

SUMMARY

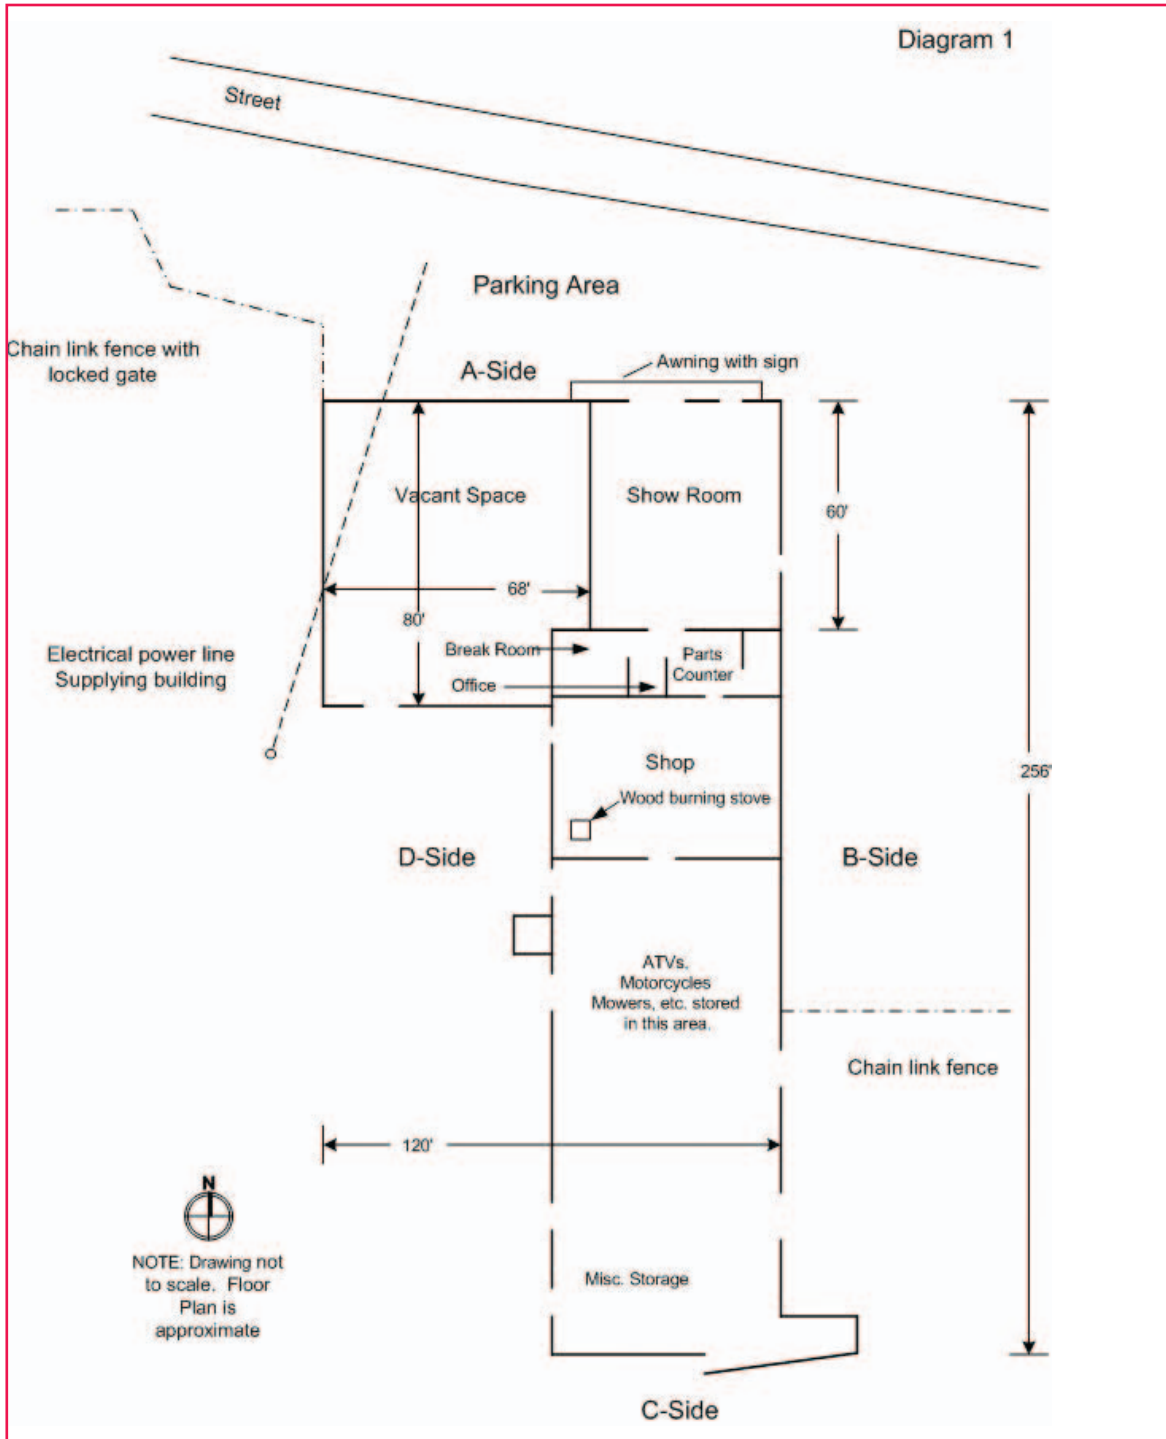
Diagram 1.

and garden power equipment, all-terrain vehicles (ATV), and paint-ball sporting equipment. The original front structure housed a showroom containing power mowing equipment, parts, and supplies such as lawn mower blades and batteries, and accessory items. A parts counter was located at the rear of the showroom. A peg-board wall separated the showroom area from the business office, employee break room and rest room facilities. Behind this was located a shop area of approximately 60 feet by 40 feet. The front portion of the structure also included a vacant storage area on the right or D-side of the building measuring 68 feet by 80 feet. The remainder of the rear portion of the structure housed ATVs, lawn mowers, and miscellaneous power equipment being repaired by the business, as well as trucks and tractors belonging to the business owner (see Diagram 1).

spaces of the heavy timber roof and contained a large quantity of paper records from the various businesses housed in the building over the years. The fire was believed to have smoldered within the storage space for several hours during the day. After the incident, three employees who had worked in the building the day of the fire reported smelling smoke during the day, but at the time attributed the smell to a wood-burning stove used for heat in the shop area (see Diagram 1).

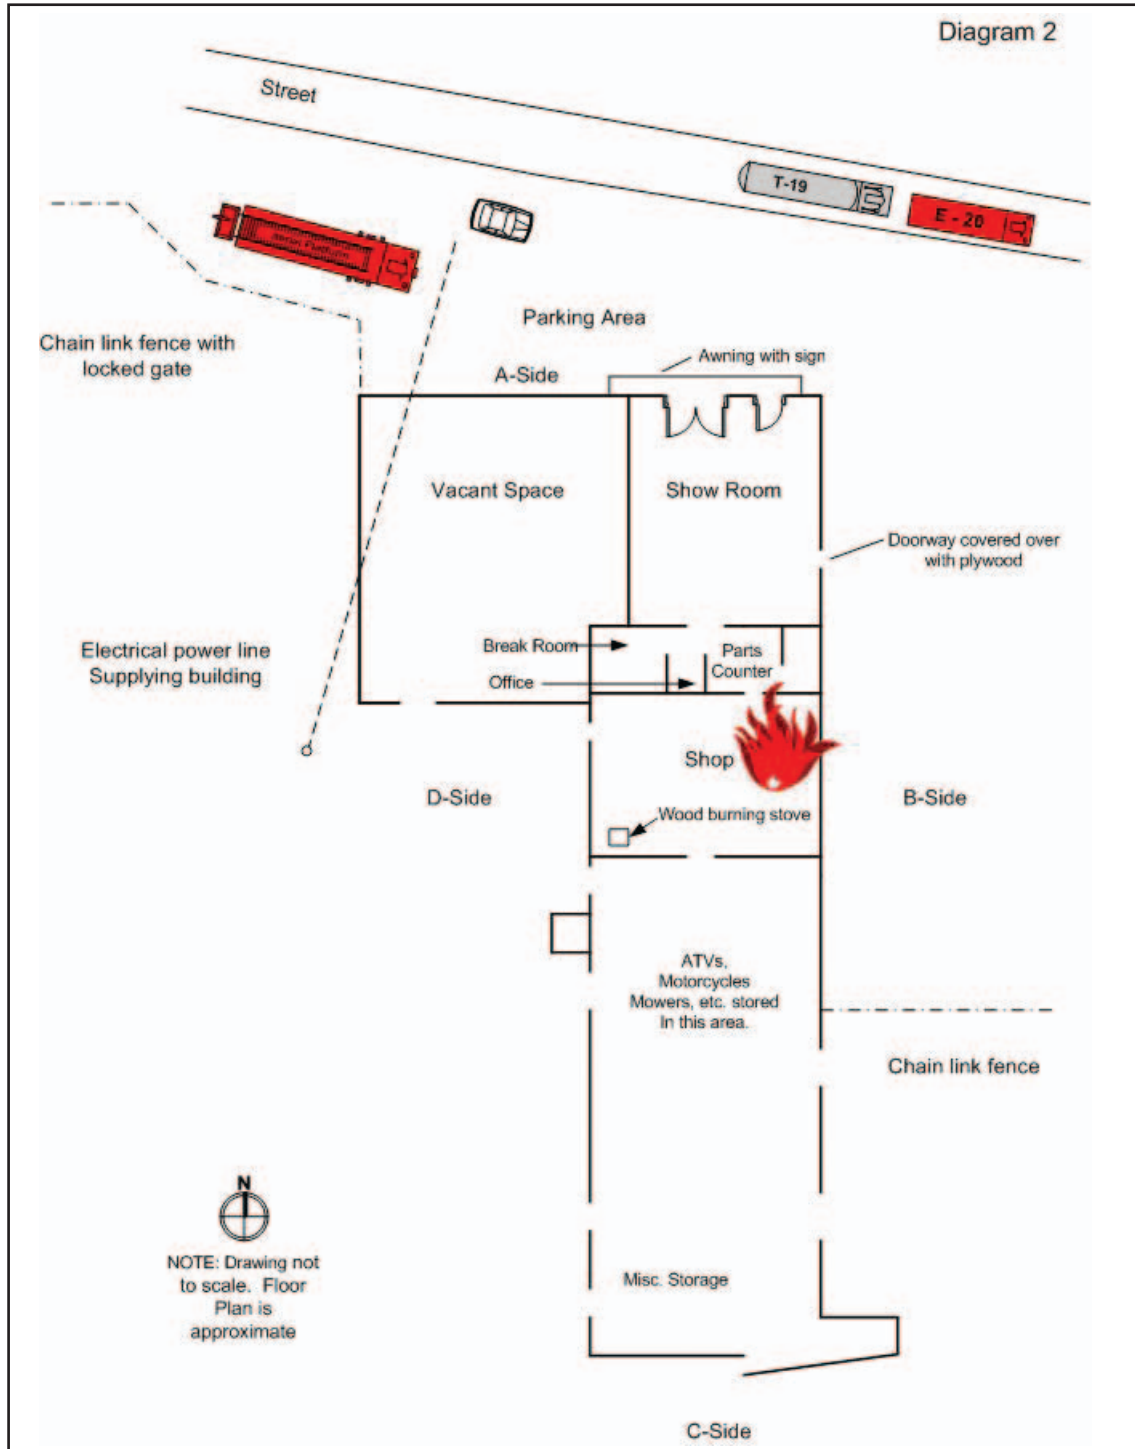
Diagram 2.

Engine 20 was the first apparatus to arrive on scene and parked in the street in front of the building (see Diagram 2). Flames could be seen coming from both the B (East) and D (West) sides of the building. The career captain driving E-20 (career captain # 1) assumed initial incident command (IC). The other captain (career captain # 2) radioed 911 and gave a report on the conditions observed at the scene, then radioed E-16 (already enroute) and requested that they

Since the fire seemed to be burning further back in the structure, it was decided to re-enter the structure through a doorway located on the B-side (see Diagram 2). This doorway was covered over by plywood on the exterior of the building. After chopping through the plywood with an axe, the fire fighters observed that the door opening had also been covered over when the interior had been renovated. A chain saw was retrieved from E-20 and used to finish opening the doorway to provide access to the interior of the building. The 1 ¾-inch handline at the front entrance was moved around to the B-side to support entry into the building.

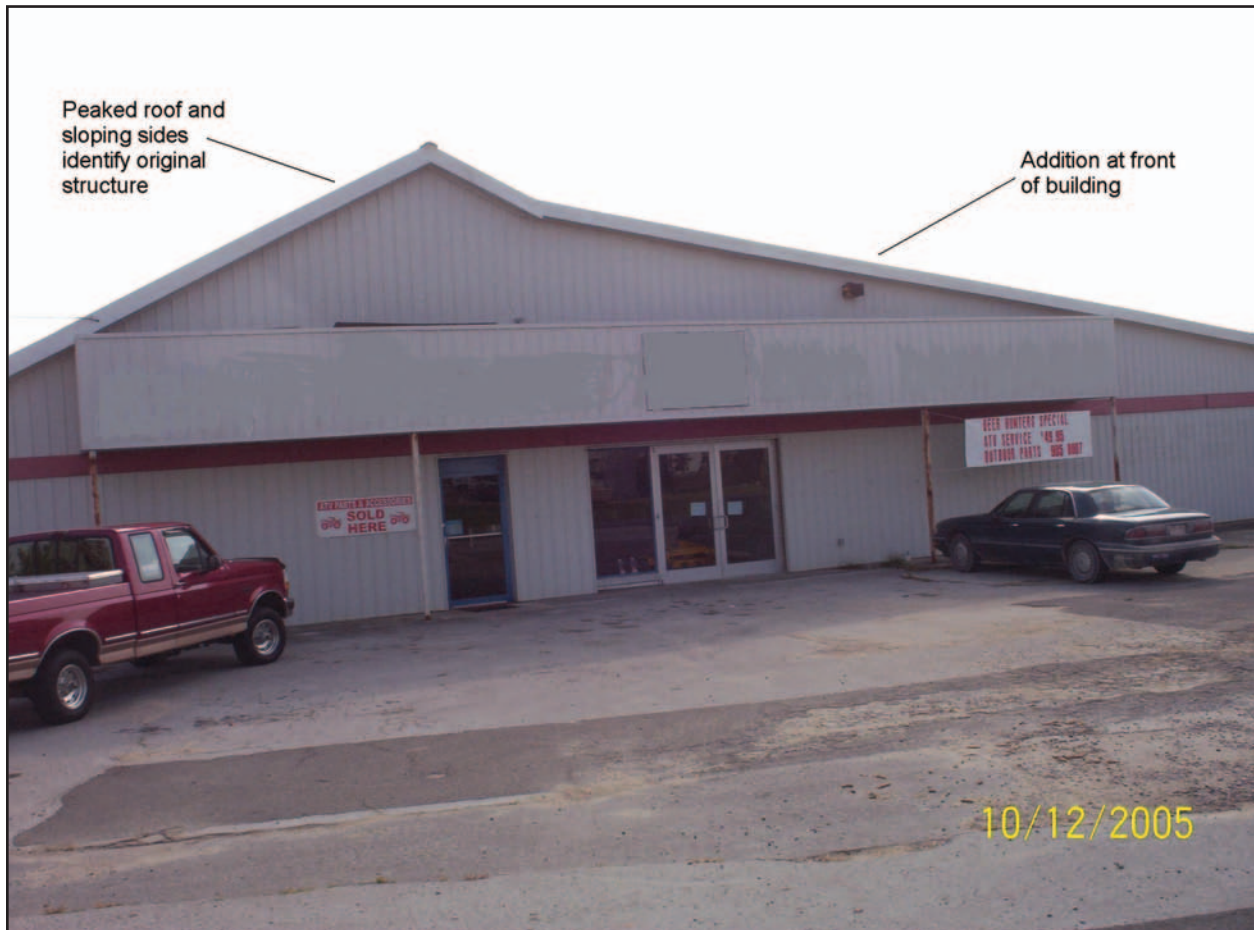
Photo 1. Photo taken four months prior to the incident. Note the front of the building and the awning over the entranceway. The sheet metal siding completely hides the presence of the underlying concrete block wall covered over with brick veneer and wooden clapboard siding. At the time of the incident, a large lighted sign was mounted on the awning above the entranceway. Photo courtesy of state fire marshal's office.

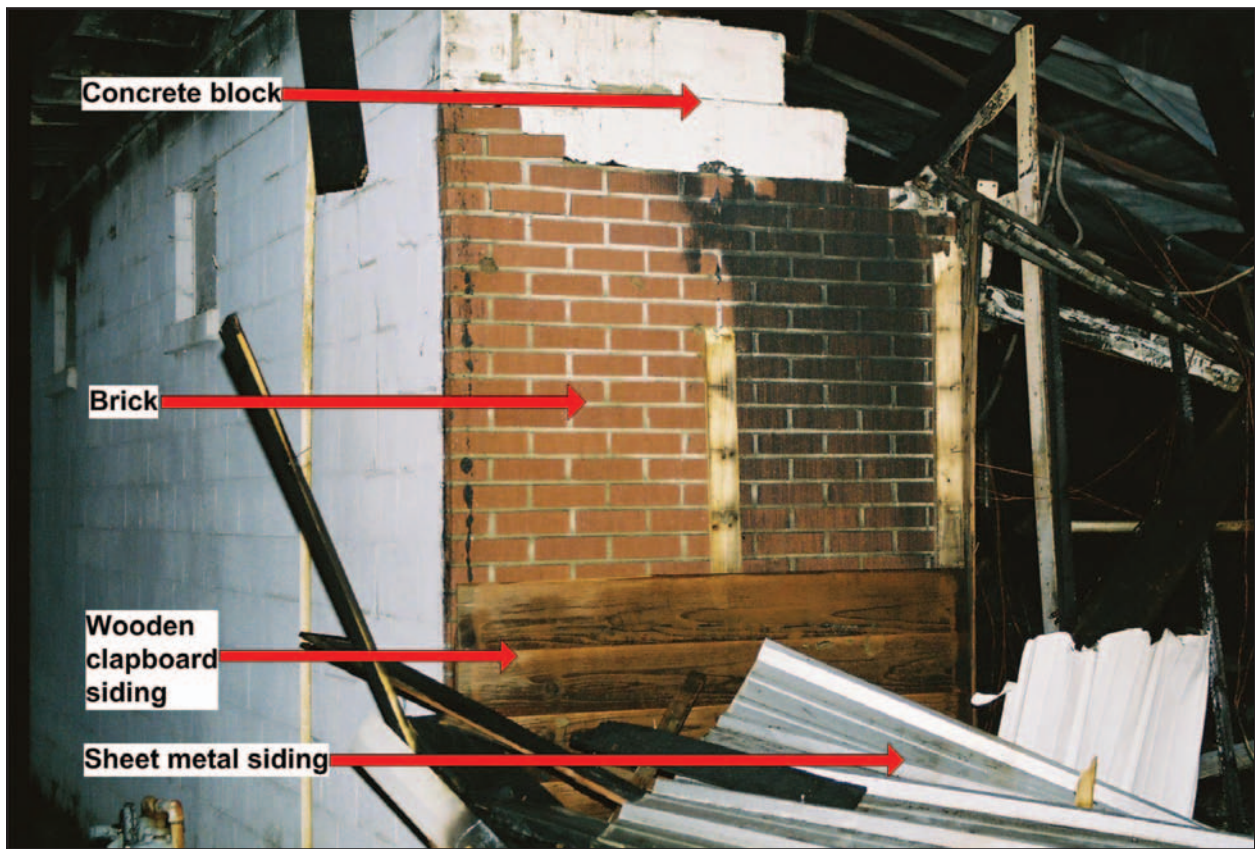
Photo 2. Photo shows the left front corner of the fire building. The 4 different layers of construction materials used on the front wall can be clearly seen. Collapse area is to the right. Photo courtesy of state fire marshal's office.

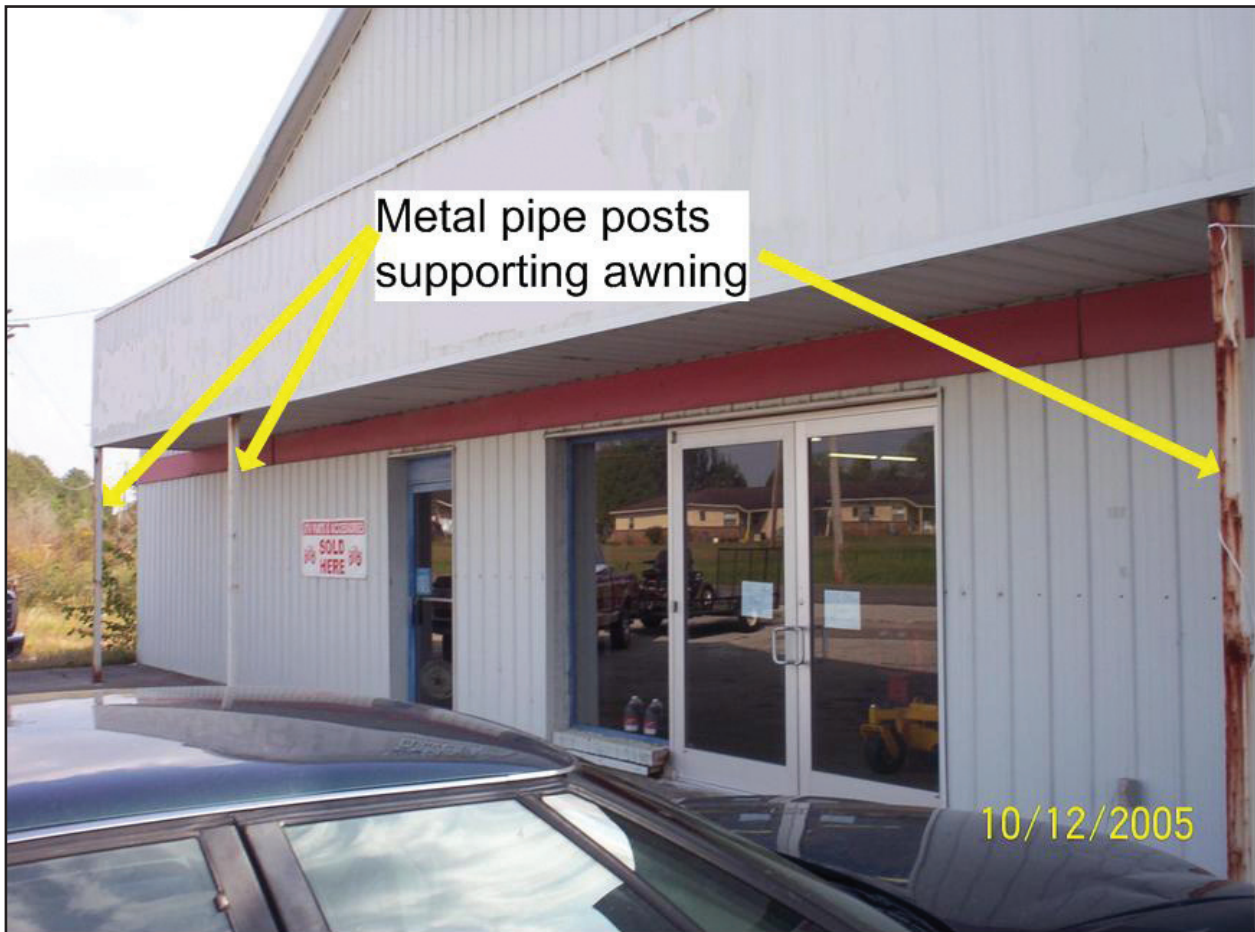
An overhanging awning extended across the front of the original building. The awning was constructed of a metal frame covered with sheet metal. At the time of the incident, a large lighted sign was mounted on the awning over the main entrance. The awning extended approximately four feet outward from the front wall and was approximately 41 feet long. The awning was attached to the exterior wall and supported from below by four round metal posts approximately 4 inches in diameter (see Photo 3).

Photo 3. Photo of A-side of the structure taken four months prior to the incident. Note the overhanging awning over the entranceway. Note the metal pipe posts supporting the front of the awning. A total of 4 metal pipe posts supported the awning. Photo courtesy of state fire marshal's office.
