Death in the line of duty...

A summary of a NIOSH fire fighter fatality investigation

April 11, 2007

Junior Volunteer Fire Fighter Dies and Three Volunteer Fire Fighters are Injured in a Tanker Crash – Alabama

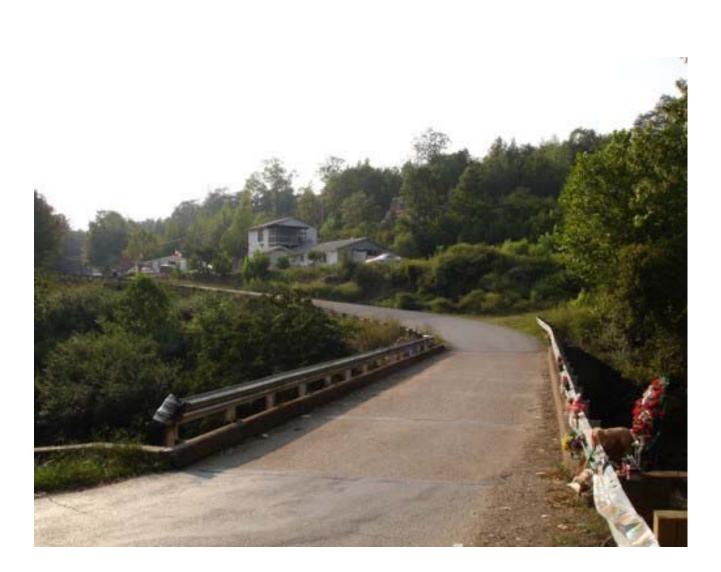
Photo 1. Crash Location

The incident occurred on a one-lane bridge located at the bottom of a downgrade on a horseshoe curve (see Photo 1) approximately 4 miles from the fire station. The asphalt road leading to the bridge is approximately 23 feet wide and the road makes a very sharp right hand curve as it approaches the bridge. According to the fire department and County 911 dispatch, there have been several vehicular incidents (with one other fatality) at this location in the last three years.

The road has a speed limit of 45 mph and the State police estimated the speed of the tanker at 40 mph as it approached the bridge. The bridge has a posted cautionary speed sign of 25 mph and is approximately 15 feet wide. The road was dry and the weather was sunny on the day of the incident.

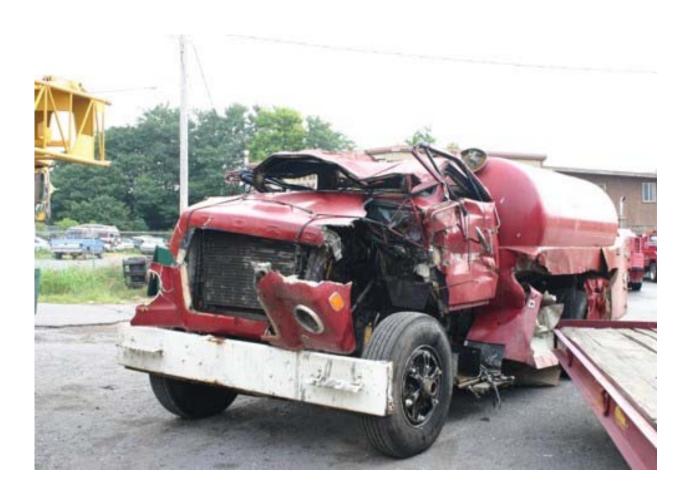
Photo 2. Front of Tanker (Photo Courtesy of Alabama State Troopers)

The tanker truck (also referred to as a tender in the western United States) was a 1982 model that was formerly a propane delivery truck (see Photo 2 and Photo 3). The tanker truck had an elliptical, 2,000-gallon tank and was full (*Note: The exact type of tank baffling is unknown. Prior to the NIOSH field investigation, the towing company scrapped the tanker. The fire department reported containment-type baffling with three longitudinal baffles, which were probably the compartment bulkheads*). The tanker truck had a diesel engine, two axles, 6 tires, a manual transmission, and an air brake system. The tanker truck had a gross vehicle weight rating (GVWR) of 33,000 lbs and was not equipped with an auxiliary braking system. The tanker truck was purchased used by the department in early 2005. The department did its own vehicle maintenance and a review of the maintenance log indicated only that minor repairs had been performed on the apparatus. The vehicle had two seats and was not equipped with seat belts.

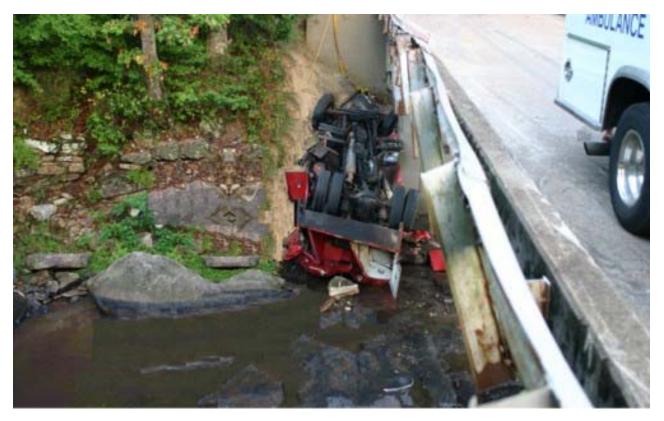
Photo 4. Incident Scene (Photo Courtesy of Alabama State Troopers)

At approximately 1915 hours, the tanker approached the bridge. The driver began braking as the tanker started downhill. One of the injured fire fighters remembers hearing "You're going too fast!" The driver replied "I've got it under control!" Then just prior to the horseshoe curve, the driver reported that the brakes failed. The driver downshifted as he reached the turn to the bridge, but the truck struck the guardrail on the driver's side. About midway over the bridge, the truck began to roll onto the driver's side. Prior to reaching the end of the bridge, the tanker rolled onto the driver's side, crashed through the guard rail and landed upside down approximately 20 feet below in the creek bed (see Diagram).
