Oxygen Regulator Flash Severely Burns One Fire Fighter - Florida

SUMMARY

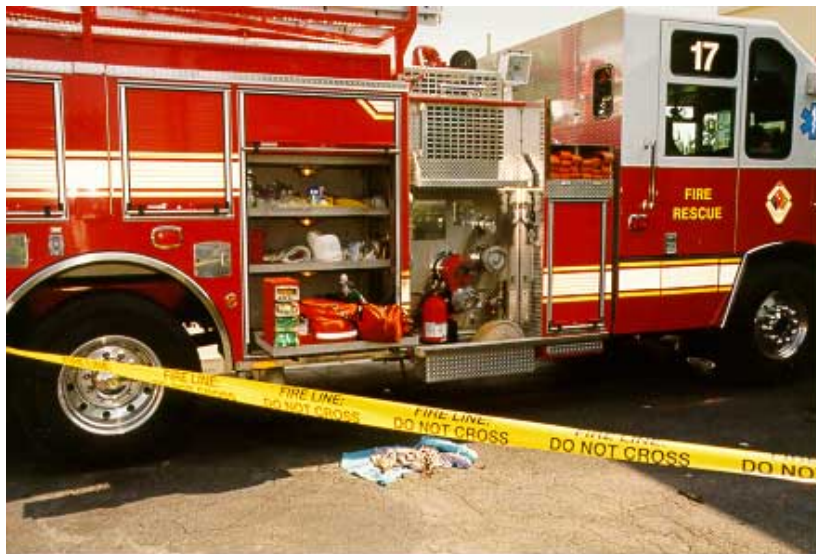
Photo 2: This photo depicts the incident scene where the victim was severely burned.
