**Jim Walter Resources # 5 Coal Mine Disaster**

**September 23, 2001;**

*A United Mine Workers of America Report*

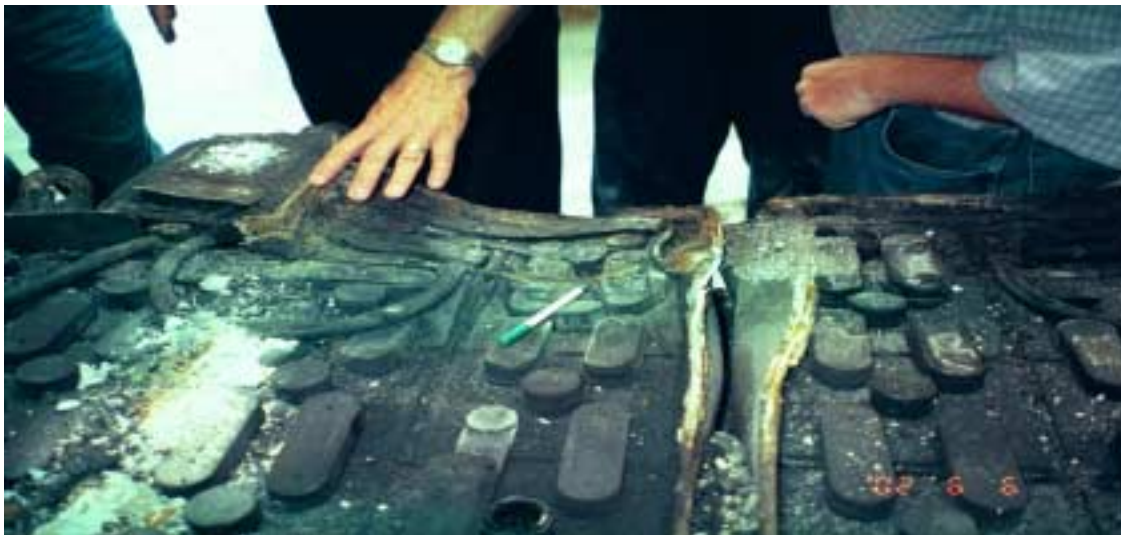
The picture below shows the damaged battery cells from the roof fall that likely caused a short circuit to the straps, allowing them to arc and become an ignition source.

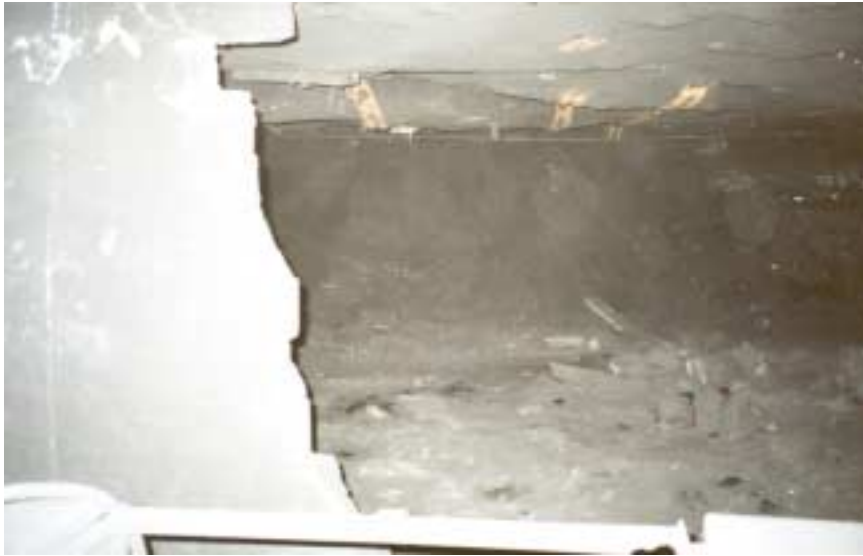
**Figure 1:**  
Concrete block blown from a  
stopping between #1 and #2 entry,  
taken from the #2 entry at spad  
#13295.

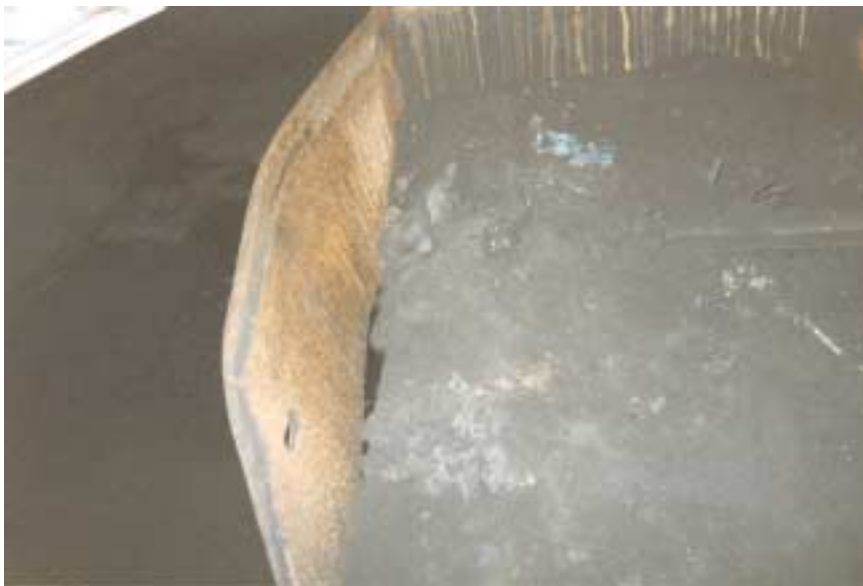
**Figure 2: Partial concrete block stopping behind the section power center looking toward the #1 entry.**

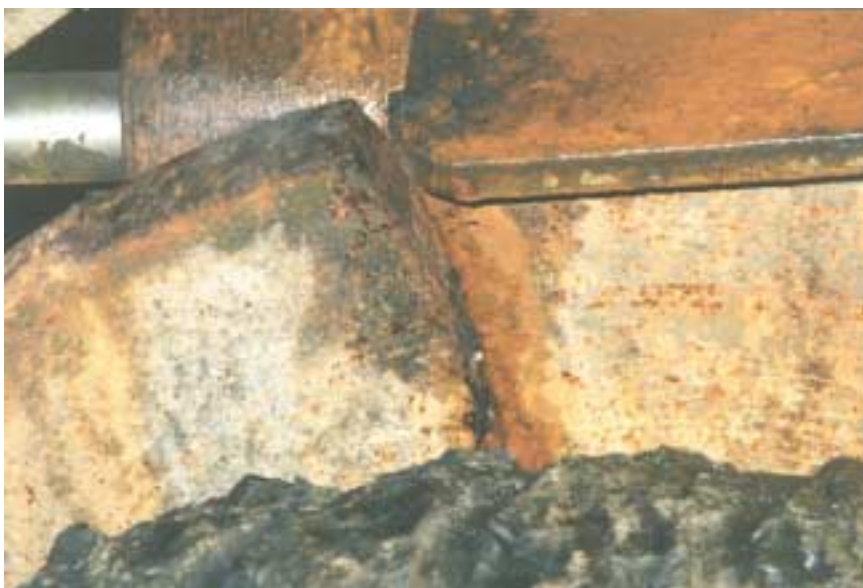
**Figure 3: Damage to the outby side plate of scoop bucket.**

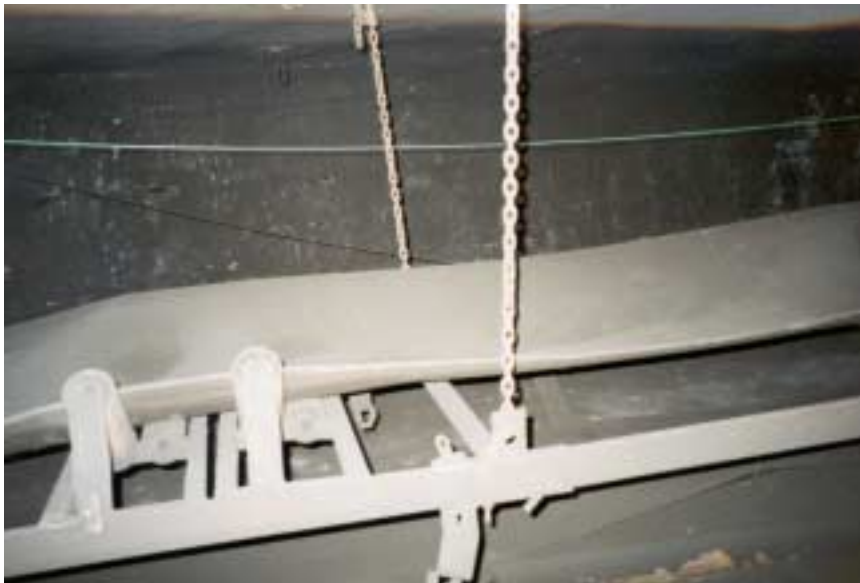
**Figure 11: Stopping material deposited in close proximity to where they were originally built. The upper portion of the picture shows the conveyor belt system. This picture was taken from the #4 entry looking into the #3 entry at the crosscut inby spads #13320 and 13318. The picture indicates very little damage to the conveyor belt system.**

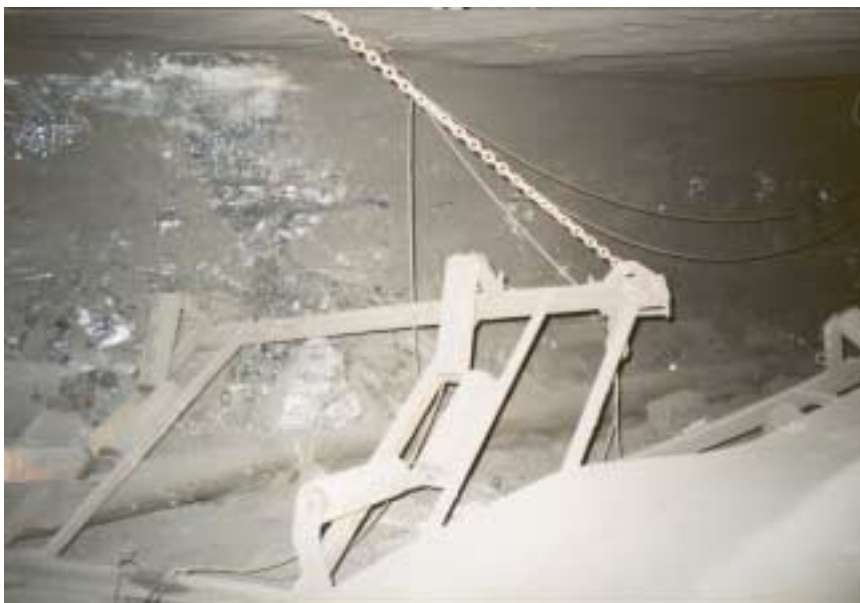
**Figure 12: Beltline looking into the #3 entry from the crosscut located between spads #13313 and 13314.**

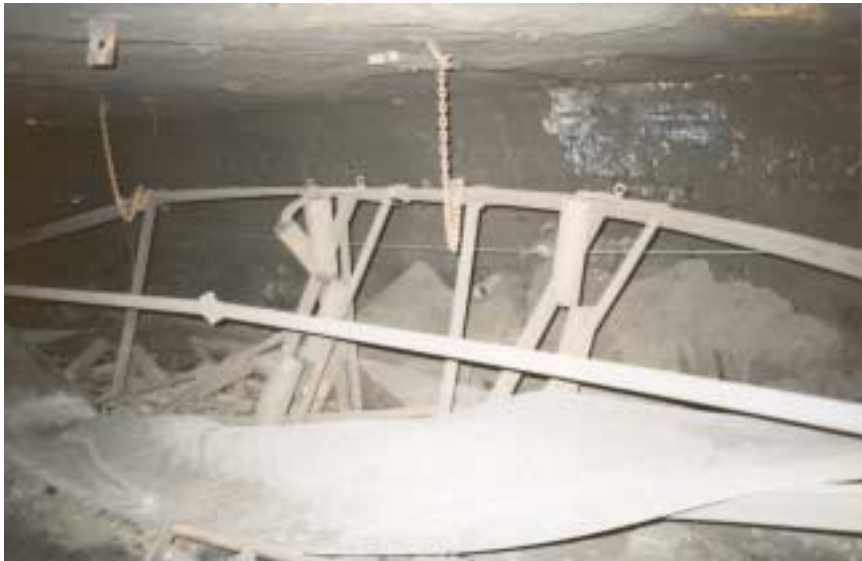
**Figure 13: Looking into the #3 entry from the crosscut located between spads #13296 and #13300. Damage to the conveyor belt system increased outby.**

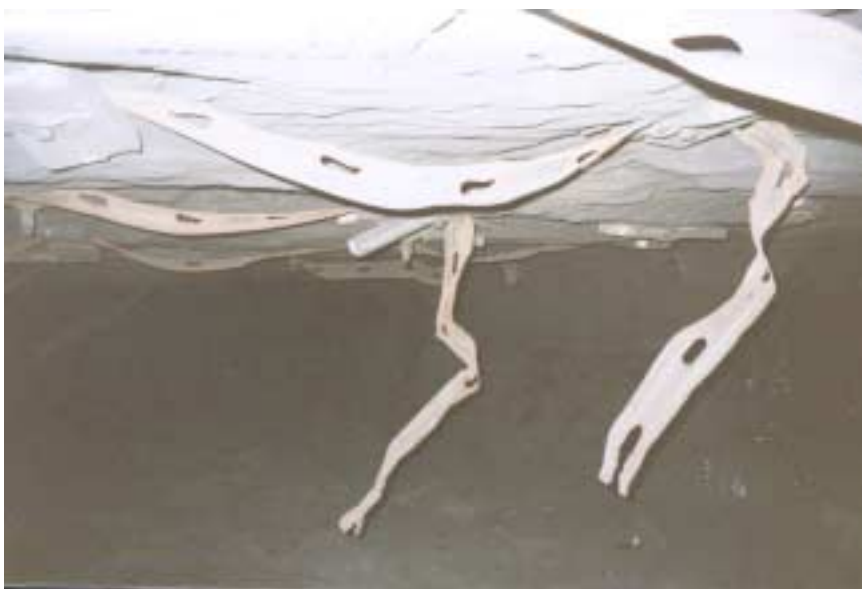
**Figure14: Looking into the #3 entry from the crosscut between #3 and #4 entry, to the right of spad #13233. Conveyor belt system is totally destroyed and deposited along the left rib of #3 entry.**

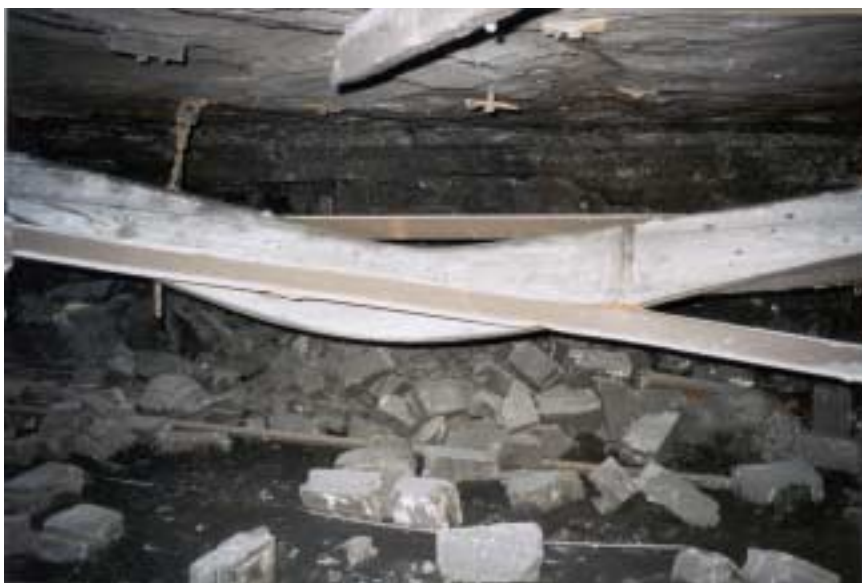
**Figure 15: Standing in the #4 entry facing outby at spad #13233, increased damage to the roof straps can be observed.**

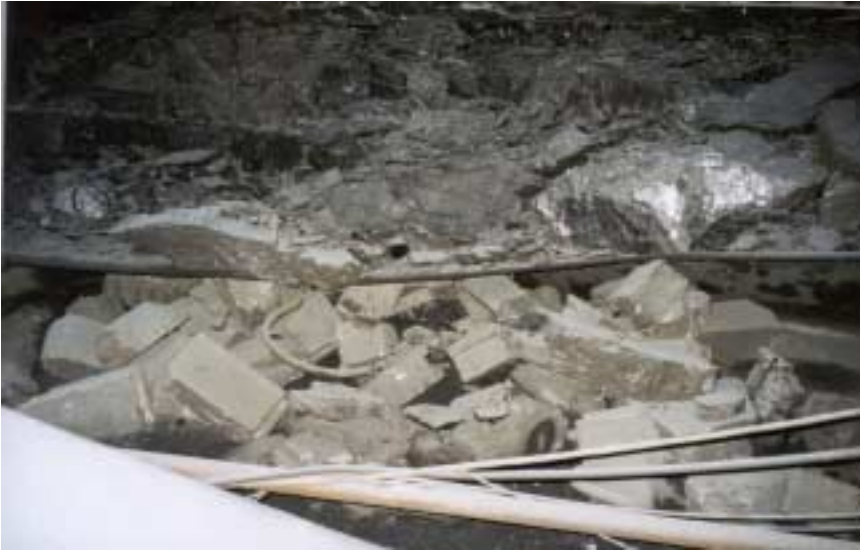
**Figure 16: Looking into the #3 entry from the crosscut located between spads #13205 and #13206 stopping material deposited along the left rib of #3 entry. Note: Starting at the outby corner at spad #13206 and extending inby toward spad #13209 in the #4 entry, six broken roof straps were located along the left side of the entry.**

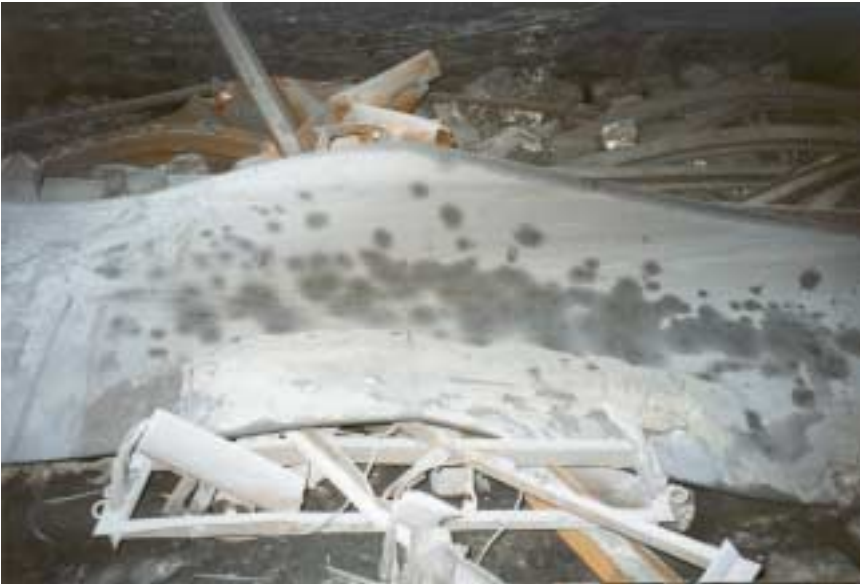
**Figure 17: Looking into the #3 entry from the crosscut between spads #13200 and #13199. Stopping material along with the damaged conveyor belt system deposited along the left rib in the #3 entry can be seen.**

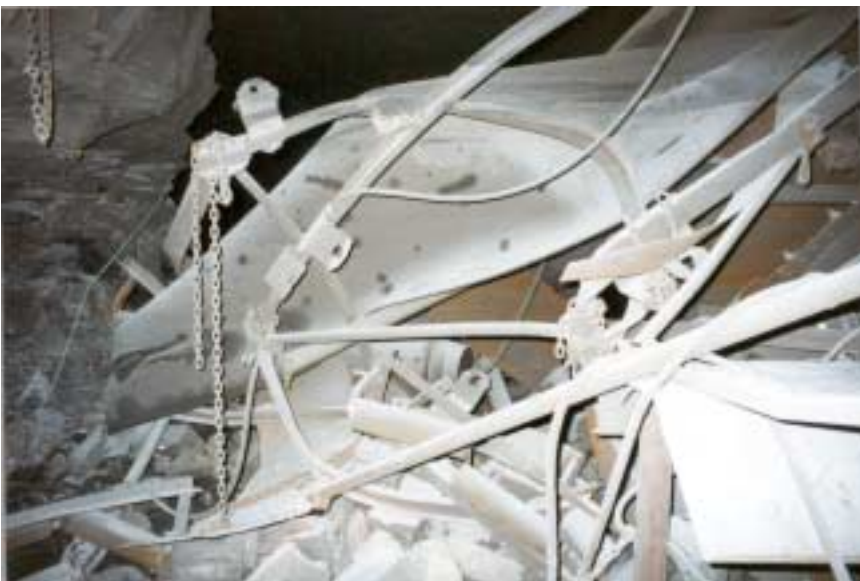
**Figure 18: Looking into the #3 entry from the crosscut between spads #13039 and #13048. The steel beams, steel plates, and concrete blocks from the belt/return overcast along with material from the conveyor belt system were deposited along the left ribline of #3 entry. Note: In the upper portion of the picture the steel beams from this overcast can be seen twisted and bent.**

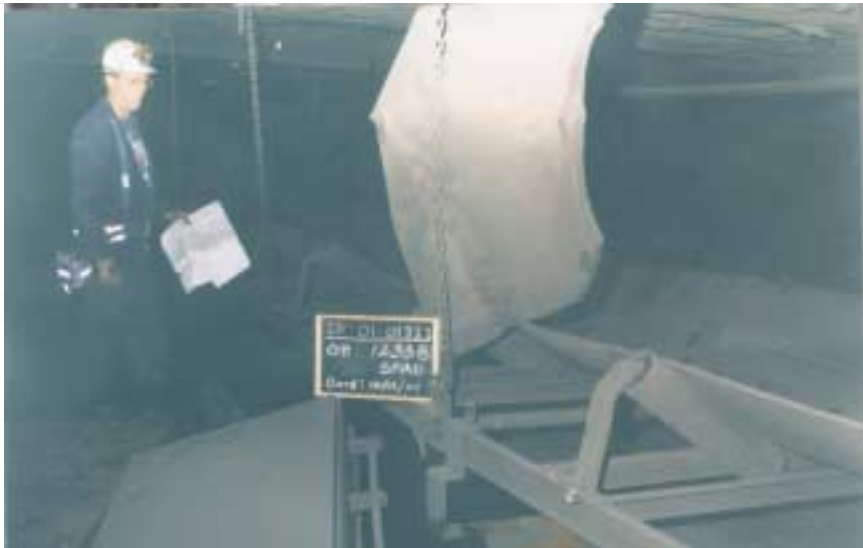
**Figure 19: Taken from the left of spad #13038 looking in by into the #3 entry of the left ribline at the No. 4 section header. Concrete blocks from the inby overcast can be seen at the bottom of the picture.**

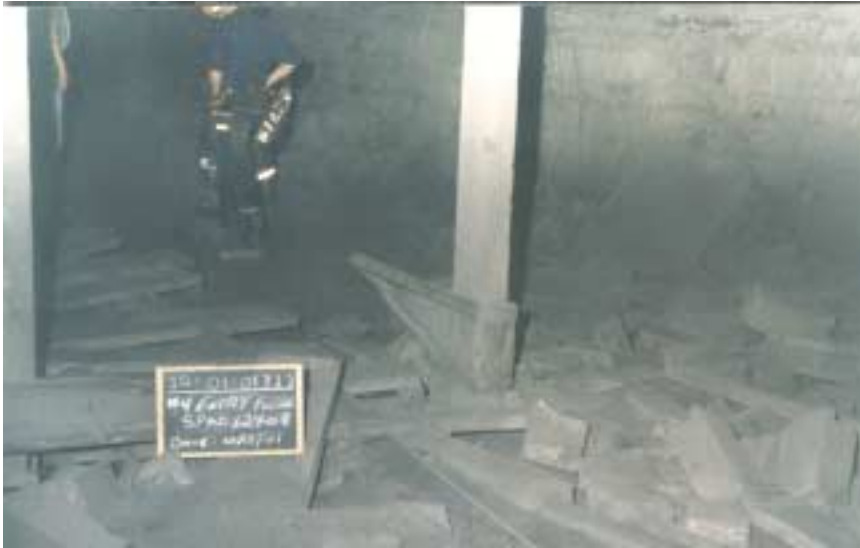
**Figure 22: Looking outby at spad #12285. Picture shows damaged vercast.**

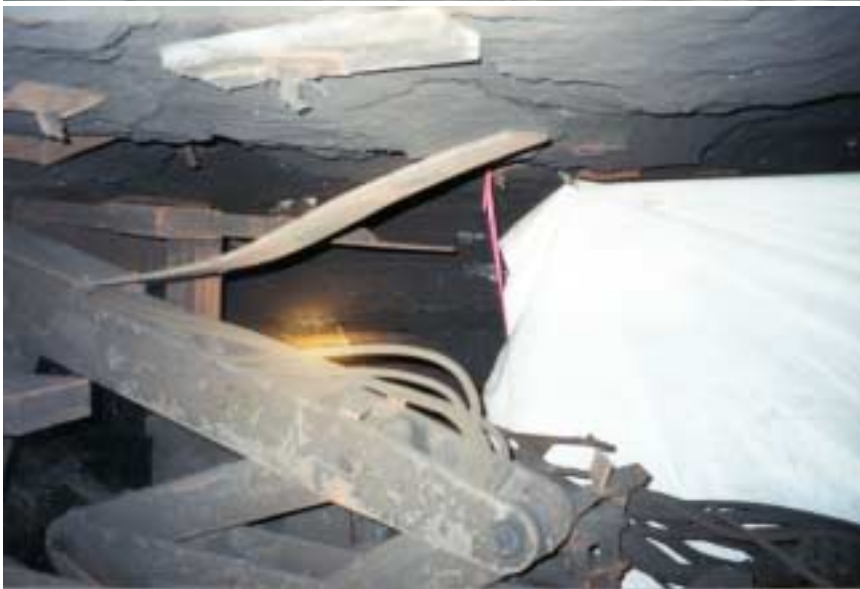
**Figure 23: Looking outby at spad #12408. Picture shows the position of a metal panel from a metal stopping.**

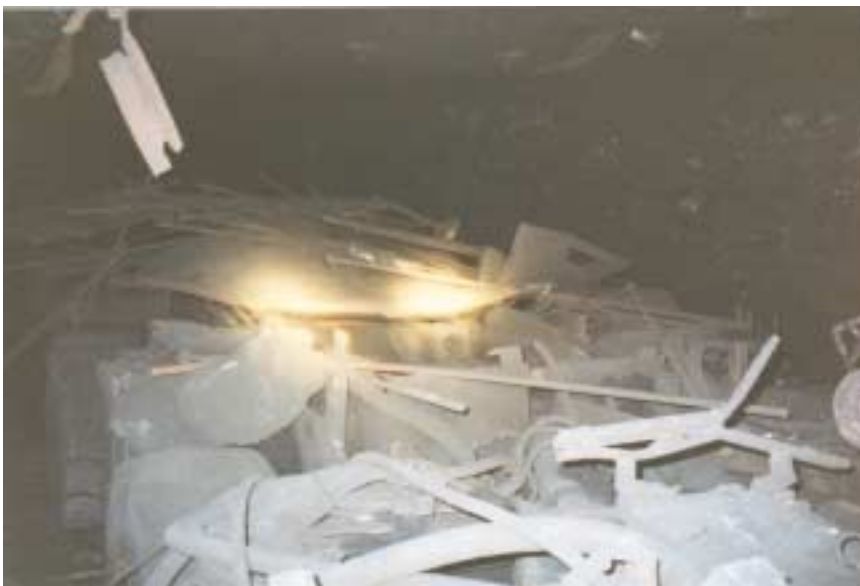
**Figure 24: Standing on the left side of the roof bolter in the face of #4 entry. A thick metal cover is bent up and in toward the direction of the face.**

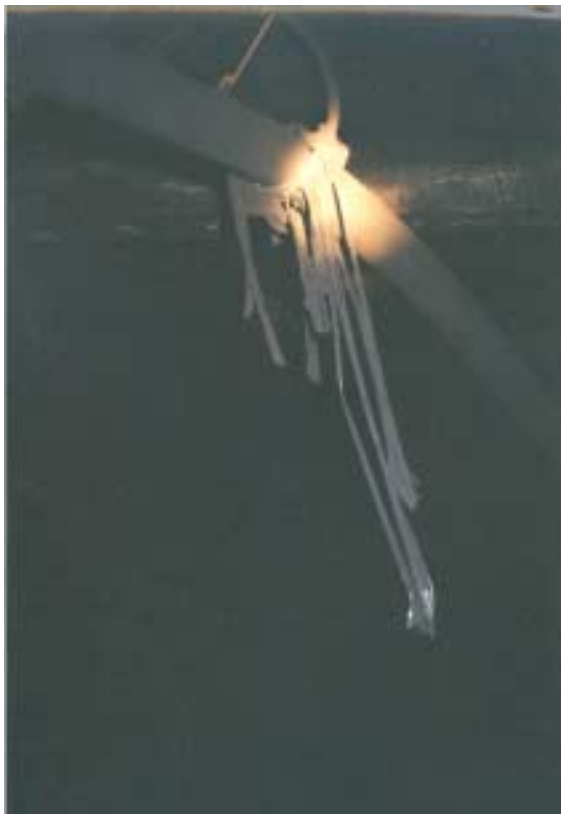
**Figure 26:** Located at the left outby rib corner at spad #13231 in the #2 entry. Picture is of a “J”hook and shielding melted into high voltage cable.

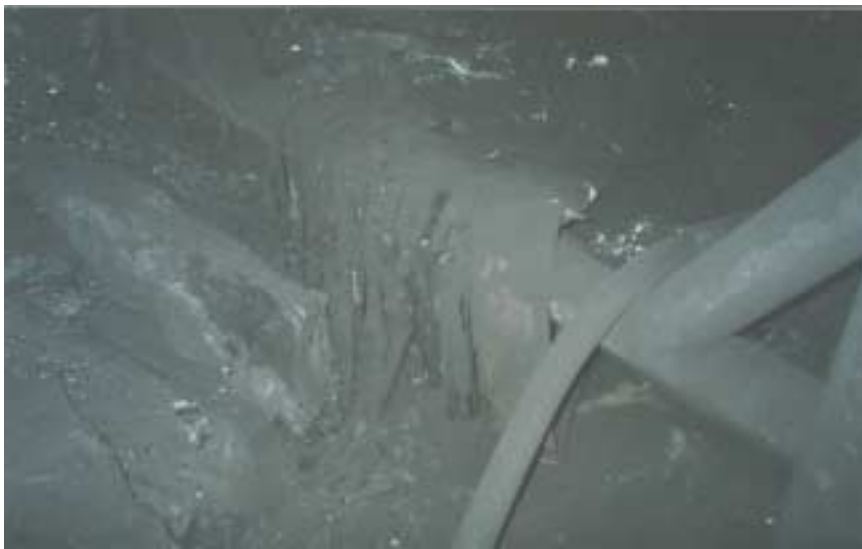
**Figure 30:** Located in the #1 entry inby spad #13349 along the right rib. Picture of a melted “J” hook on the continuous miner water line.

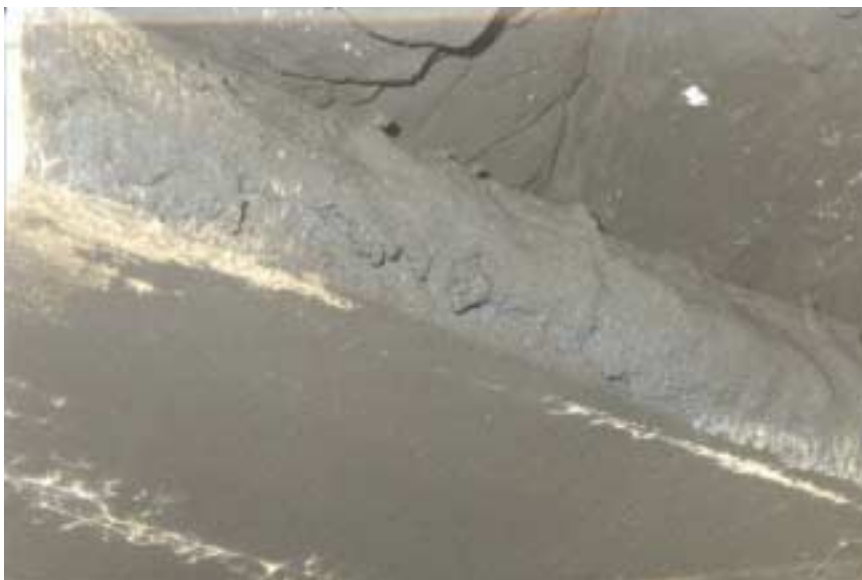
**Figure 31:** Located in the #3 entry along the inby ribline of the last open crosscut between spad #13352 and spad #13353. Picture of melted resin cartridges on the supply sled.

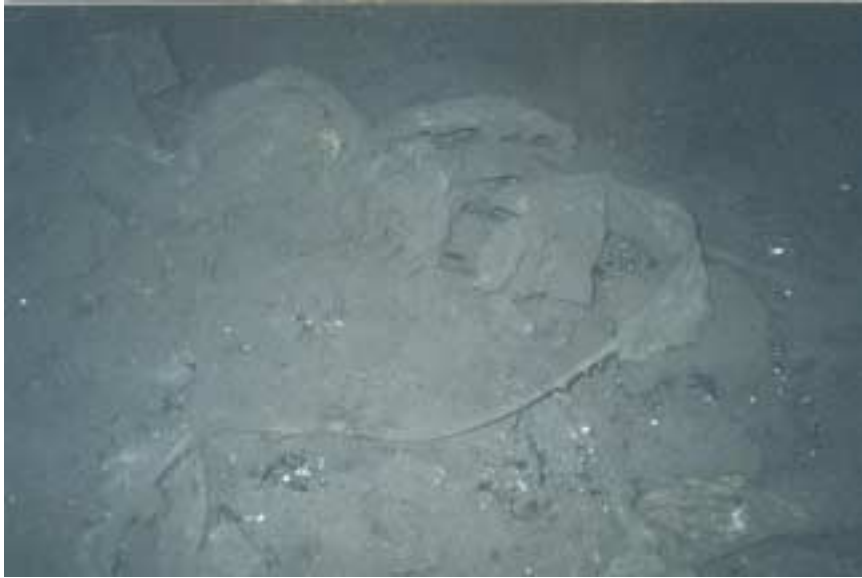
**Figure 32:** Located in the last open crosscut between spad #13352 (#2 entry) and spad #13353 (#3 entry), 50 feet into the crosscut from #3 side. Picture of coking on “T-Board”.

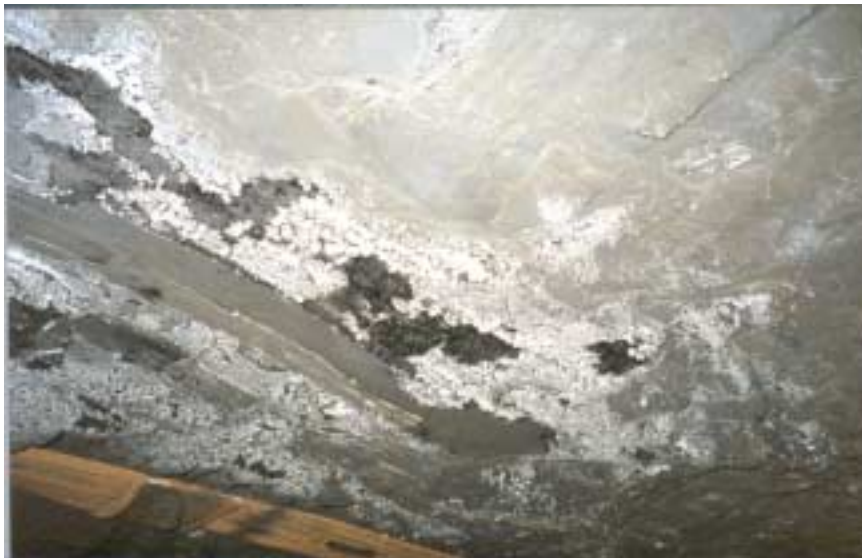
**Figure 33: Located in the #3 entry at spad #13353. Picture of melted curtain line material.**

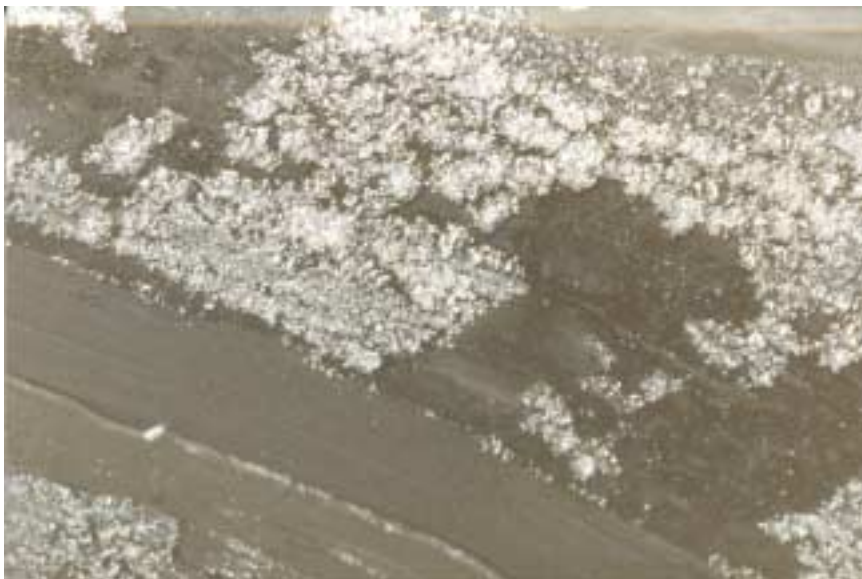
**Figure 34: Located in the #3 entry inby the last open crosscut (Inby spad #13353). Picture of coking on the roof starting 30 feet outby the #3 face.**

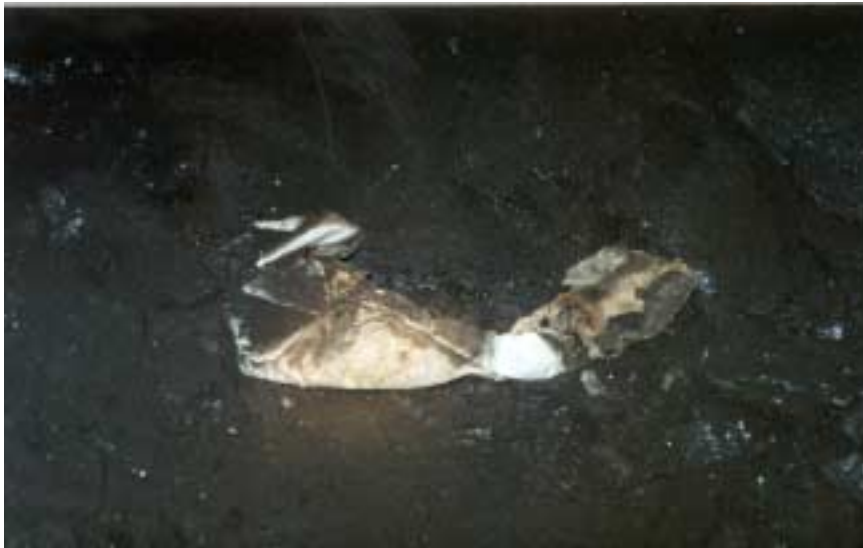
**Figure 36:** Located in the #3 entire inby the last open crosscut (Inby spad #13353). Picture of burnt paper sack located 20 feet outby the face and four feet off the left rib.

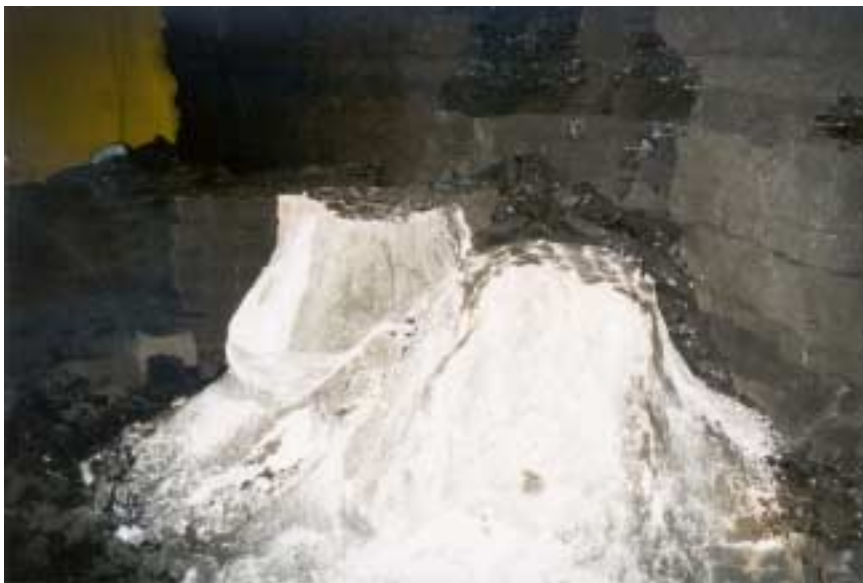
**Figure 37:** Located in the #3 entry inby the last open crosscut (Inby spad #13353). Picture of burnt paper sack located at the #3 face, in the center of the entry.

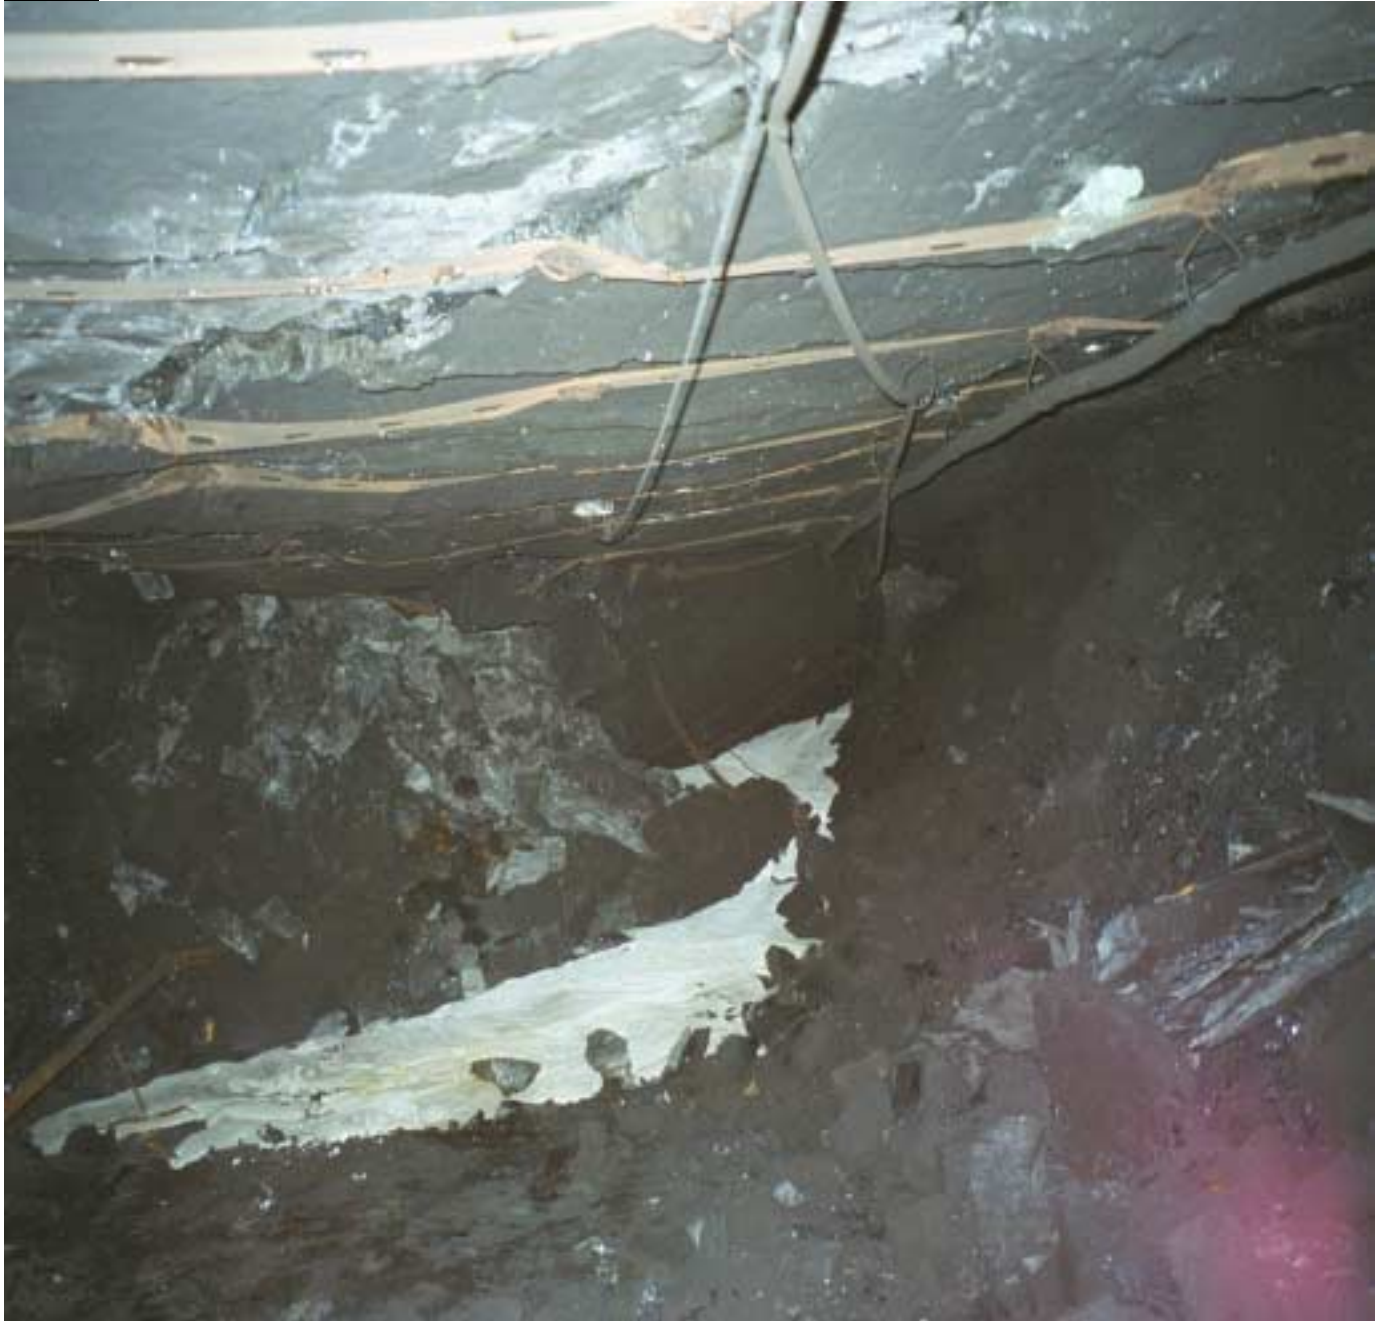
**The roof of the crosscut above the scoop between Spad 13352 in the #2 entry is shown without any straps installed. This was evident in all the crosscuts between # 1and # 2 entries even when the slips and joints were well-defined in the roof of the crosscuts.**

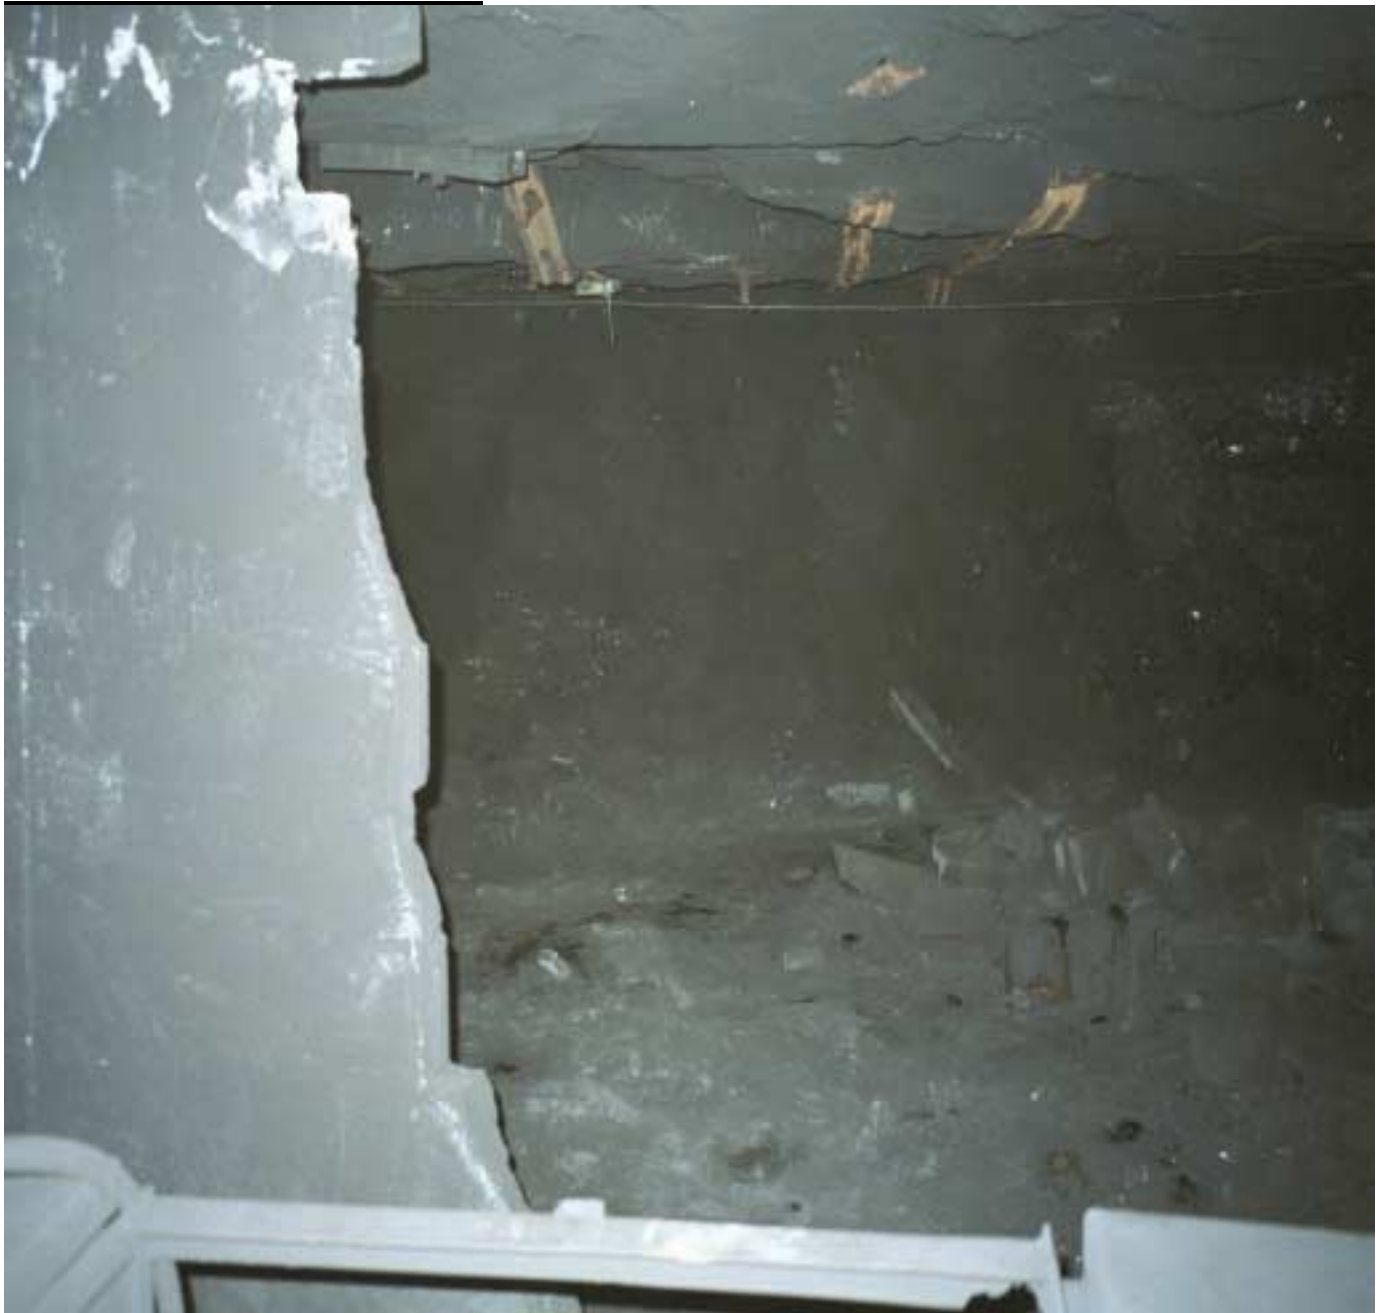
**This picture was taken facing outby at Spad #13348 in the # 2 entry toward the rockfall at Spad #13333. A well-defined joint/slip can be seen in the roof. The roof straps and roof bolt plates can be seen across the joint/slip running diagonal from right to left. This is a clear indicator that this well-defined joint/slip was present at the time of the roof bolt installation.**
