# **REVELATIONS FROM A SINGLE STRONG-MOTION RECORD RETRIEVED DURING THE 27 JUNE 1998 ADANA (TURKEY) EARTHQUAKE**

**Mehmet Çelebi**  
**Research Civil Engineer, Earthquake Hazards Team**  
U.S. Geological Survey, MS 977,  
345 Middlefield Rd., Menlo Park, CA 94025  
[Tel; 650-329-5623, Fax: 650-329-5163, e-mail: celebi@usgs.gov]

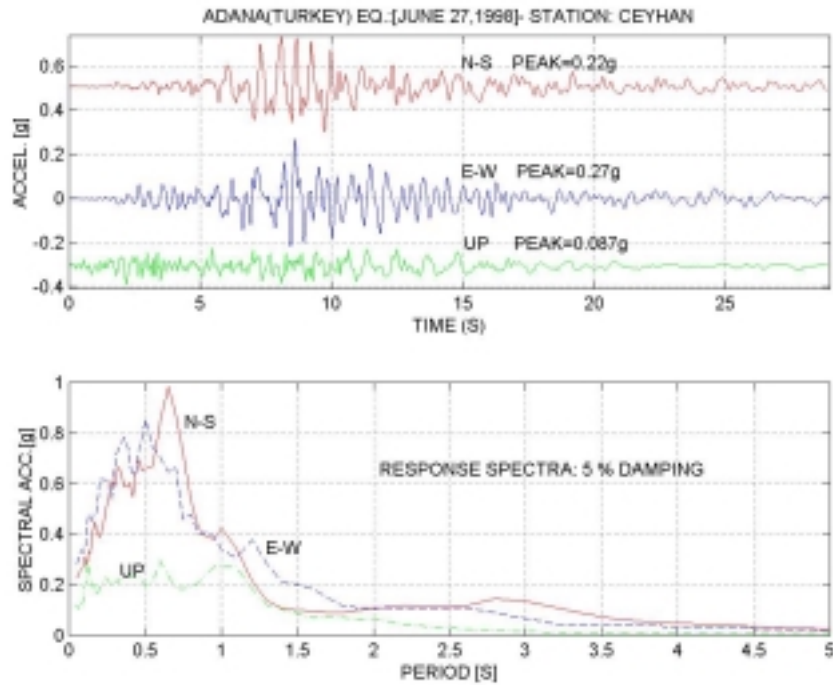
Figure 2. Strong-motion records from the Ceyhan Station (on the ground floor of a three-story building) and corresponding response spectra.

Although several strong-motion records were obtained from the sparsely deployed strong-motion accelerographs in the region, the most important record was retrieved from the station in Ceyhan (Figure 1) in the immediate epicentral region. This record from Ceyhan, where the largest number of deaths and damage occurred, had peak accelerations of 0.22 g (NS), 0.27 g (EW) and 0.087 g (UP). Figure 2 shows the components of the records and their response spectra. The response spectra clearly demonstrates that the horizontal components of motion have several dominant peaks within 0.2-0.7 second band. These peaks are very significant in describing the damages to the structures in Ceyhan.

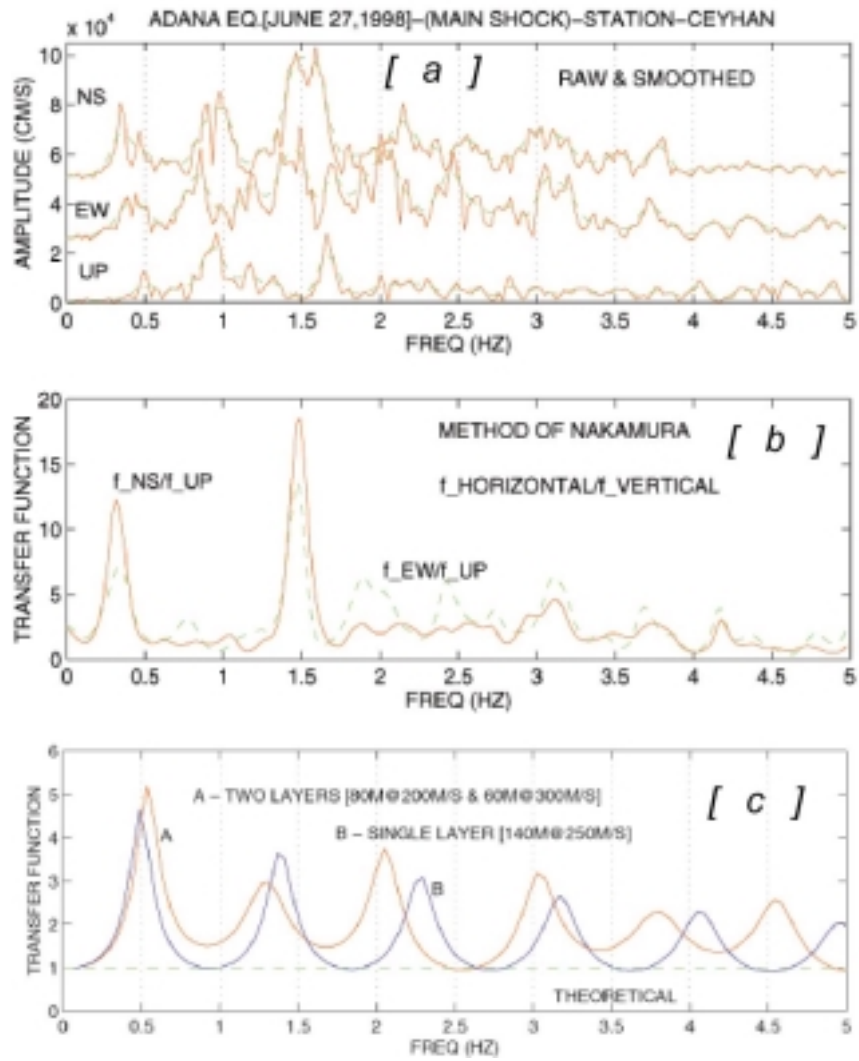
Figure 3. (a) Amplitude spectra of recorded motion in Ceyhan, (b) transfer function using Nakamura's method, and (c) transfer function using Haskell's method.

Figure 3a shows the Fourier amplitude spectra of the Ceyhan record. Each horizontal component of the Ceyhan record show several dominant frequencies (periods) at approximately 0.7, 1 and 1.5 Hz (1.4, 1 and .67 s).

Figure 3b shows transfer function calculated using Nakamura's method [1]. In absence of reference rock sites in close proximity to those soft and/or alluvial sites (as in Ceyhan) to calculate spectral ratios, this method facilitates calculation of the transfer function using the relationship  $R = A(f)_{\text{horizontal}} / A(f)_{\text{vertical}}$ . As seen in the figure, both the amplitude spectra and the transfer function shows the resonating peaks within the frequency band 1-1.5 Hz.

To further demonstrate the effect of ground motions on the performance of structures in Ceyhan, we proceed to calculate site transfer function using Haskell's method [6, 7]. The available geotechnical logs are from within Ceyhan (Aktar [8]). The logs available are about 140 meters in depth. A single layer as well as two layers of depth are considered in Figure 3c. As in Figure 3a and b, also from this figure, it is seen that site resonance can take place around 1.5 Hz (0.67 seconds). It is therefore possible that one of the main causes of collapses or severe damages inflicted on the mid-rise (7-10 story buildings) in Ceyhan is due to double resonance.

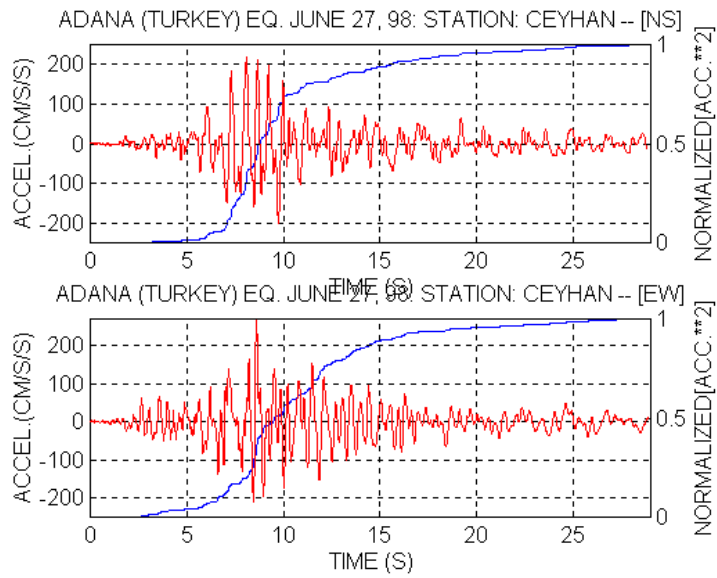
Figure 4. Horizontal components of Ceyhan main-shock and time variation of normalized cumulative energy.

Figure 4 shows the NS and EW acceleration and the normalized cumulative energy variation with time. Particularly for the NS component, it is seen that between 6.7 – 10.0 time frame, approximately 65 % of the shaking energy takes place within about four, relatively harmonic excursions. The rate of increase in energy is decreasing after about 10 seconds. However, the strong shaking within this time frame must have been quite damaging to those structures with 0.5-0.7 second fundamental periods. Figure 5 shows the NS component and its Fourier amplitude spectra calculated using the total record and the band between 6.7-10 seconds. The signal within that time-band exhibits the same peaks and significant percent of the amplitude (>50%) as that from the total time band.

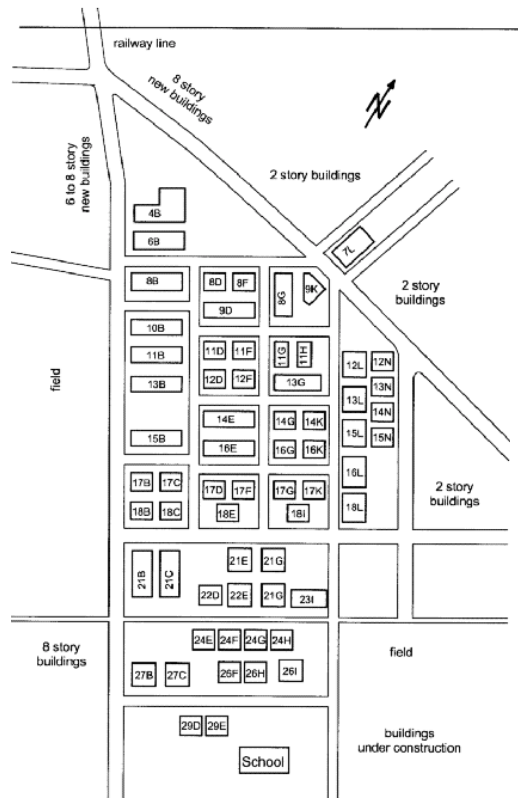
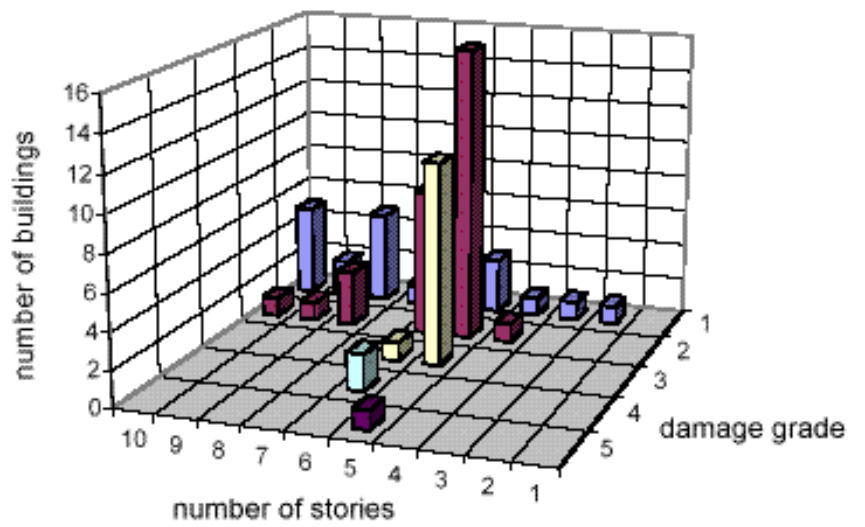
Figure 6. A subdivision of Ceyhan and damage distribution (from Wenk and others, 1998).

A study of 65 buildings in a well defined subdivision of Ceyhan (Figure 6) was performed by Wenk, Lacave, and Peter [9] who classified the buildings according to degree of damage as

defined by European Macroseismic Scale (Grunthel and others, [10,11]). Their conclusions, summarized in Figure 6, also indicates that the most severely damaged (or collapsed) buildings were 5-7 stories with estimated frequencies of 1.5-2 Hz. This study confirms the effect of the resonating motions in Ceyhan at ~1.5 Hz. The foundations of the buildings in Ceyhan were shallow (continuous footing on the surface or with little or no embedment). The buildings with infill walls being relatively rigid and on alluvial site conditions were at ideal setting for soil-structure interaction. Thus, the fundamental frequencies of these rather stiff buildings may have lengthened with soil-structure interaction and coincided with the dominant periods of the site.
