Surface Haulage Accidents...

...Ways to Prevent Them

MSHA's investigations of surface haulage accidents reveals two key points:

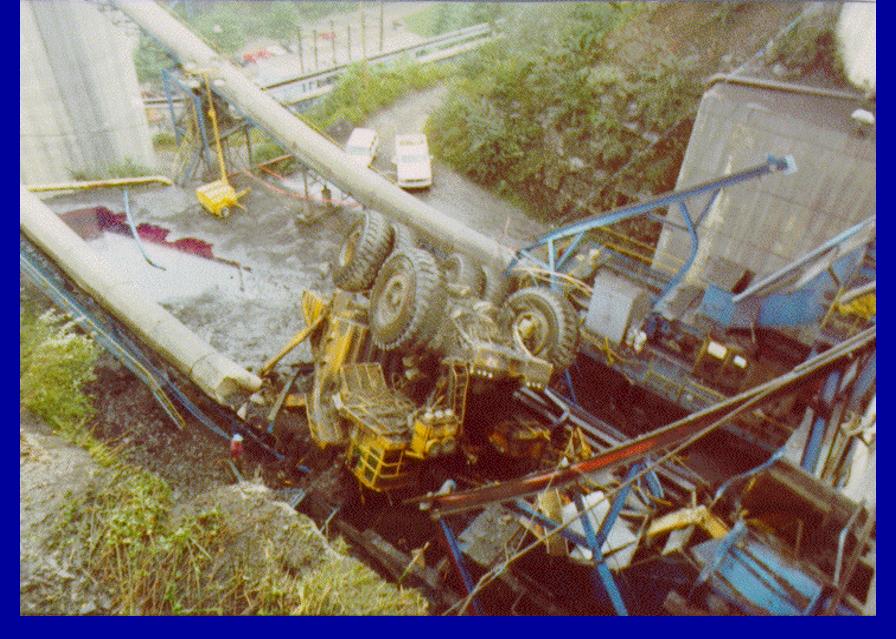
Example of a fatal haul-truck accident: The operator of this 170-ton capacity haul truck was killed when his truck went out of control as he descended an 8-percent grade.

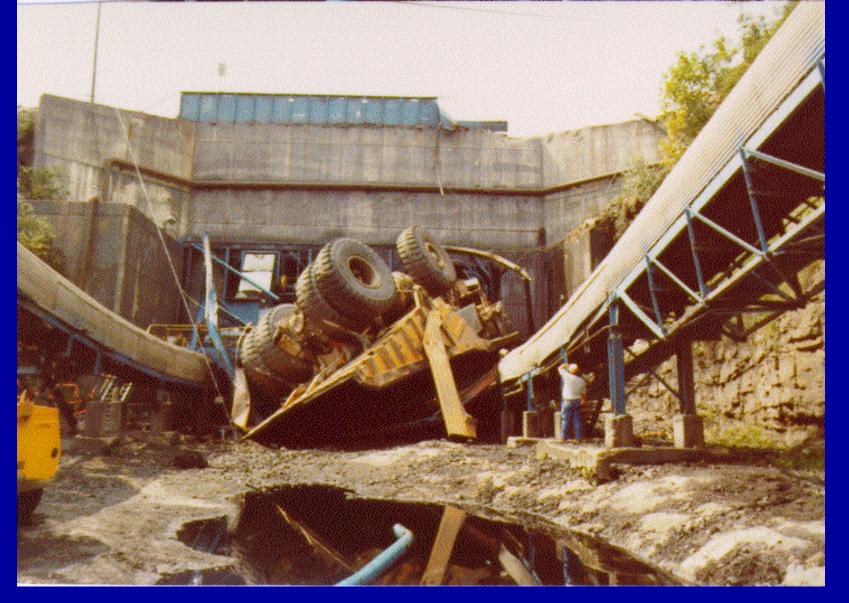
The truck went over the wall and ended up here. The victim was not wearing a seatbelt. The accident investigation revealed that the electrical retarder had failed to operate because of a problem with the contacts between the brushes and the commutator.

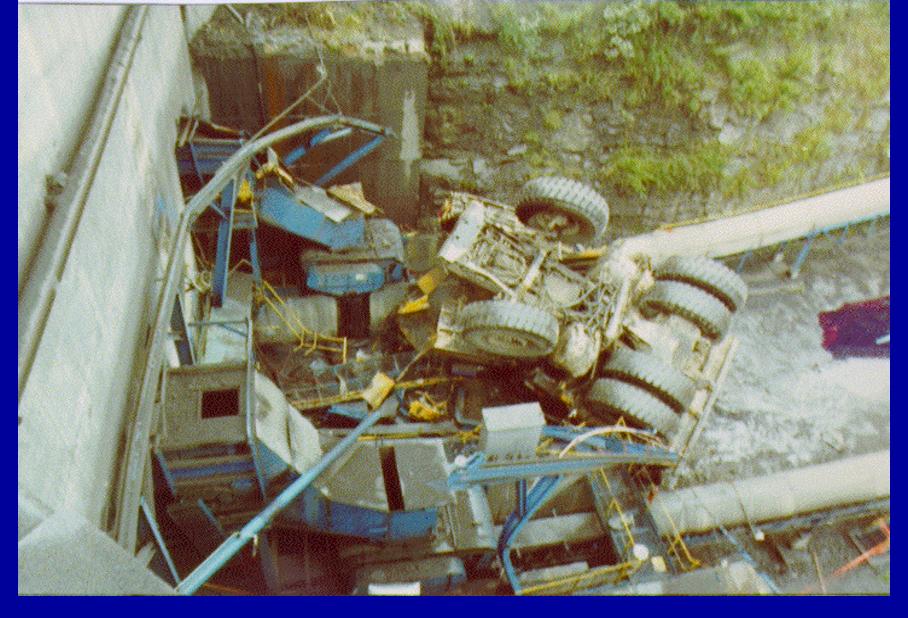
The accident investigation also revealed that there was no braking effort available from the front service brakes because of a leaking seal. The rear service brakes were found to be capable of providing 78 % of their design braking capacity.

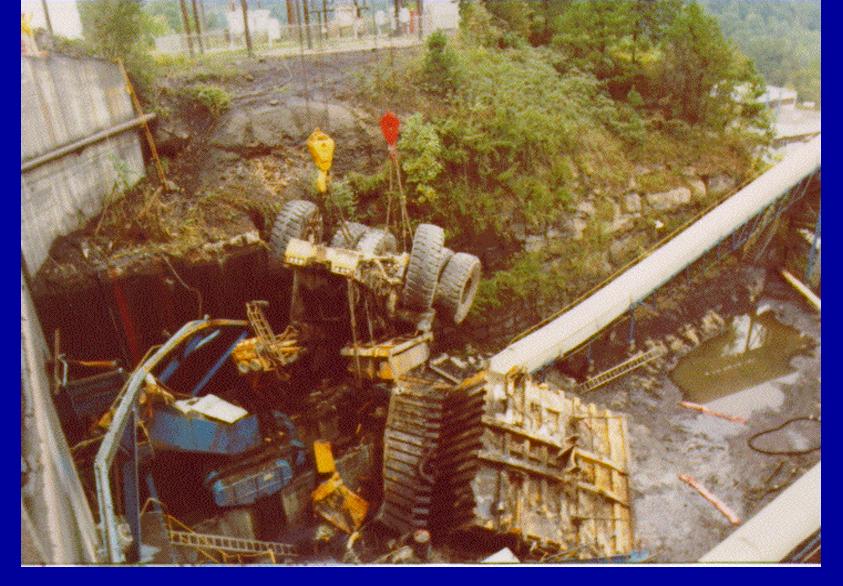
In summary, this fatal accident occurred because the truck's retarder system was defective and the inadequately maintained service brakes could not provide enough braking force to stop the truck.

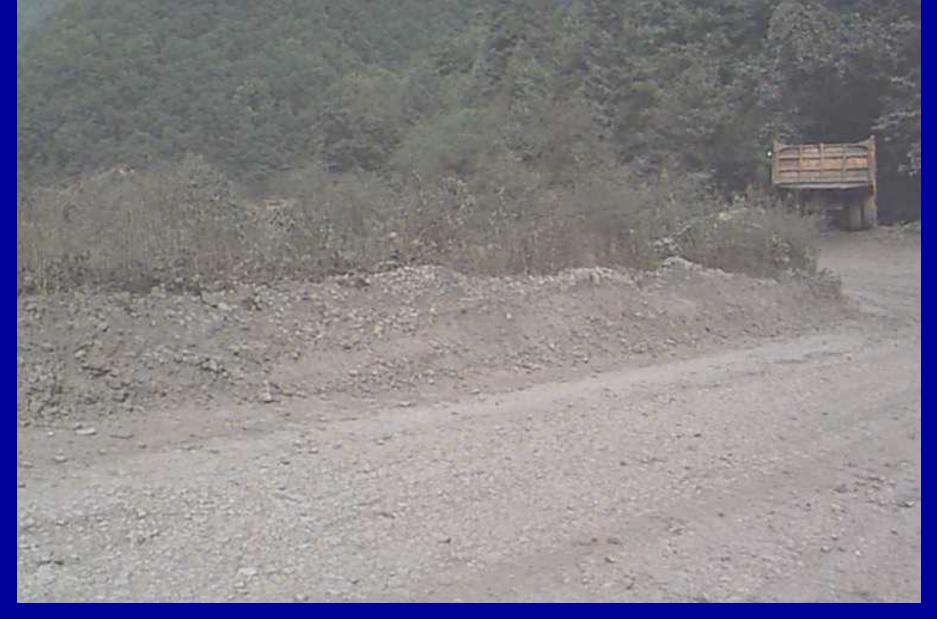
The accident occurred at a point where the grade was near 19%. The road was wet and the victim had reporting "spinning his wheels" on the way up. On the return trip the empty truck skidded off the road, as shown above.

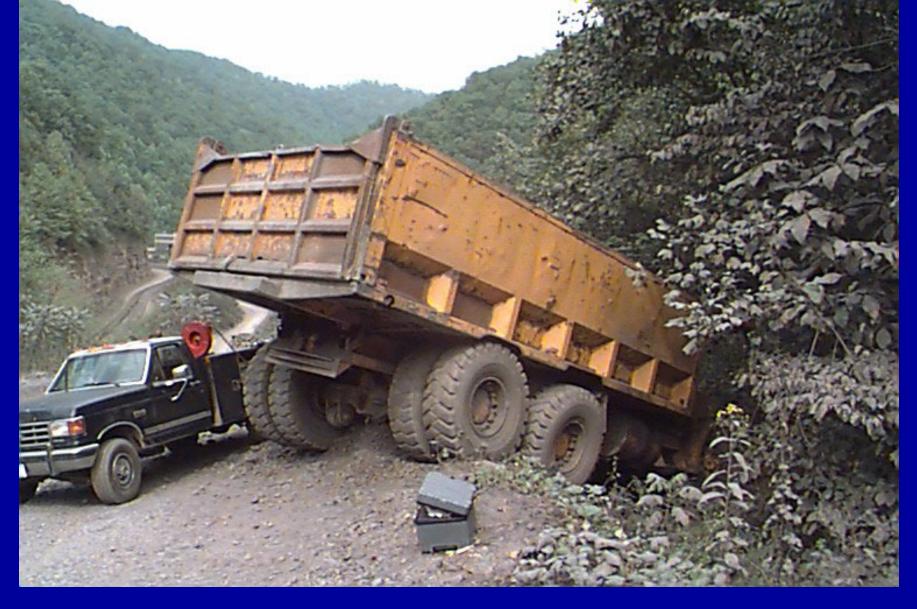
The accident investigation revealed that the front brakes were inoperative and there was no braking force from the right rear brake.

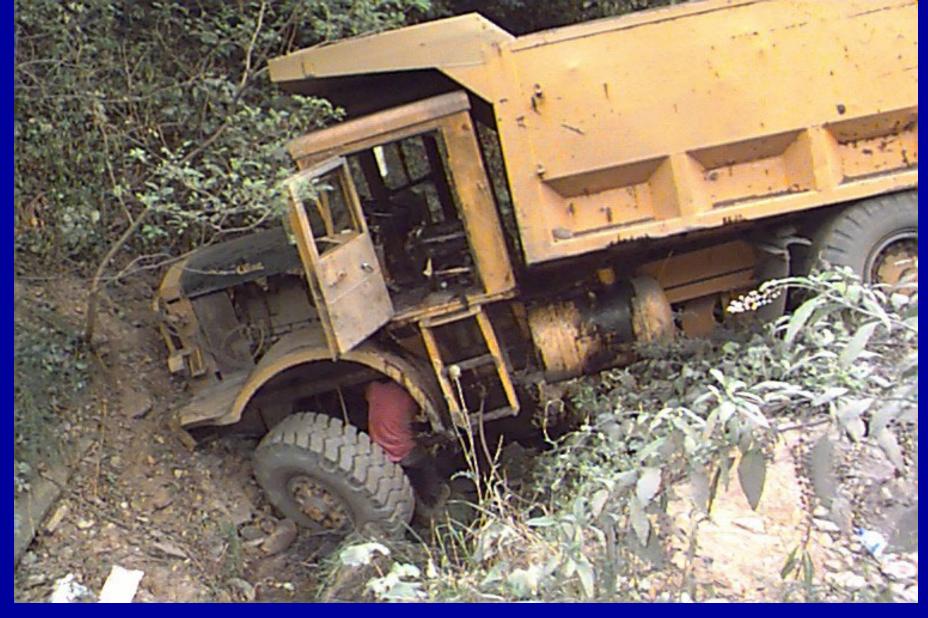
The conclusion on this accident was that the deficient and uneven braking, combined with speed too fast for the wet and steep-road conditions, resulted in the truck leaving the haul road. The victim was not wearing a seatbelt and was thrown through the windshield.

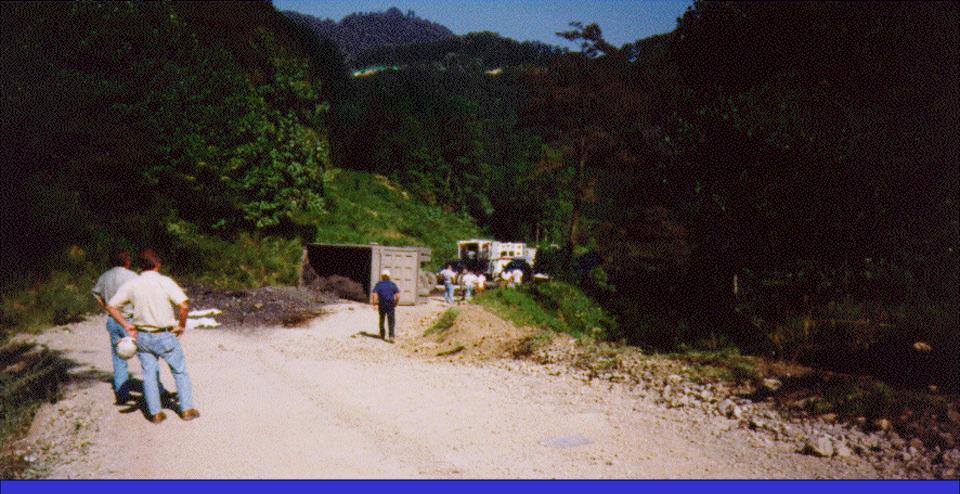
This fatal accident occurred on an 11% downgrade. The accident investigation found that there were problems with the brakes and the truck was overloaded.

- Three of the six service brakes were found to be providing no braking force grease was found on the brake linings. The other three service brakes had brake drums which exceeded their allowable diameter.
- The truck was loaded to the point where it <u>exceeded</u> the truck manufacturer's maximum recommended gross vehicle weight by over 30,000 pounds.

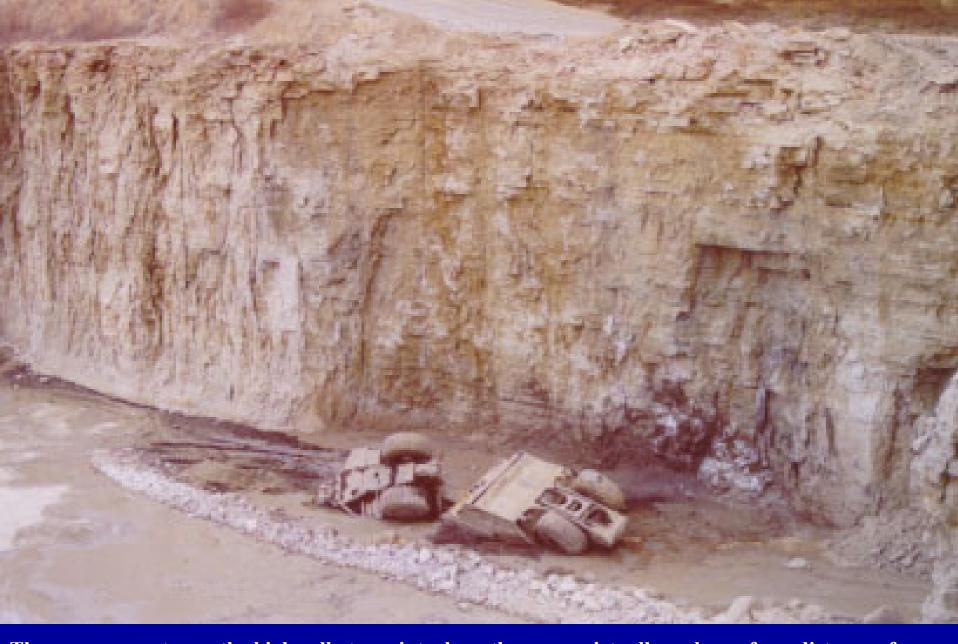
The scraper went over the highwall at a point where there was virtually no berm for a distance of about 65 feet.

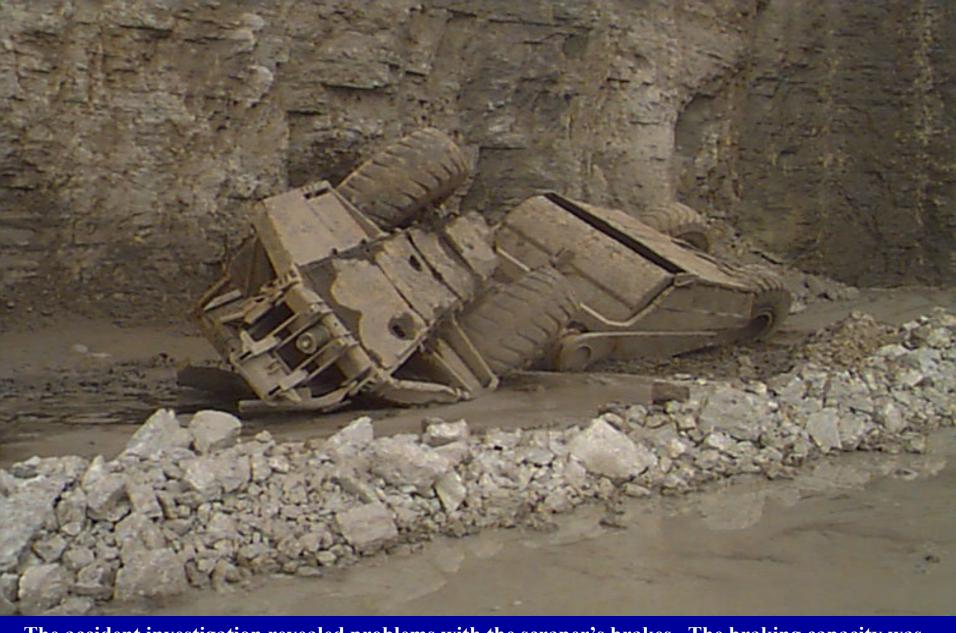
The accident investigation revealed problems with the scraper's brakes. The braking capacity was diminished because the pushrods were out of adjustment and there was no lining-to-drum contact on two of the wheels.

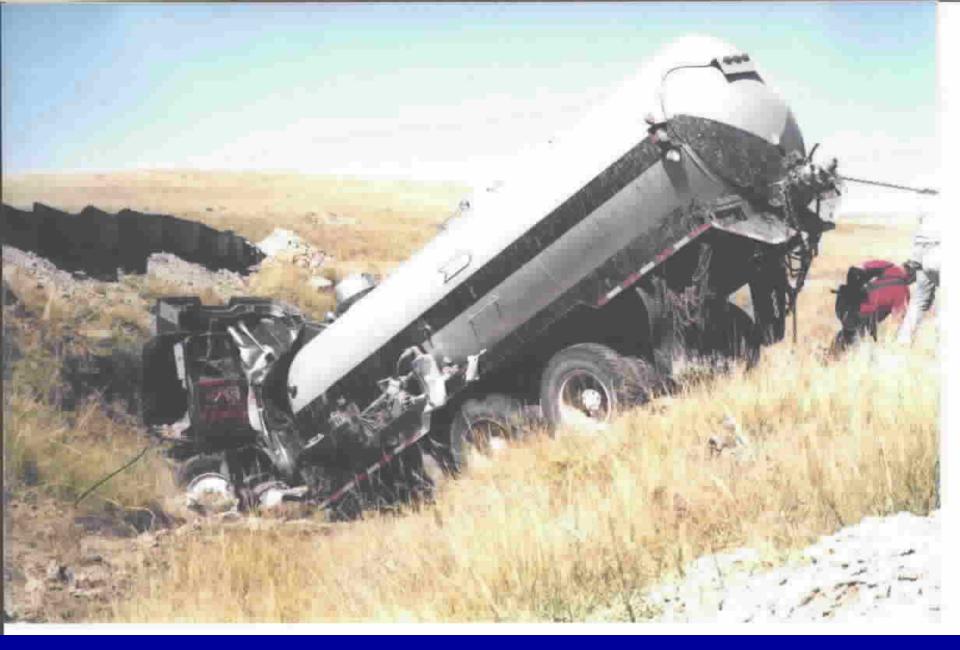
...the water truck crashed into a ravine that ran through the field.

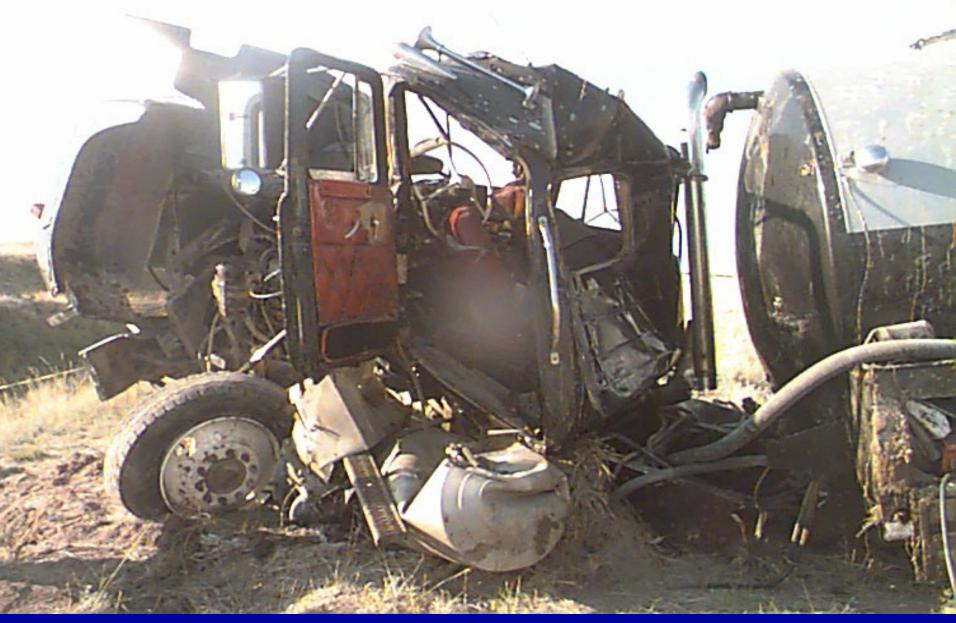
The accident investigation revealed that the truck's front brakes had been removed and the rear brakes were defective. Rear brake problems included a severe air leak, oversized brake drums, and excessive pushrod stroke...

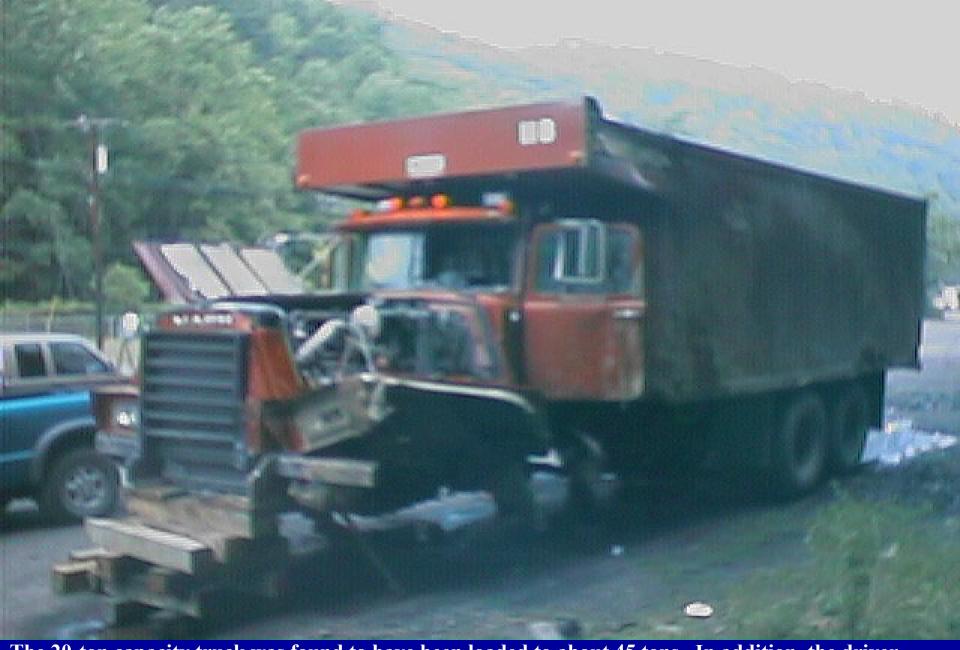
The 20-ton capacity truck was found to have been loaded to about 45 tons. In addition, the driver apparently was not adequately trained on the operation of the truck and the escape-ramp safety features.

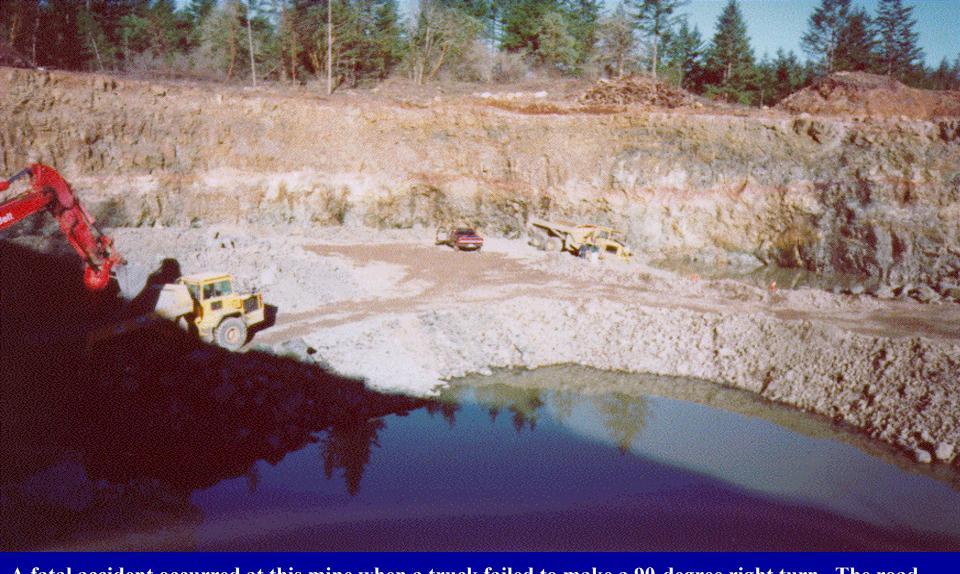
A fatal accident occurred at this mine when a truck failed to make a 90-degree right turn. The road was narrow and there was little or no berm. The trucks normally took two attempts to make the sharp turn. When the driver attempted to make the turn on one try, he ended up going into a small pond. Even though the water was only 10 deep, the truck ended up on its side and the operator drowned. The lessons here were that roads should be adequately widened on curves and substantial berms should be provided where equipment travels near ponds.

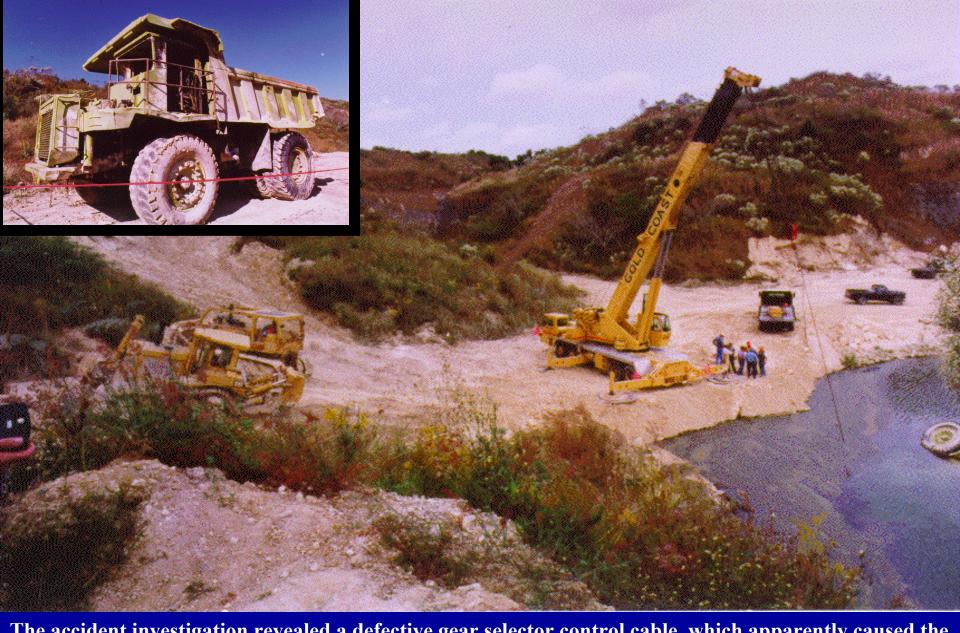
The accident investigation revealed a defective gear selector control cable, which apparently caused the truck to be shifted into reverse instead of 1st gear. Apparently the truck stalled and the emergency steering became depleted. The pond was 42 feet from the road and was not bermed.

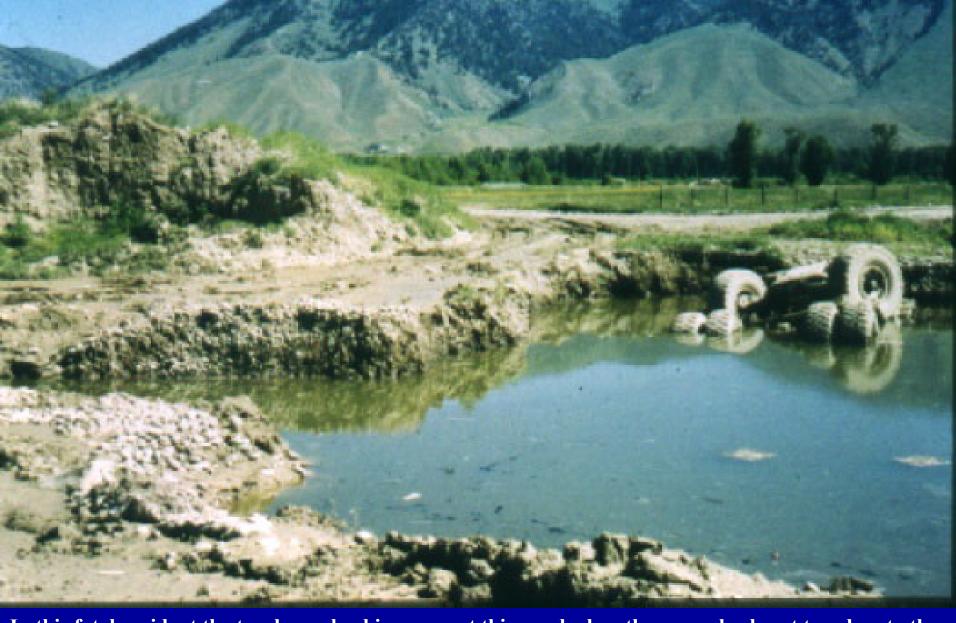
In this fatal accident the truck was backing up past this pond when the rear wheels got too close to the edge. No berm had been provided. A berm should serve the three functions of providing a good visual indicator of the edge of a drop off; impeding equipment from going over the edge; and keeping the weight of the equipment back a safe distance from the potentially unstable edge of a drop off.

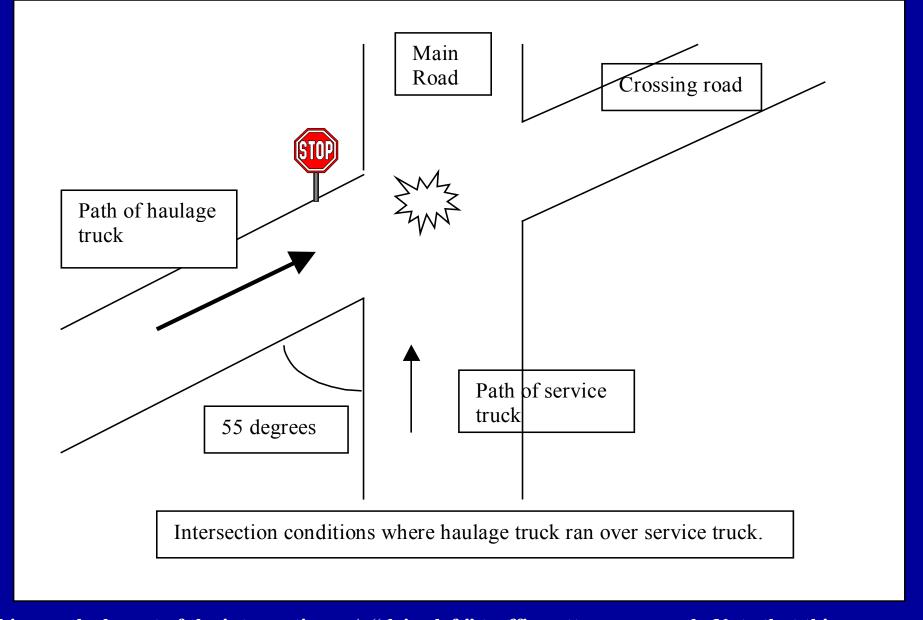
This was the layout of the intersection. A "drive left" traffic pattern was used. Note that this intersection layout - with the crossing road intersecting at an angle of about 55 degrees - would have made it more difficult for the haulage truck driver to see traffic approach the intersection from his right side.

Intersections should be laid out keeping this right side blind spot in mind. Avoid intersections at angles of less than 90 degrees to the truck's right side. Layout intersections to provide the drivers with as much sight distance as possible.

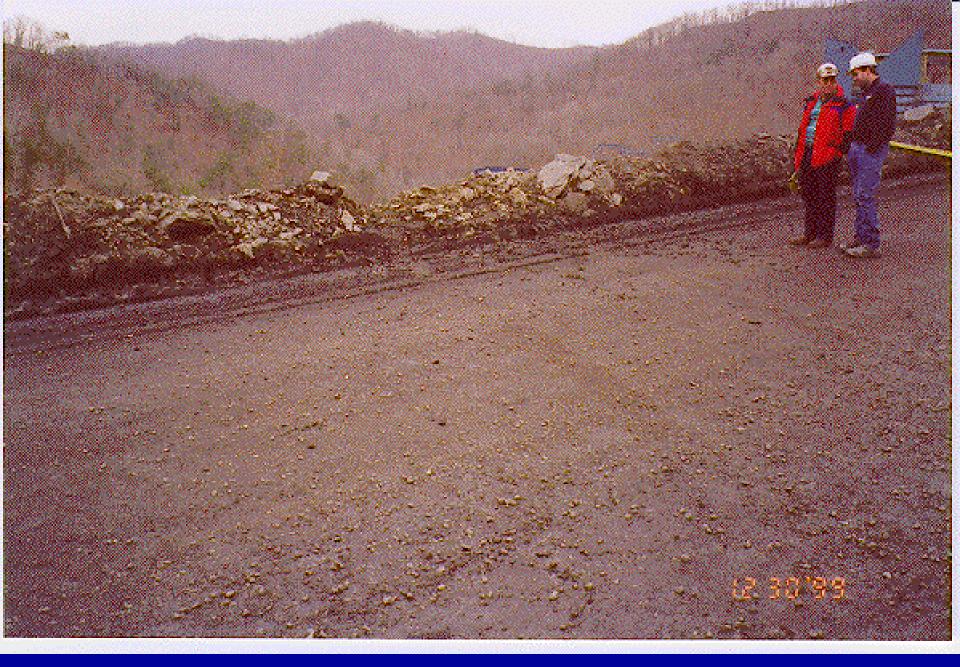
The skid marks were 125 feet long and led through this berm and over a highwall.

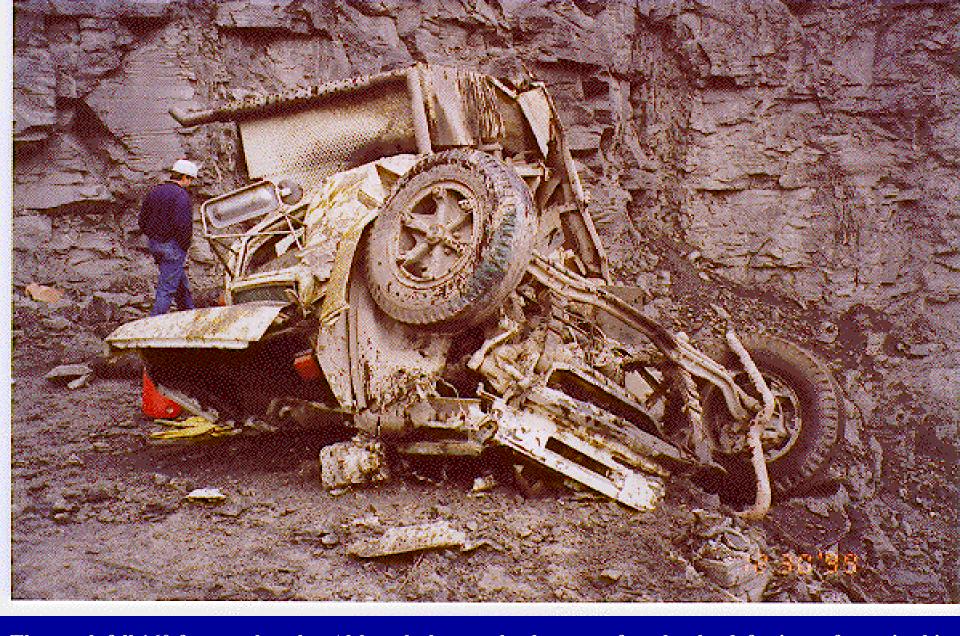
The truck fell 160 feet to a bench. Although the rear brakes were found to be defective, a factor in this accident may have been the victims unfamiliarity with the mine roads while driving after dark. The use of road side reflectors may help in this type of situation.

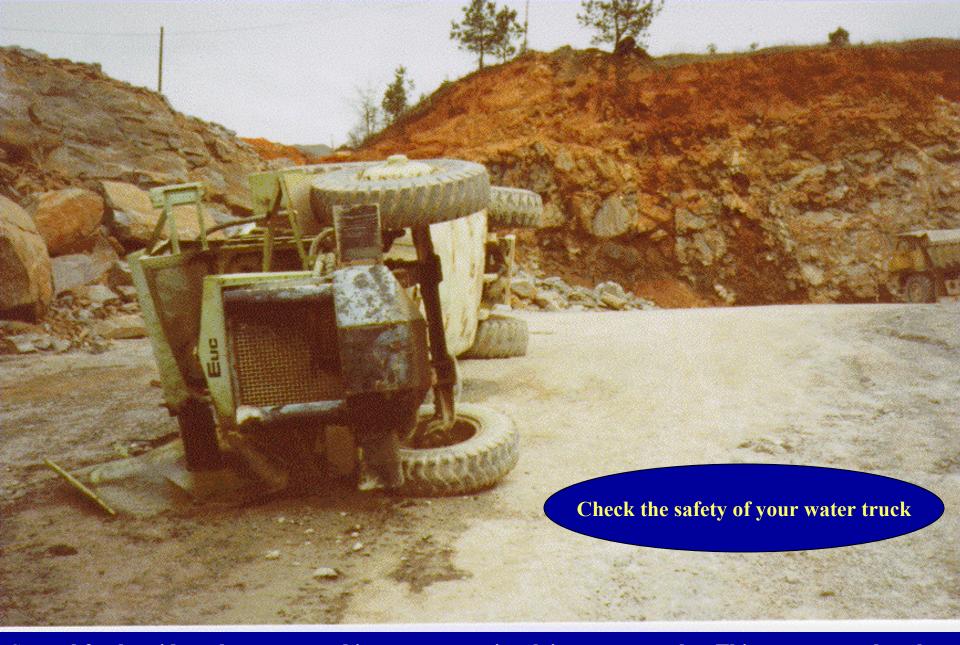
Several fatal accidents have occurred in recent years involving water trucks. This one occurred as the water truck rounded a curve while descending a 7 to 9 % grade. The victim's regular job was in quality control and he only occasionally drove the water truck.

The water truck was about half full at the time of the accident and the tank was baffled from front to back.

A witness reported that the truck appeared to be "going too fast" as it rounded the curve.

The victim was not wearing the seatbelt and the rear brakes were found to be defective.

Avoid water-truck accidents by ensuring that: water trucks receive preventive maintenance just like production equipment; water tanks are baffled to control the effects of the water movement in the tank; and water-truck drivers are properly trained on operating the truck.
