**Aquatic Park Amphitheater
Focused Historic Structure Report**

San Francisco Maritime National Historical Park
San Francisco, California

National Park Service

Architectural Resources Group
Architects, Planners & Conservators, Inc.

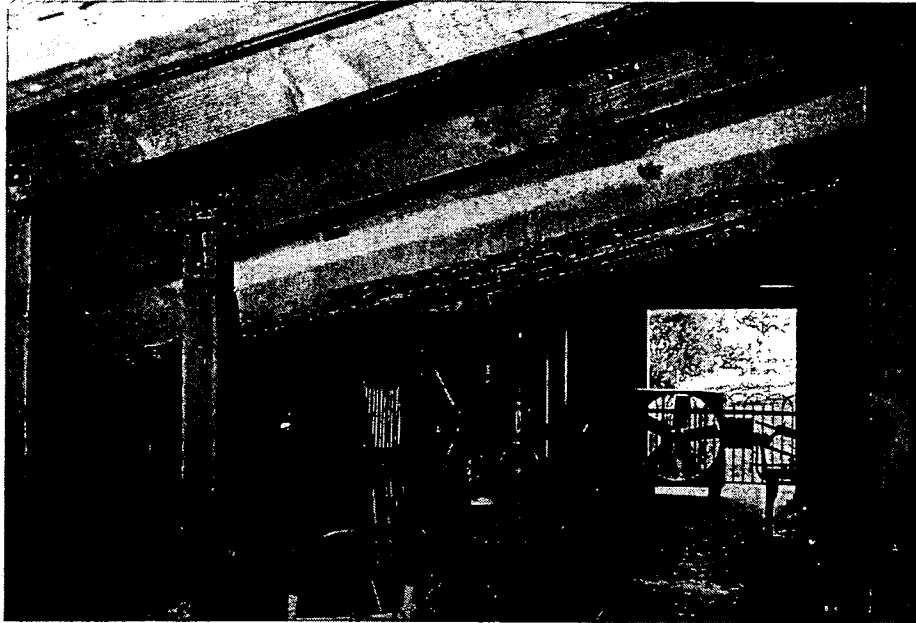
On the interior typical conditions include evidence of water infiltration to the below grade spaces. While it is most serious in the easternmost bleachers, water infiltration is occurring in all below grade spaces. Extensive concrete spalling and erosion of material and corrosion of steel reinforcing bars is present throughout the interior spaces and is more serious below the east bleachers. Water penetration occurs at the rear retaining wall.

Figure 1: View of interior space below east bleacher, looking east to exit. Note exposed reinforcing bars and shoring due to failing concrete structure. Photo dated March 2005 by ARG.

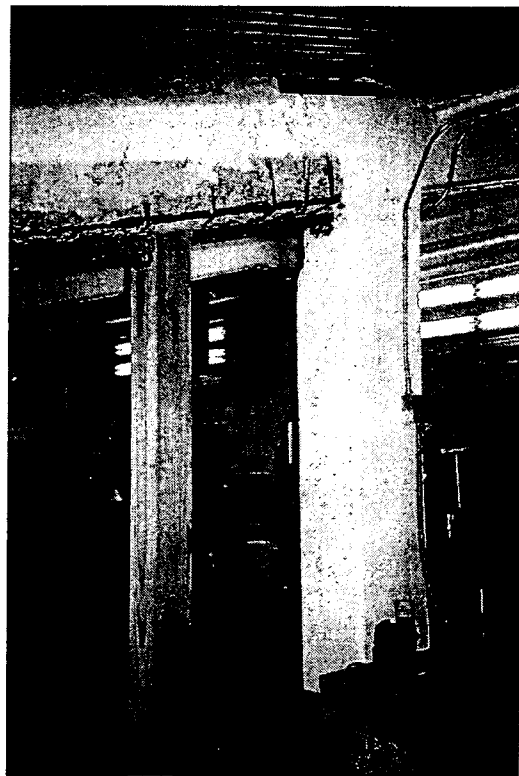
Figure 2: Detail view of exposed reinforcing bars and concrete spalling in interior space below east bleacher. Photo dated March 2005 by ARG.

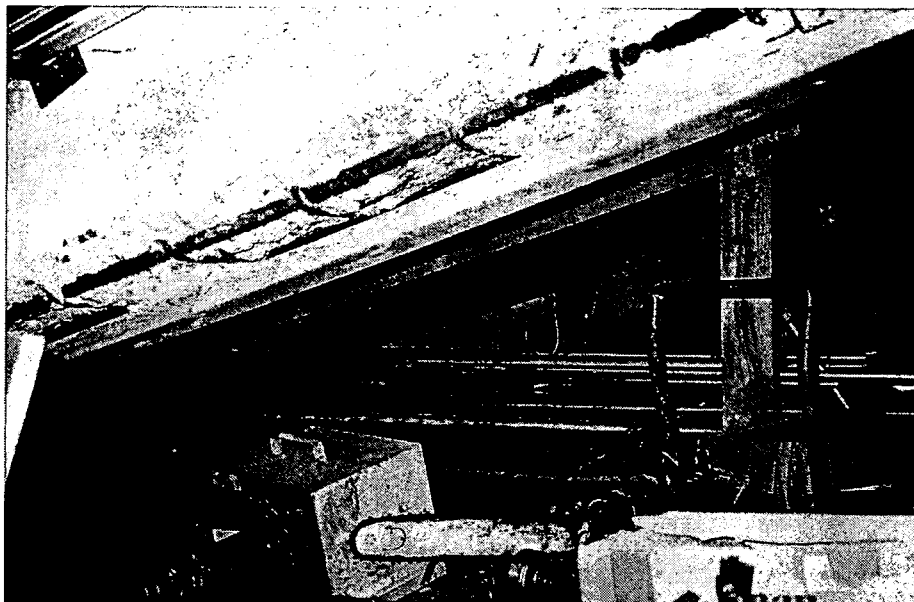
Figure 3: Detail of spalled concrete below east bleacher.
Photo dated March 2005 by ARG.

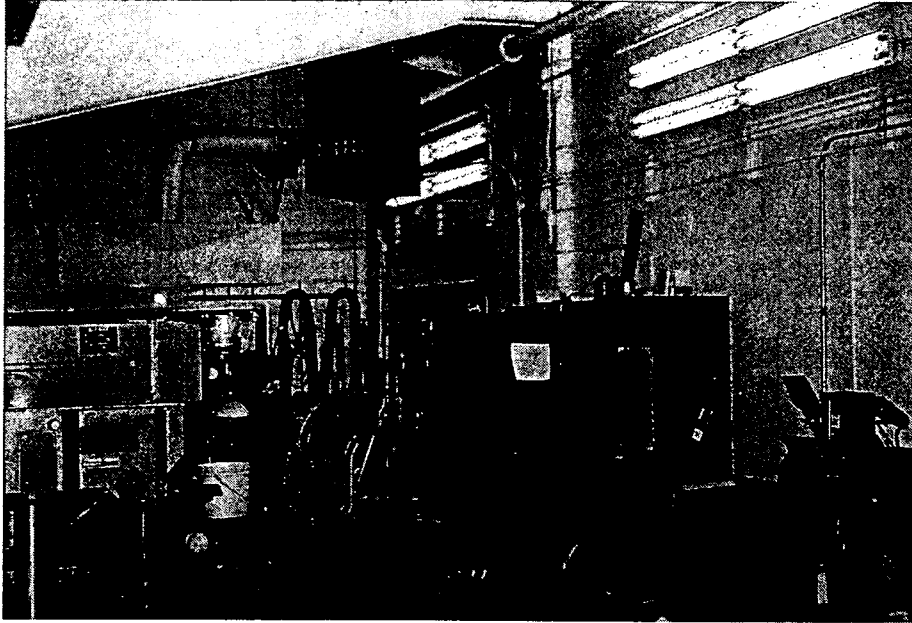
Figure 5: Rear wall of the interior space (at right in this photo) below the east bleacher is the location of recurring water infiltration. Photo dated March 2005 by ARG.

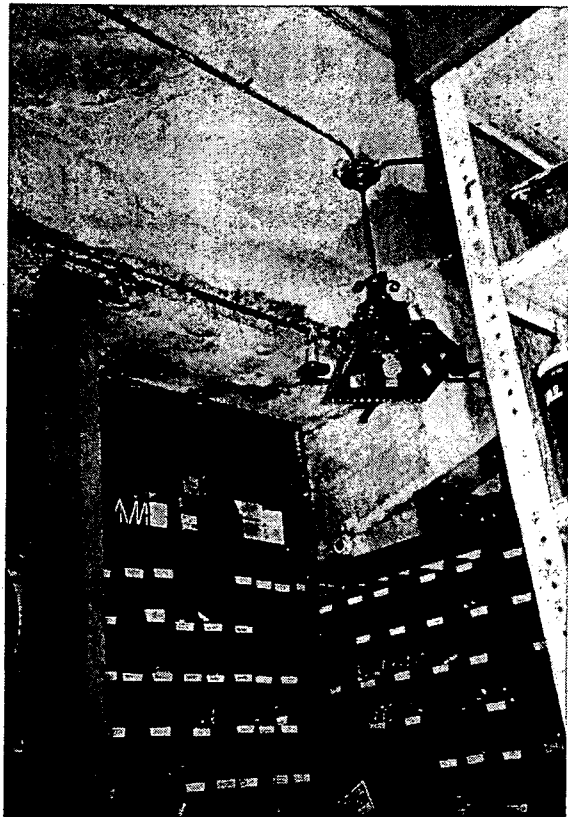
Figure 8: View of evidence of water infiltration and exposed rebar on the plaster ceiling surfaces in the storage area off the NPS offices, east bleacher. Photo dated March 2005 by ARG.

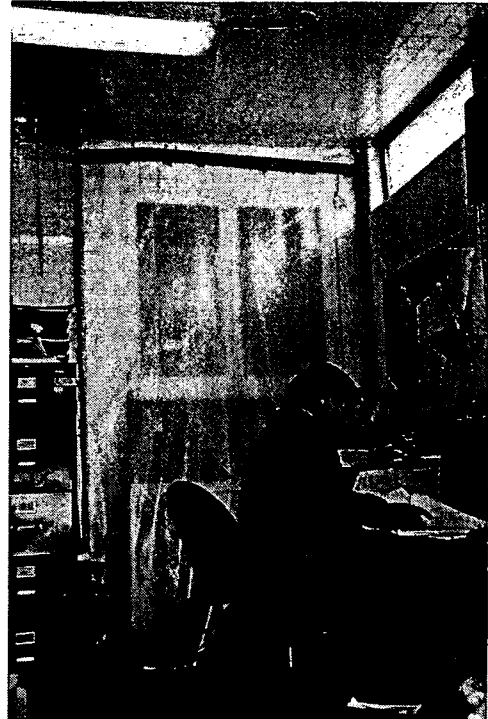
Figure 10: Water infiltration in the NPS offices, east bleacher, has damaged cabinetry. Photo dated March 2005 by ARG.

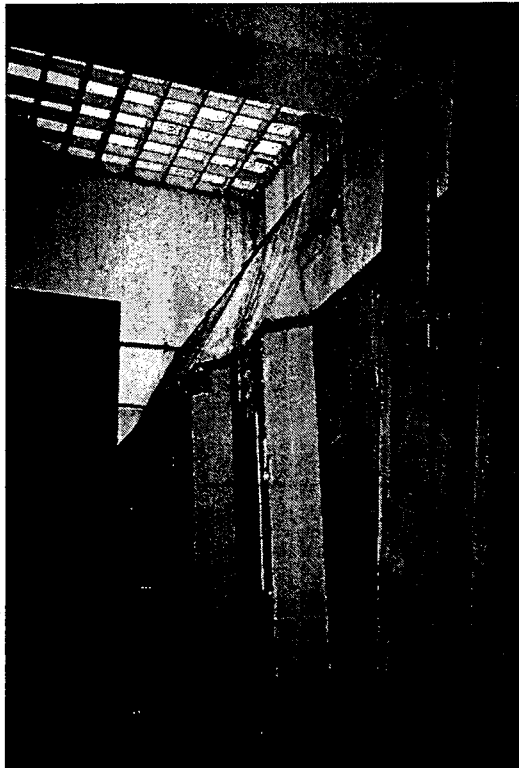
Figure 12: View of tiled surfaces of former men's shower, now used as storage. Note staining from arrested water infiltration in the area of the skylights, east end of central bleacher, looking west. Photo dated March 2005 by ARG.

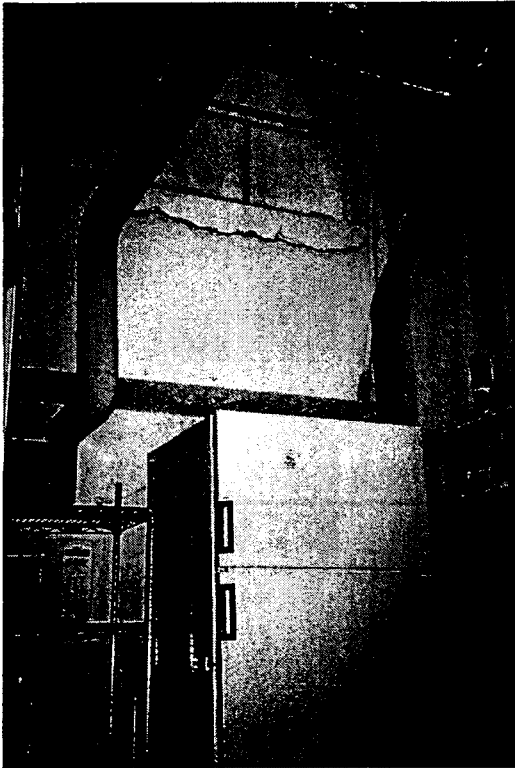
Figure 18: View of north wall of storage/kitchen area below west bleacher. Note crack below window. Photo dated March 2005 by ARG.

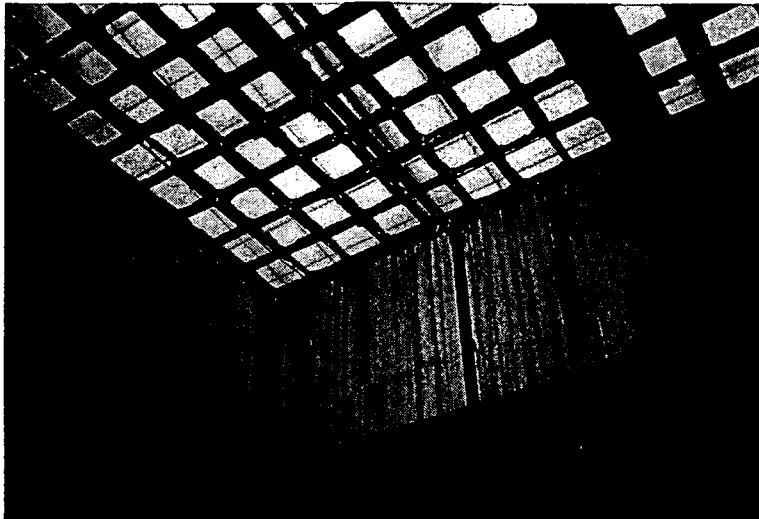
At various times all of the skylights have failed. The protective covers have served to arrest active water infiltration, however past water infiltration has left extensive staining on the interior.

From the interior skylight failure includes square wire glass lites that are missing or cracked. Biological growth is evident. The deterioration of the concrete grids that supports the lites is evident upon visual inspection on the interior.

Figure 20: View of typical condition of skylights with evidence of water infiltration . Photo dated March 2005 by ARG.

Replacement of the skylights will be necessary, however it is recommended that the original design intent of the skylights be retained, as an exterior landscape feature and to provide natural light below.

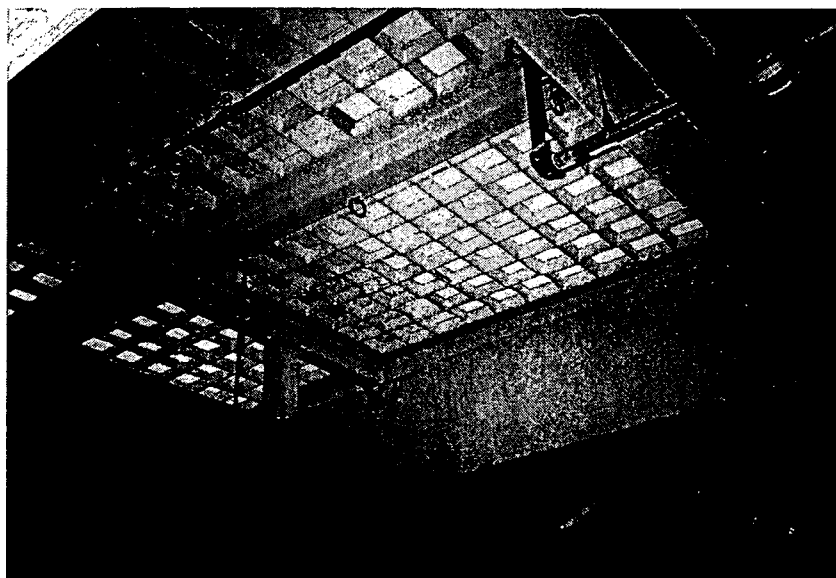
Figure 21: View of typical condition of skylights with evidence of water infiltration . Photo dated March 2005 by ARG.
