BLASTING ALERT

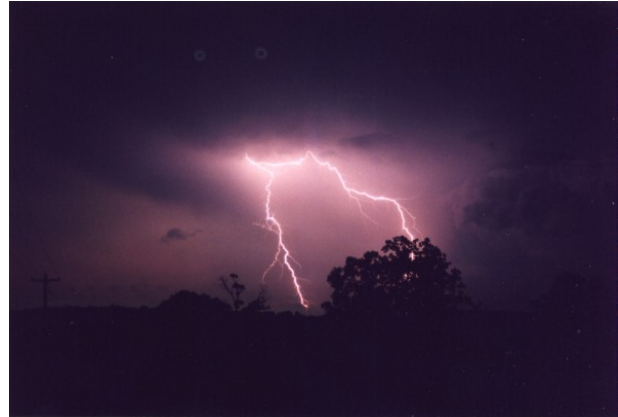
On June 10, 2005, an unplanned detonation of a blast hole occurred at a surface coal mine in Indiana. A total of 189 blast holes had been drilled, loaded, and primed for blasting. The mine was using the Orica electronic blasting system to set up the blast, check the circuitry, log and assign delay sequence timing, program and arm the electronic detonators for blasting, and to detonate the round. In preparation for the blast and once all personnel were off of the blast area at a point of safety, the blaster connected the Orica Logger to the Orica Blaster and then began the calibration and programming process. While the electronic detonators were being programmed, the number 173 blast hole unexpectedly detonated after a short time into the programming sequence. No injuries or property damage occurred.

Thunderstorms and lightning had been noted in the area at the time of the incident. This incident is currently under investigation to determine the cause of the unplanned initiation of the number 173 blast hole.

- Insure that the manufacturer's instructions for the use of an electronic blasting system are being followed.
- Insure that the blast site is cleared and secured and that blasting personnel are in a safe location when using any electronic blasting system to program and arm the electronic detonators for the blast.
- Determine that stray electrical current is not present during the blast set up to create a safety hazard.
- Suspend blasting operations during the approach and progress of an electrical storm and withdraw persons from the blast area or to a safe location.
