NEAR MISS CRANE HOISTING INCIDENT

U.S. Dept. of Labor Mine Safety and Health Administration

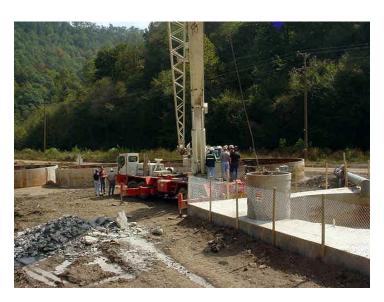
A non injury incident occurred while hoisting a bucket of muck during the construction of a shaft with five men working below. Bolts on the crane hoist drum, designed to prevent free spooling sheared off. The loaded bucket dropped and landed on the shaft coping.

- NEVER modify crane hoists without manufacturer approval
- NEVER disable hoist safety features
- Ensure cranes are examined daily for defects
- Properly maintain equipment
- Don't exceed weight limits
- Properly train equipment operators
