PROGRAM INFORMATION BULLETIN NO. P08-17

SUBJECT: Potential Boom Failure on Komatsu America Corp. Model
PC400LC-7L Excavator

CAMPAIGN NUMBER: 7C064 1

SUBJECT: PC400LC-7L REPAIR OF ARM CYLINDER BRACKET ON BOOM. ***NOTE:
EXTENDED COMPLETION DATE 6/27/2008 KF***

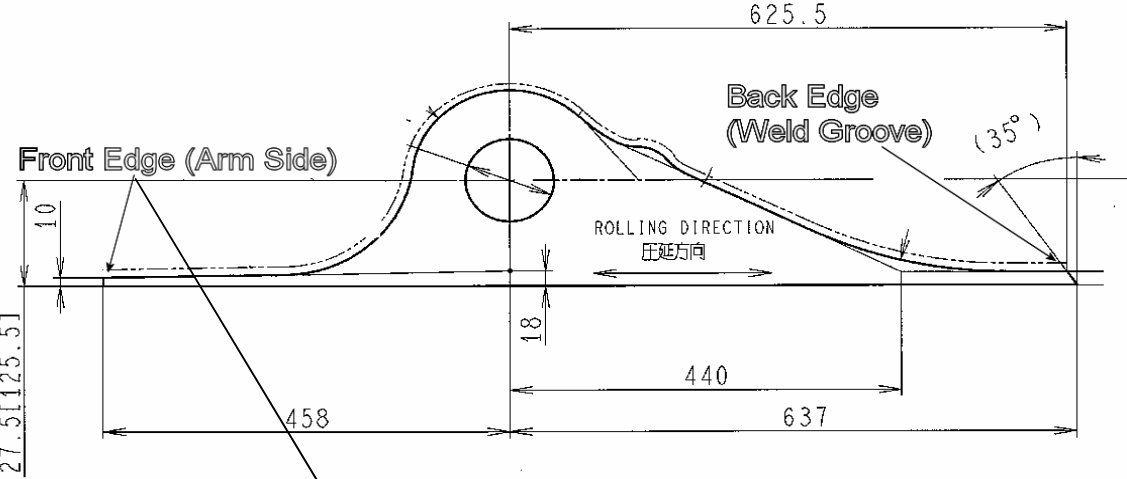
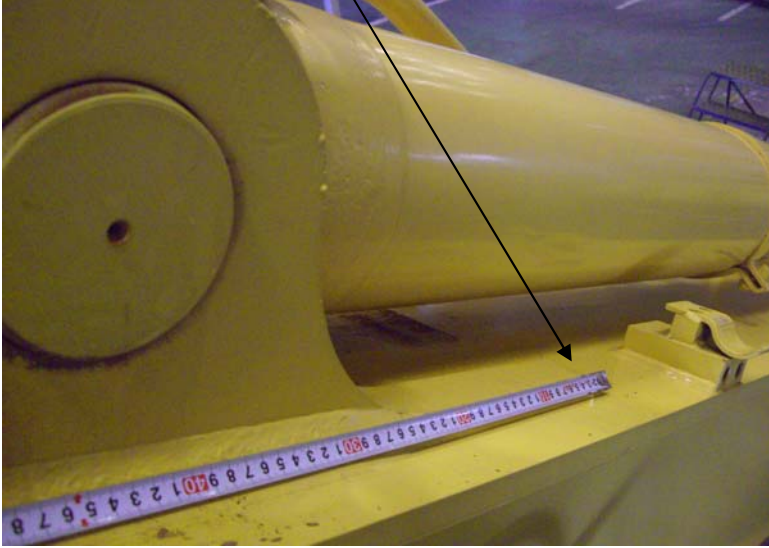
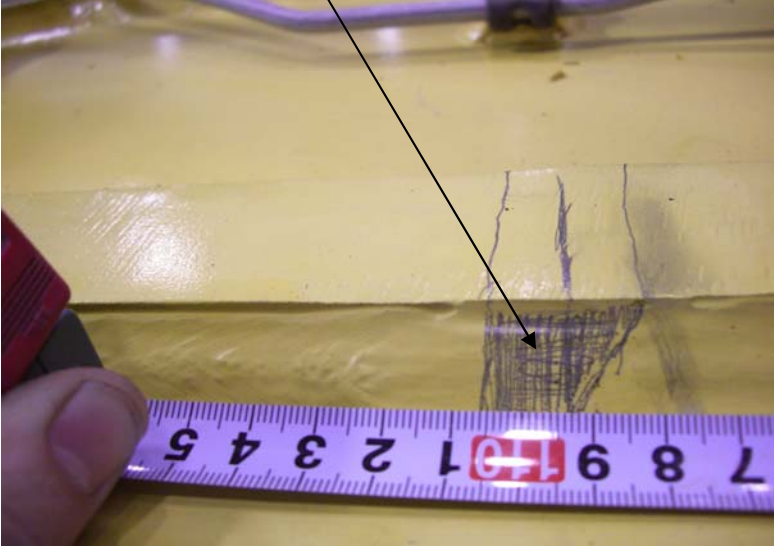
If there is no visible crack, weld root is 1095 mm from front edge of bracket.

4. Layout and mark area to be ground out.

Note: Protect work lamp, hoses, cab etc. from grinding/gouging sparks with fire proof blankets.

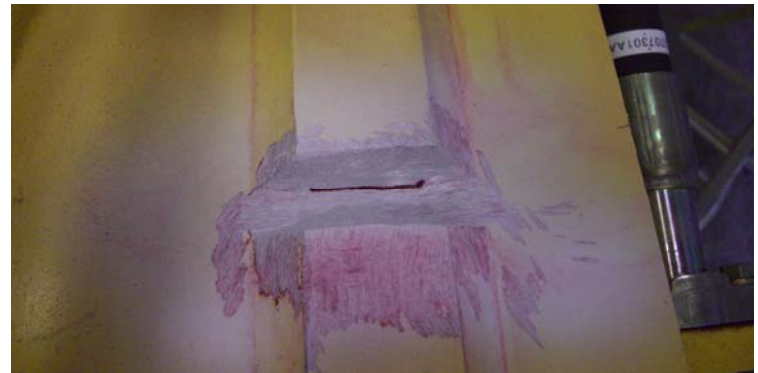
6. Liquid penetrant (PT) inspect weld groove to ensure top plate is not cracked. *Note: Dye will bleed out between cyl. bracket and top plate and between reinforcing strip and top plate as shown; Check is to ensure there is no crack in fillet welds at side of bracket or in the boom top plate.* **If cracking has occurred in top plate; See page 4/5 for additional instructions.**

Proceed with step 7 if top plate is not cracked.

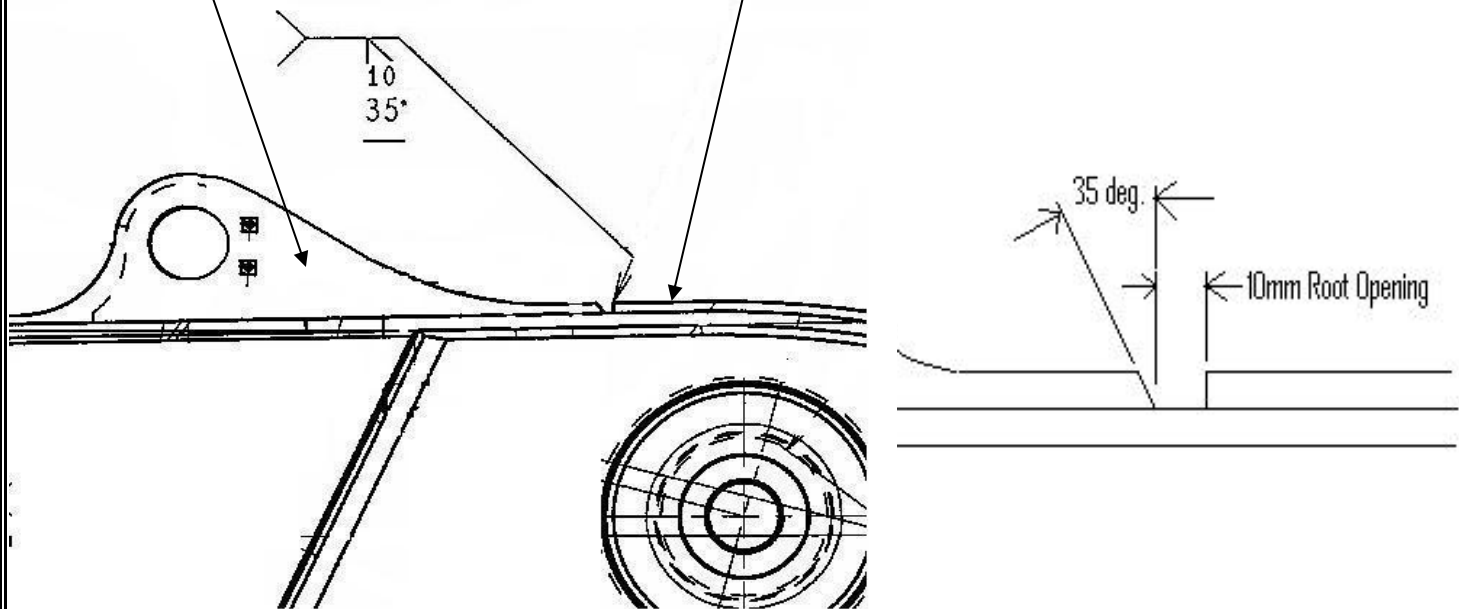
WELD JOINT

There have been field failures on PC400LC-7L due to the arm cylinder bracket to bracket strip weld set-up. The drawing calls for a 10mm gap to be maintained at this weld joint to achieve penetration. However some units may have been manufactured with a gap below 10mm. With high stress and improper weld penetration at these points, cracks may develop in this area and in some cases propagate across the top plate.

1. Air arc or grind out entire crack 16mm deep including 5mm on each side into sound base metal. Include 35 deg. Bevel.
2. Liquid penetrant (PT) or Magna Flux (MT) inspect weld root area to ensure crack has not progressed into boom top plate.
3. Weld per procedure on page 6.
4. Grind weld cap pass flush with bracket and blend ends of weld with existing fillet weld.
5. Recommended (but not mandatory) UT inspection of finished weld to ensure there is no lack of fusion.
6. Paint.

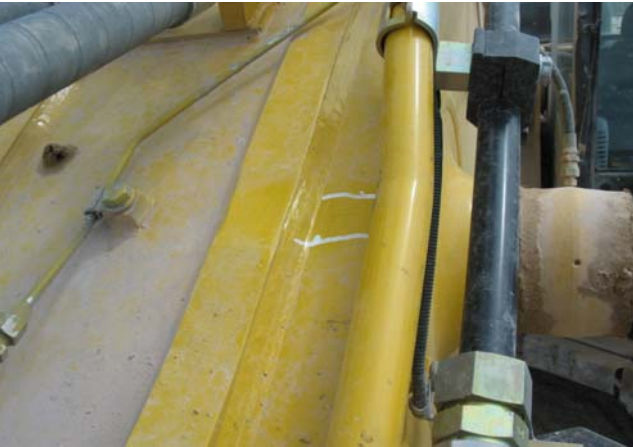
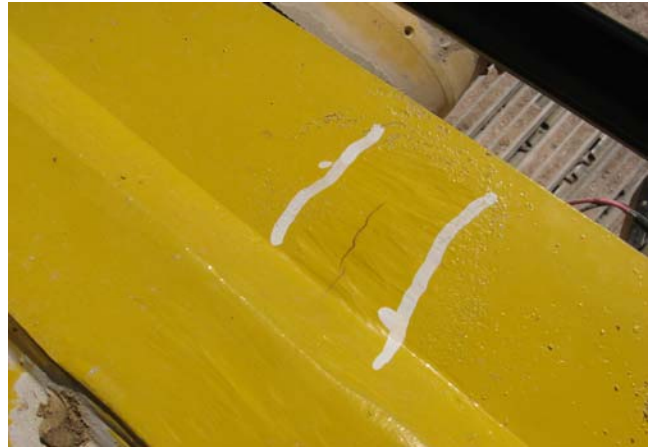
Do not bridge groove without backing: cracking may reappear as shown in pictures below of a previously repaired machine.

Use liquid penetrant insp. to ensure entire crack has been completely removed prior to weld repair.

If cracking is excessive and has propagated from top plate into sideplates, please contact service representative prior to performing any work.
