REPORT OF INVESTIGATION

Fatal Underground Coal Mine Electrical Accident  
May 16, 2008

Aracoma Alma # 1 Mine  
Aracoma Coal Company, Inc.  
Stollings, Logan County, West Virginia  
I.D. No. 46-08801

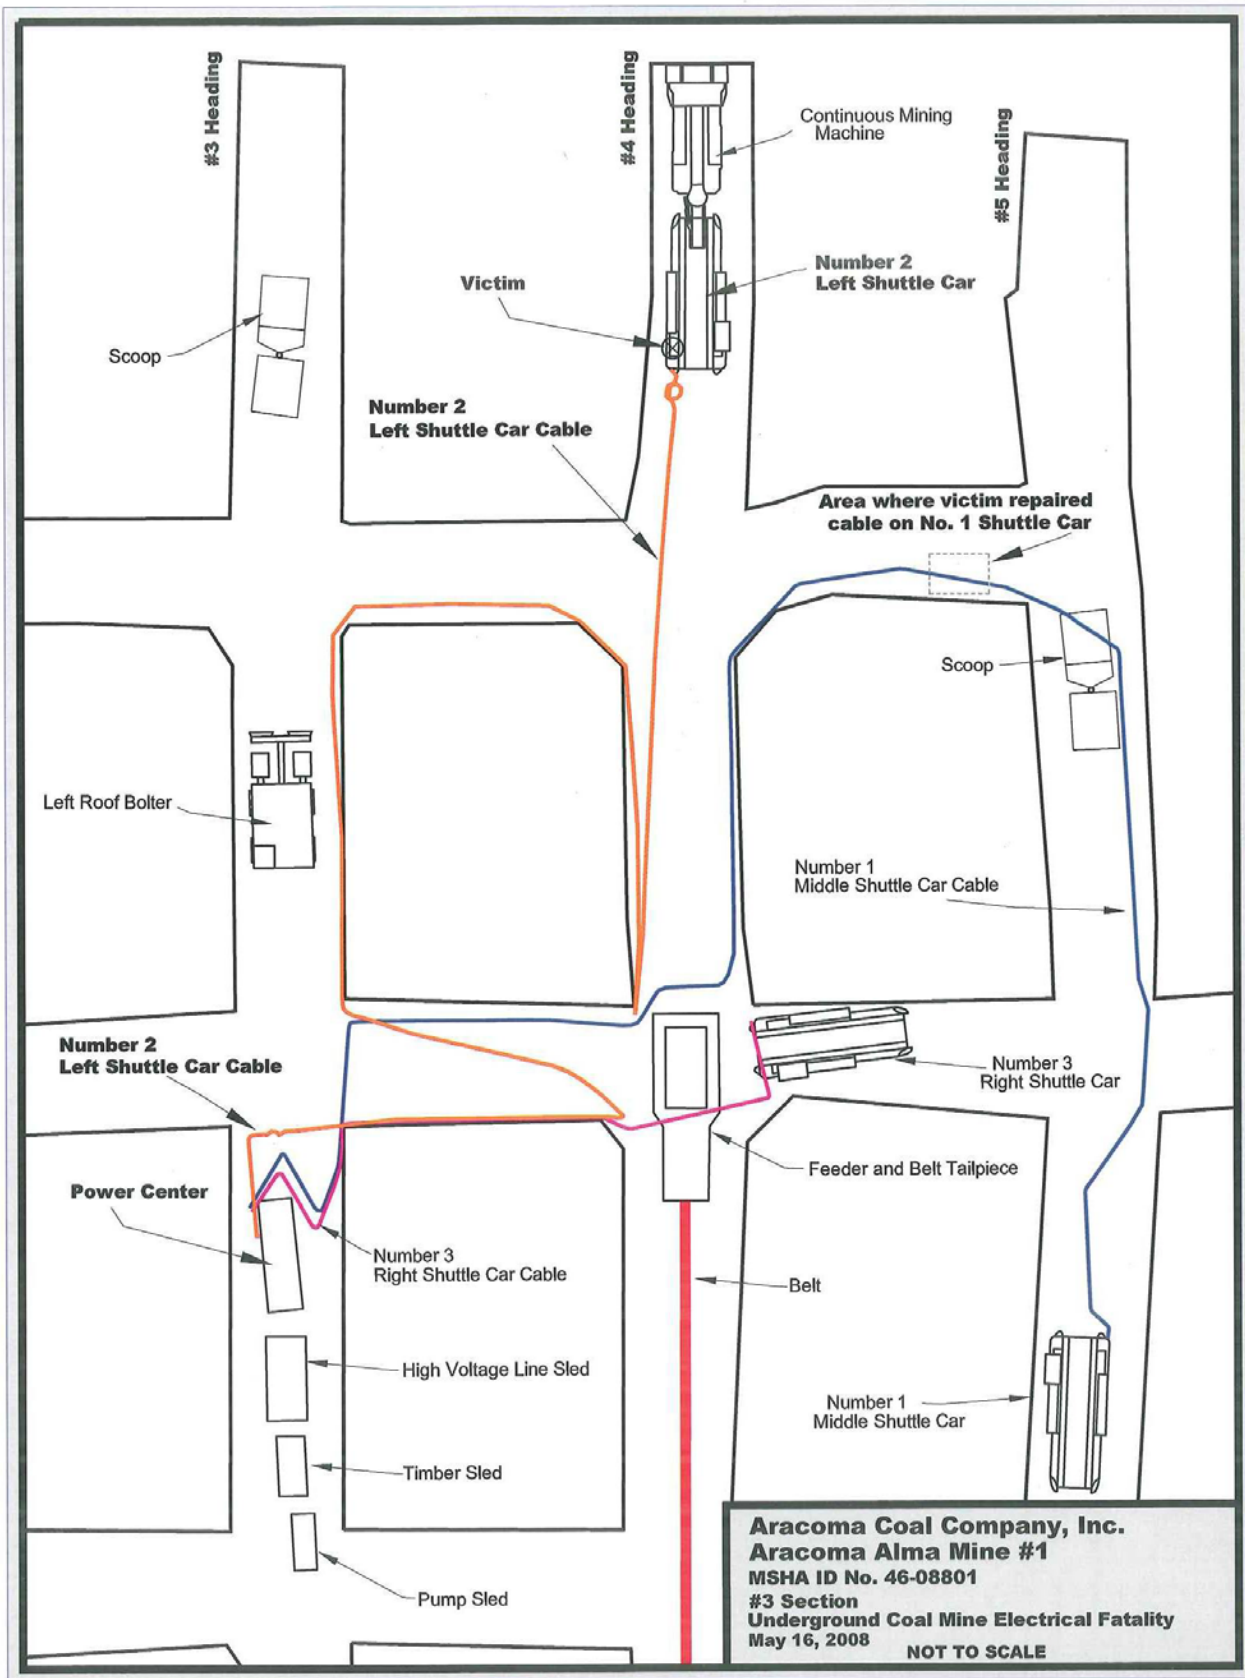
DRAWING OF ACCIDENT SCENE

Prior to the accident, the Mine Safety and Health Administration completed the last regular safety and health inspection (E01) on March 17, 2008. The non-fatal day's lost (NFDL) injury incidence rate for the mine in year 2007 was 0.00, compared to a National NFDL rate of 4.75 for a mine of this type. The accident occurred on the No. 3 Section, which was developing seven entries. The accident occurred in the No. 4 belt entry near the face.
