# NOAA Abandoned Vessel Program Removal Case Study: *F/V Mwaalil Saat*

Contributing Agency: CNMI Office of Coastal Resource Management, USCG

NOAA AVP #:	2546
Vessel ID#:	1101004

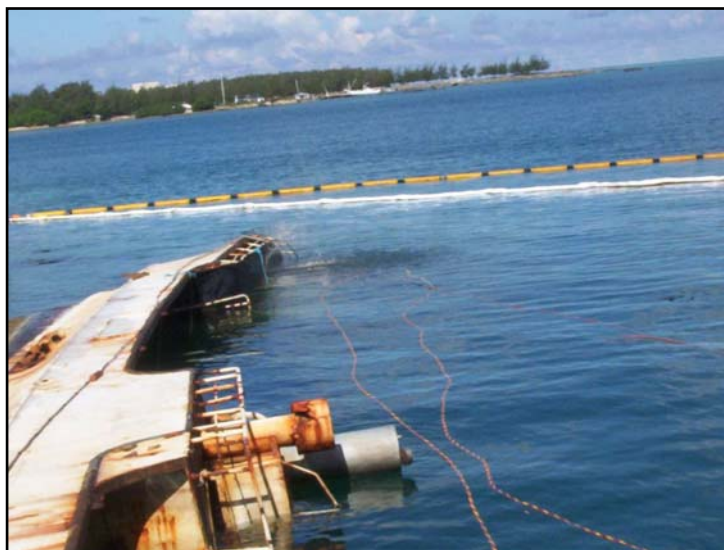
*Grounded vessel being cut underwater (black water)*

The operation occurred in two distinct phases; removing the vessel from the water and breaking it for scrap. During the first phase Titan Maritime removed vessel debris from the area surrounding the vessel, cut the ship into five large sections and moved the sections to the upland staging area. In the staging area Titan proceeded to cut the ship into sections small enough for their subcontractor, AMPAC, to load into trucks and haul to a local scrap company. These sections were typically about 5 tons. As this phase proceeded, the salvors used sorbent material to collect and contain as much oil as possible. They also had to remove asbestos as it was found. Another contractor, South Pacific Environmental, was on hand to collect runoff water (used to cool hotwork during cutting). They also cleaned the engine room before it was cut up.

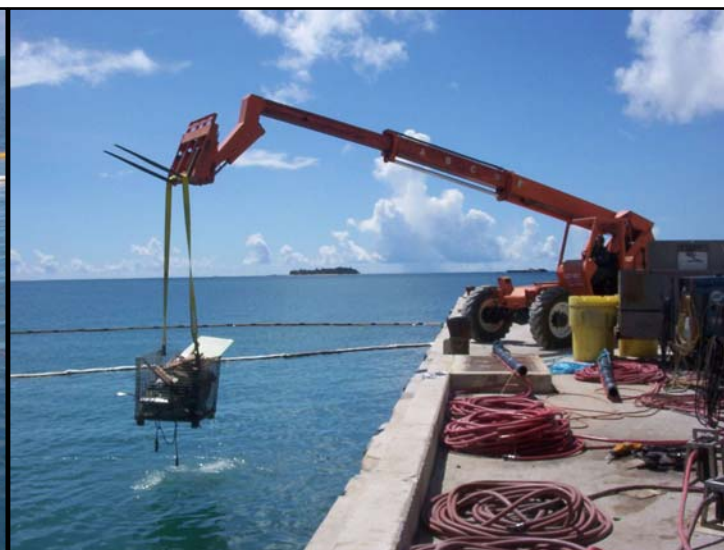
*Debris lifted from the water*

The debris brought up from the vessel and the area surrounding it were returned to the owner or sent to a landfill after being tested for PCB contamination. 50 cubic yards of contaminated sediments were packed up and shipped to an EPA regulated waste disposal site in Washington State for processing and disposal. 125.5 metric tons of scrap was recycled by KP Scrap.

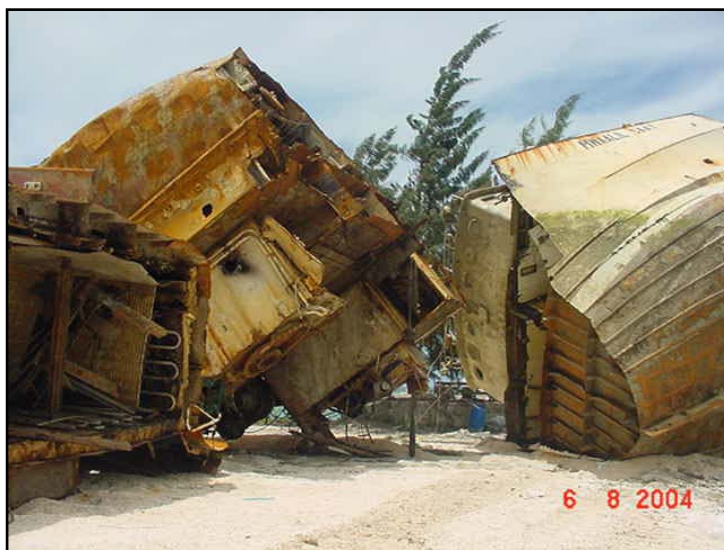
*Sections of hull staged for further work*

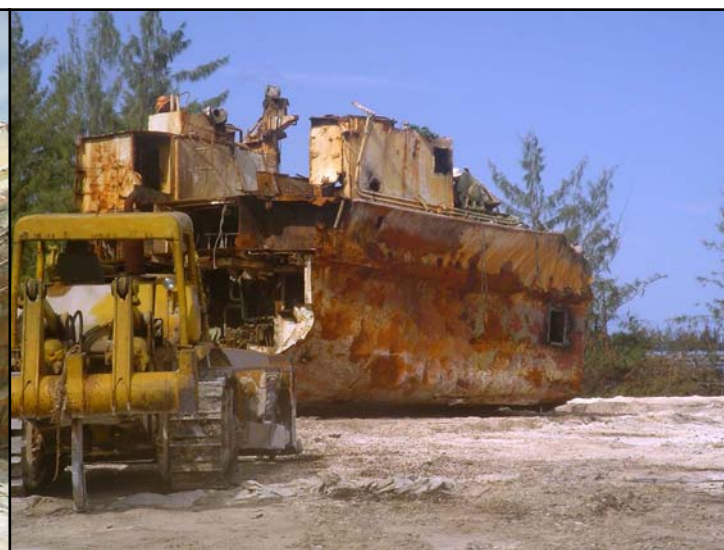
*Machinery and hull section*
