Subject: Alterations to Rear Elevations

Applicable Standards: 2. Retention of Historic Character
9. Compatible New Additions/Alterations

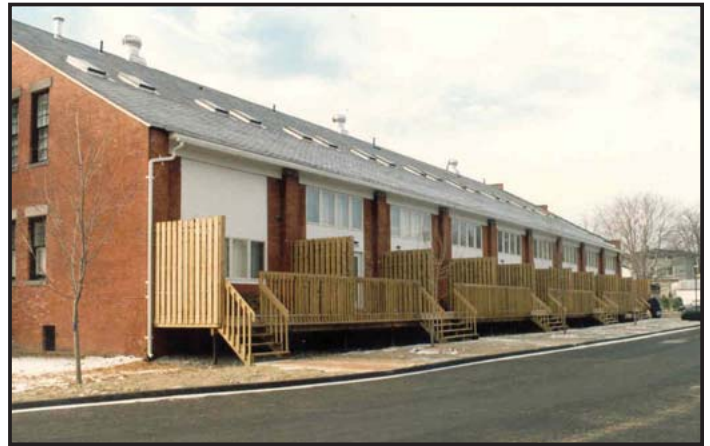
The rehabilitation successfully retained the historic character of the interior and the exterior of the head house. But unsympathetic alterations were made to the exterior of the drill shed during its conversion to apartments. The original paired, nine-over-nine wood sash windows in the rear wall were removed along with a considerable amount of brick. These enlarged openings were replaced with a wood infill panel, new windows and a door to create an individual townhouse unit in each of the bays. The addition of wood decks with privacy screens further gave this elevation the appearance of a residential townhouse complex.

Above: The enlarged openings were infilled with wood panels, stock windows and doors (left). As a result, (right) the rear elevation of the drill house row has the residential appearance of townhouses.

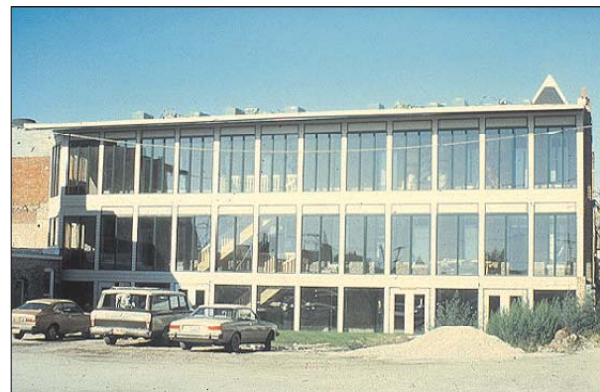
Application 2 (*Incompatible treatment*): Four row houses, part of a block of late-19th century brick row houses, were rehabilitated for office use. The office conversion involved some relatively minor changes to the interior layout and room configurations. Because it was done for a single business, some openings were made in the party walls that separated the individual houses in order to connect the interior spaces. The rehabilitation carefully retained the historic character of the exterior of the buildings on the front and their appearance as individual row houses. However, as part of the rehabilitation a continuous glass curtain wall was constructed across the back of the four row houses, completely obliterating their distinctive rear brick walls. As a result of this treatment the houses have lost their identity as separate buildings. In addition, the glass curtain wall is incompatible with the late 19th century historic brick row houses and with the residential character of the historic district. The rehabilitation project did not meet the Standards.

Above: The rear walls of the row houses were covered with a single glass curtain wall that is incompatible with the character of the historic houses as well as the character of the historic district.
