Fatality #5 - February 19, 2009 (Victim Died April 12, 2009)
Machinery - Puerto Rico - Dimension Limestone
Master Aggregates Toa Baja Corp Pta 3 Carolina - Cantera Carolina Pta #3

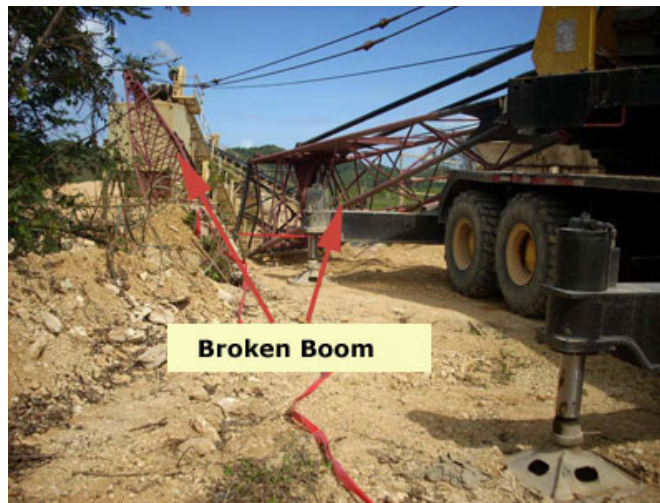
METAL/NONMETAL MINE FATALITY - On February 19, 2009, a 61 year-old laborer with 12 years of experience was injured at a sand and gravel operation when he was struck by a crane's falling boom. The crane was lifting a crusher and the victim was acting as a signalman when the accident occurred. He was hospitalized and died on April 12, 2009, as a result of his injuries.

- Prior to attempting a lift, know the weight of the load (including the load block and rigging) and make sure it is less than the crane's lifting capacity for the required reach. Refer to applicable load charts.
- Perform a thorough pre-operational inspection of the crane and rigging components.
- Stay clear of a crane's overhead boom and do not work beneath a suspended load.
- Always be certain that the object being lifted is completely detached from its supporting structure prior to attempting a lift.
- Insure that the crane turntable is level prior to lifting.
- Make sure the load is aligned directly beneath the centerline of the boom to prevent side loading.
- Confirm that the load will not exceed the allowable capacity of the rigging.
- Follow the crane manufacturer's recommendations when making structural repairs and use certified welders.
