Special Report 84-2

**US Army Corps
of Engineers**

Ice observation program on the semisubmersible drilling vessel SEDCO 708

L. David Minsk

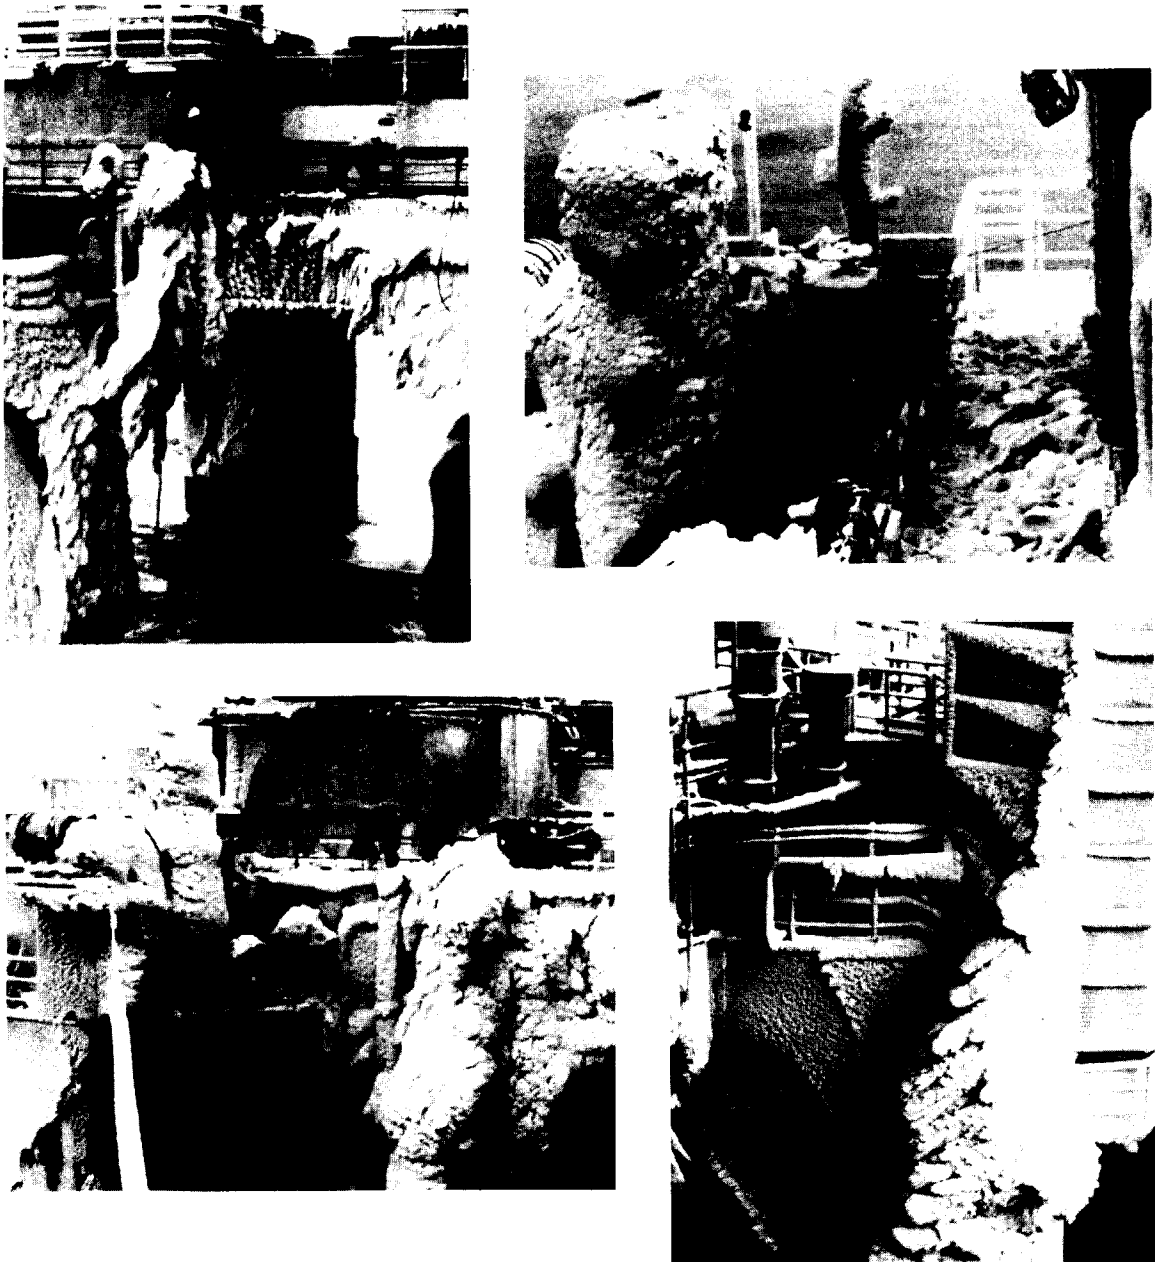
Ice accretion on ocean structures can seriously affect their performance and in the extreme create a hazardous condition on manned structures. The icing event on the Ocean Bounty in December 1979, in lower Cook Inlet (near Shelikof Strait) at latitude 59°N , longitude $153^{\circ}30'\text{W}$, during which an estimated 400 tons of ice was accreted on the semisubmersible drilling vessel, demonstrated the danger that could arise from a combination of high winds, high seas and subfreezing temperatures (Fig. 1). Though there was reportedly no immediate danger to the vessel and its crew, it was necessary to jettison drilling mud as a precaution to maintain trim and stability (Nauman, in prep.).

Figure 1. Ice accretion on the Ocean Bounty in lower Cook Inlet, December 1979.

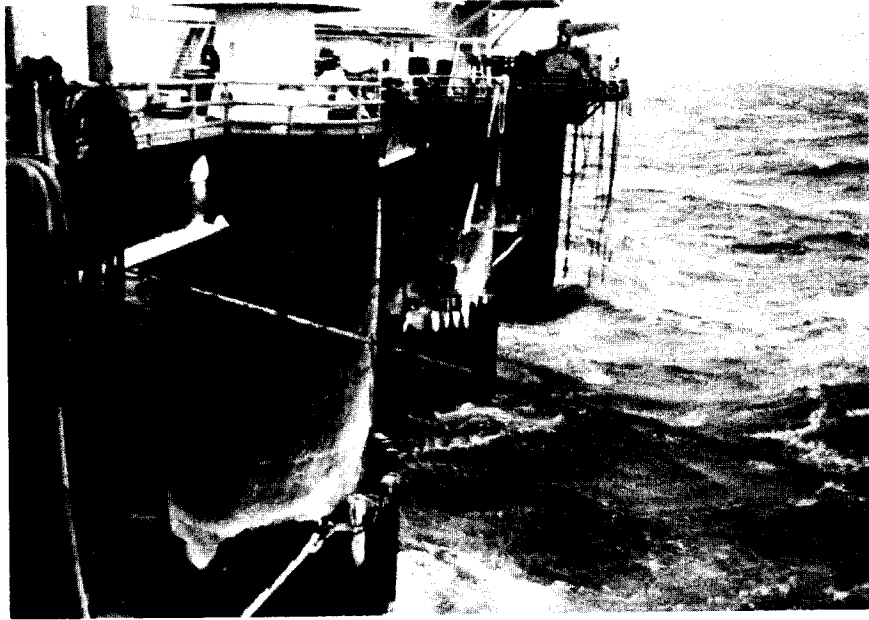
Contrary to what one might expect, the windward columns (those facing north) accreted very little ice even though the timber bumpers on the central two columns should have because they offered increased area above the wave zone (Fig. 7 and 8). Accumulation was heaviest on the diagonal cylindrical trusses in the central part of the structure, where ice thickness up to approximately 5 in. was estimated by scaling photographs (Fig. 9 and 10). The lower third of the exposed stiffeners was scoured by wave action and was completely ice-free, and accumulation tapered off with height, that is, as the underside of the deck was approached. No ice accreted on the underside of the deck (Fig. 11); as waves broke or crashed against the structure, the droplets that were generated were carried in clouds that diminished in height as they passed under the deck, and no droplets appeared to reach the underside of the deck. Only a rough estimate of the total mass of ice that was accreted can be made by scaling photographs; the

Figure 7. Minor ice accumulation on north-facing columns (starboard, windward side). View approximately west (6 January 1983).

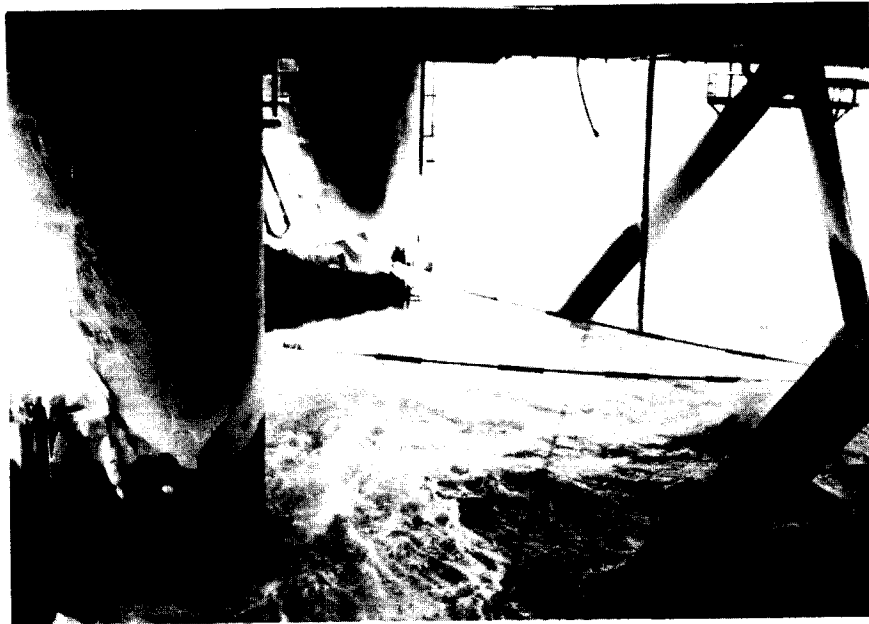
Figure 8. View east from below-deck porthole of starboard aft columns (lee to right). Only slight icing occurred (6 January 1983).

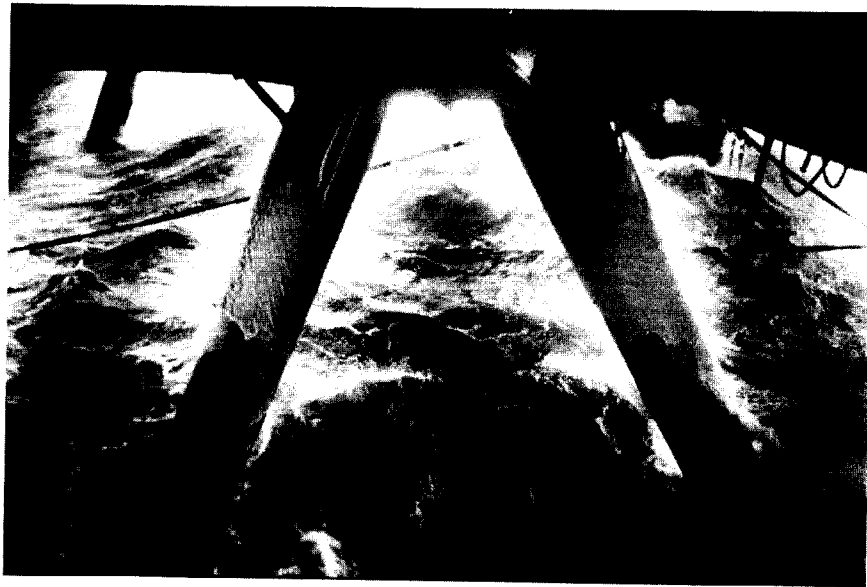
Figure 9. Ice accumulation on diagonal cylindrical trusses under rig (immediately aft of below-deck porthole), which reached a thickness of about 5 in. at bottom, tapering to near zero at underside of main deck. View southwest from below-deck porthole of aft port area (6 January 1983).

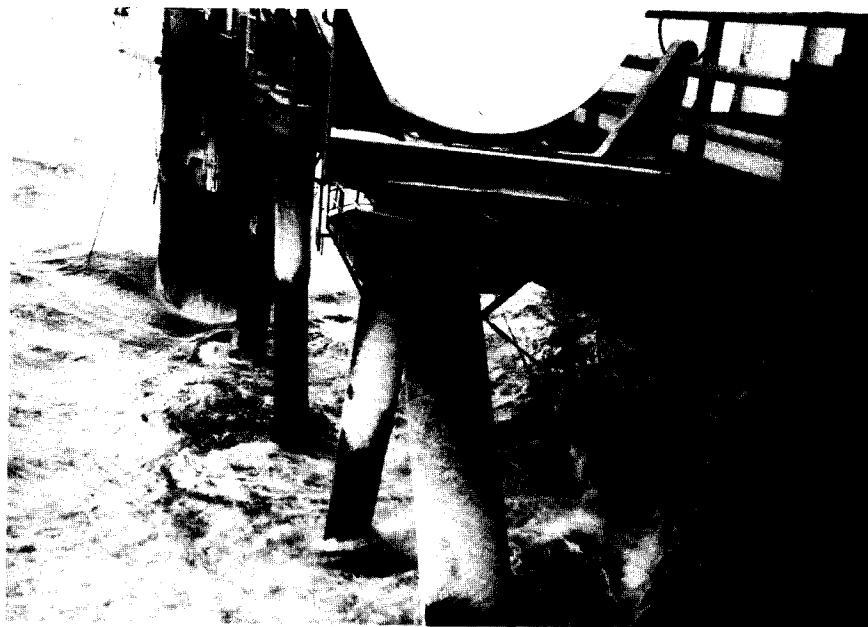
Figure 10. Aft of rig looking approximately south toward aft port column, showing ice accumulation on diagonal trusses (6 January 1983).

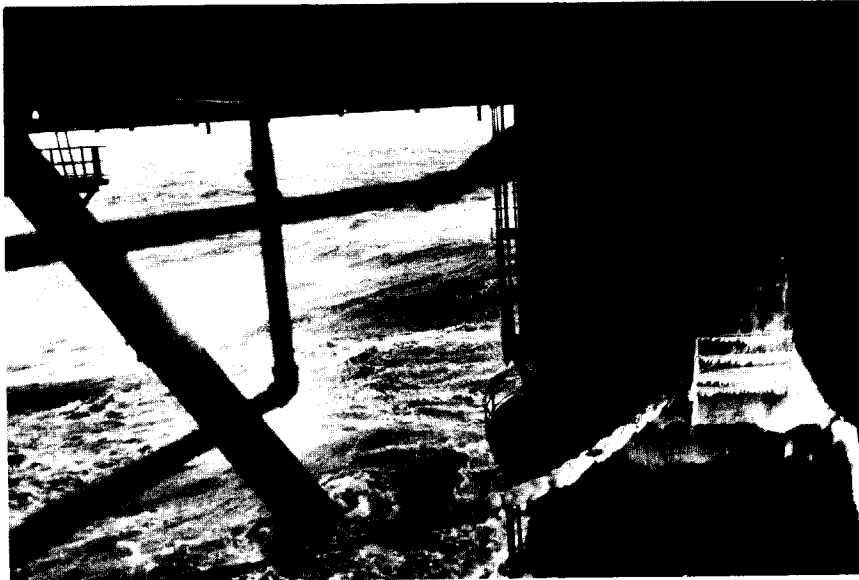
Figure 11. View southwest from below-deck porthole of forward port column; note that underside of deck has no ice accumulation (6 January 1983).
