REPORT OF INVESTIGATION

**Fatal Falling Material Accident
January 6, 2009**

**Matich Corporation
Redlands Rock Plant
Redlands, San Bernardino County, California
Mine I.D. No. 04-05614**

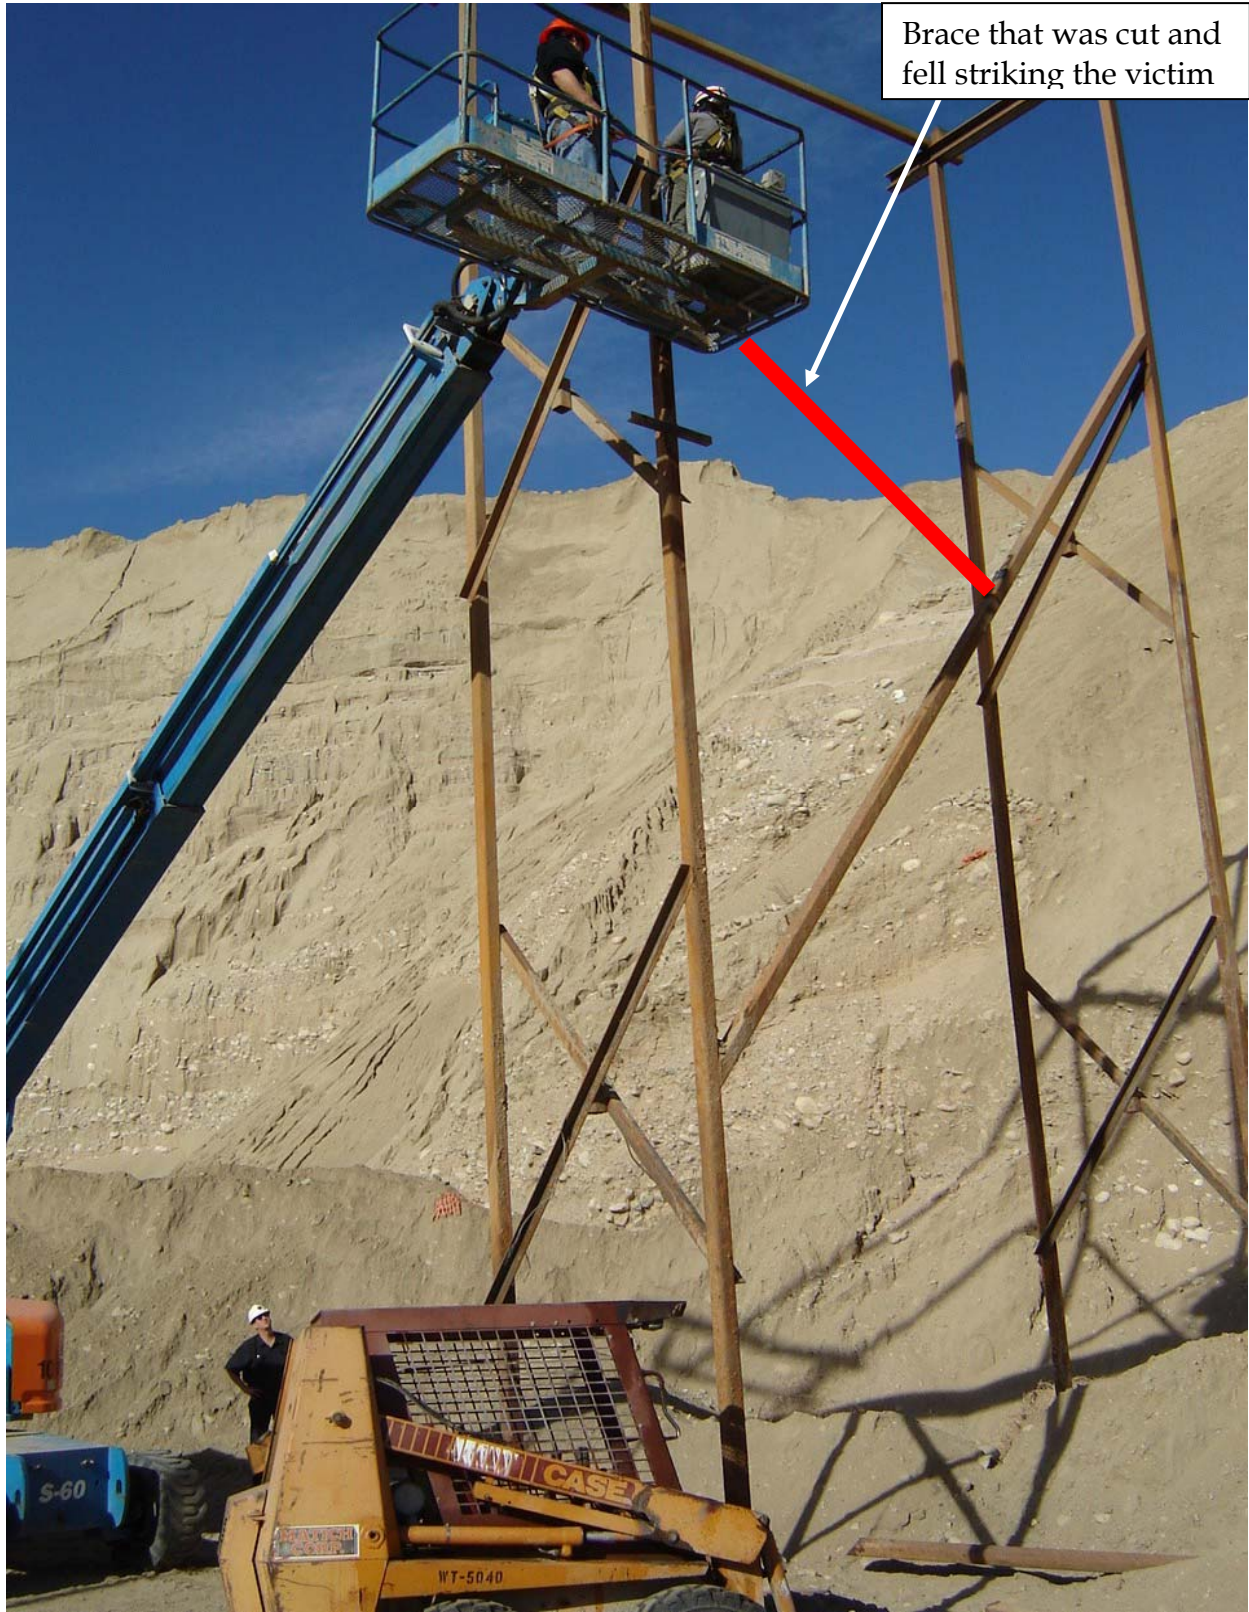
This illustrates the position of the man lift and skid steer loader at the time of the accident.

Gisler repositioned the man lift so Cervantes could cut the short piece of the Y-brace on the east side of the structure. Cervantes cut the bottom of the brace. About 2:30 p.m., Cervantes cut the top of the brace and it fell directly into the cab of the skid steer loader and struck Lerma as his skid steer loader approached the structure.

The steel tubing that struck the victim was the shorter component of the Y-bracing. This member was oriented perpendicular to the continuous leg. The square tubing was 11 feet 10 inches long and 4-inch x 4-inch x 0.5-inch in cross-section with a computed weight of 256 pounds. It fell from a height of 32 feet above ground level.

Corrective Action: Management should establish policies and procedures to ensure that persons could safely dismantle the belt conveyor support system. A risk assessment should be conducted to identify and correct hazards associated with the task to be performed. All persons performing the work should be trained regarding the established policies and procedures.
