## Coastal Change During Hurricane Ivan 2004

Category 3 Hurricane Ivan came ashore near Gulf Shores, Alabama, on September 16, 2004. The barrier islands of the northern Gulf of Mexico near the Florida/Alabama border were exposed to the strongest winds. The communities of Gulf Shores, Pine Beach, and Orange Beach, Alabama, are, in places, very low lying with their dunes rising up only several meters. These dunes were unable to contain the 3- to 4-m storm surge.

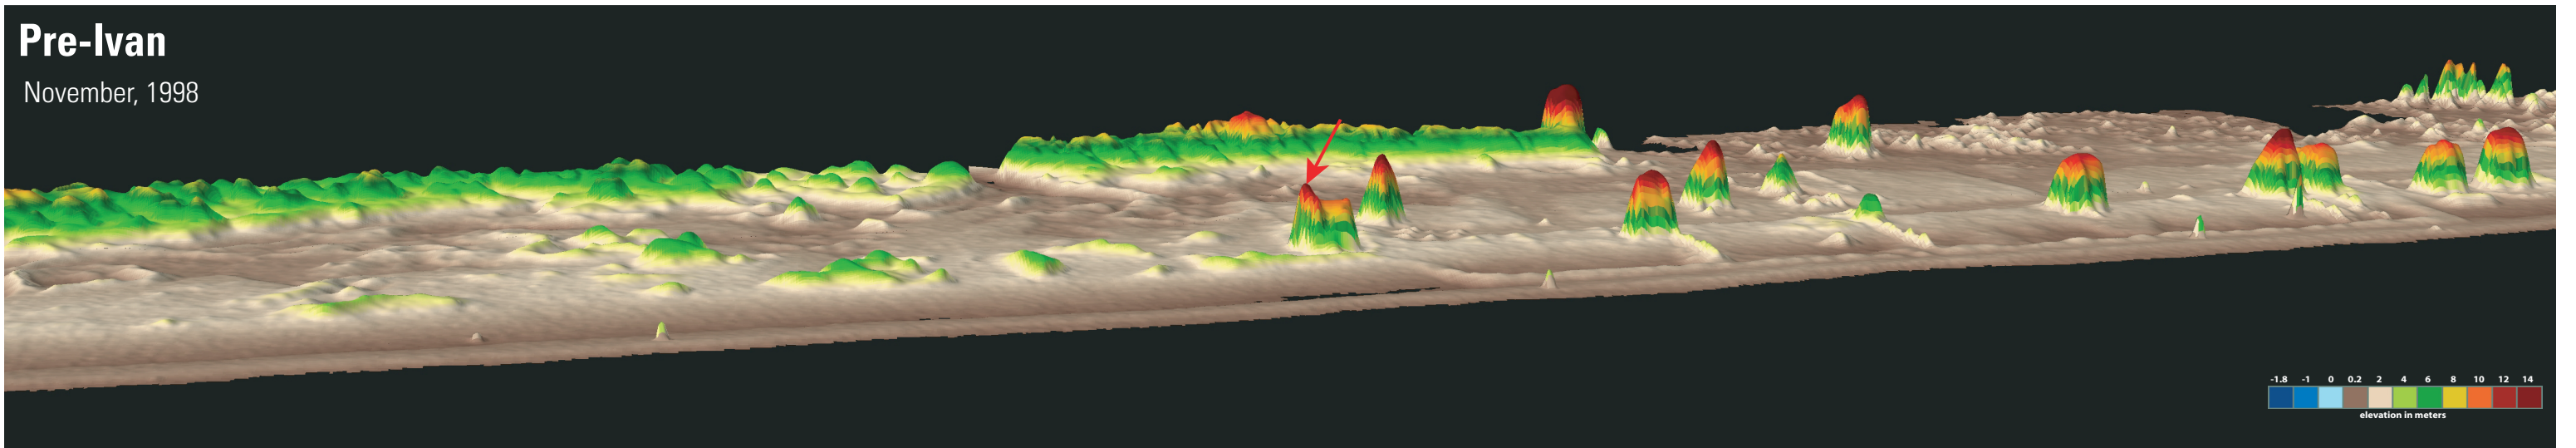
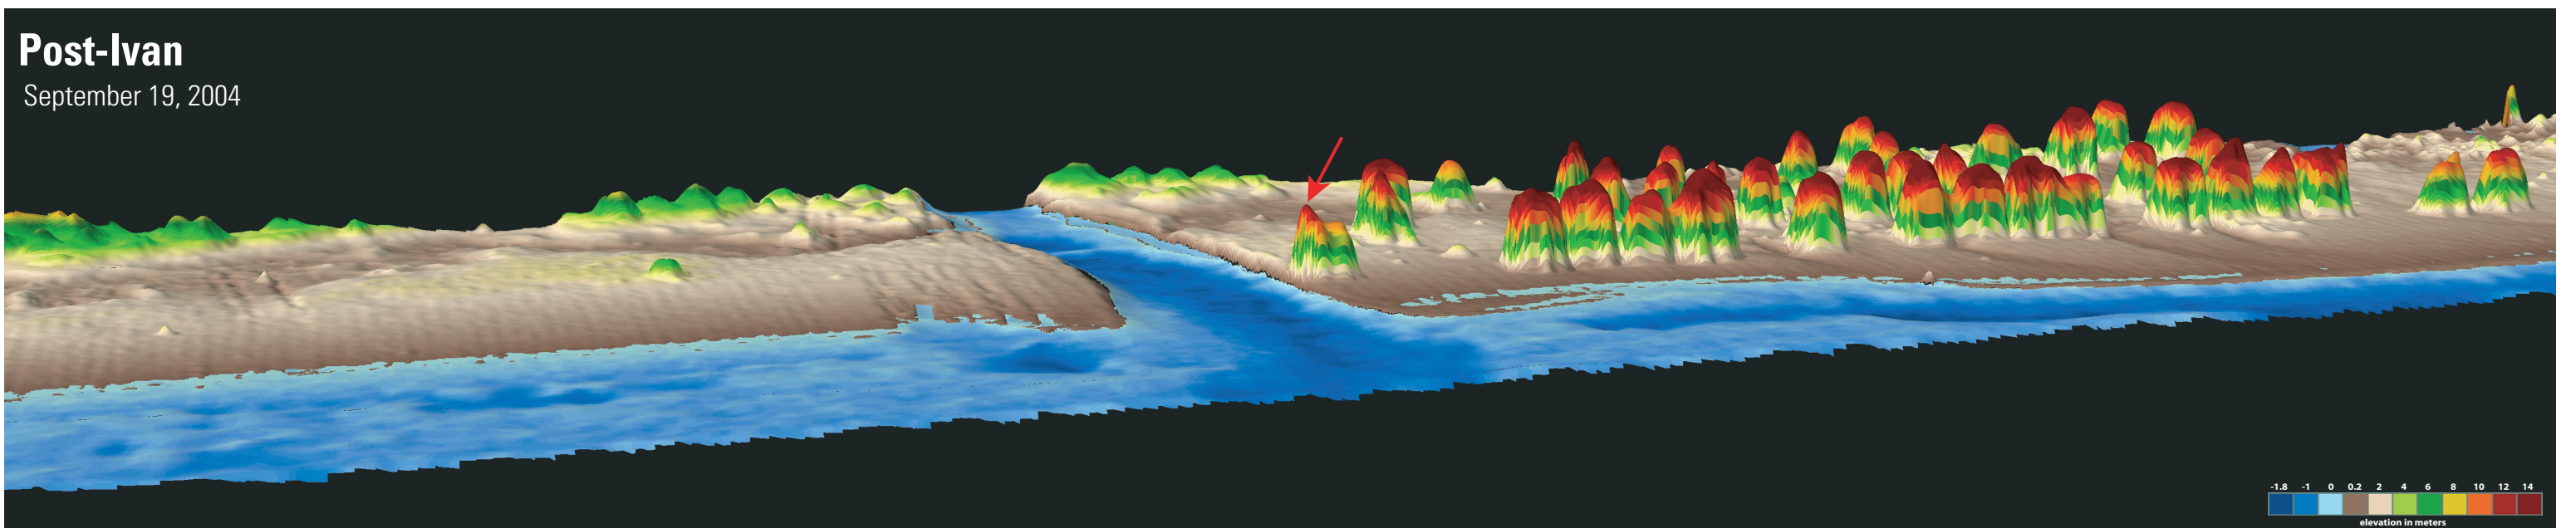
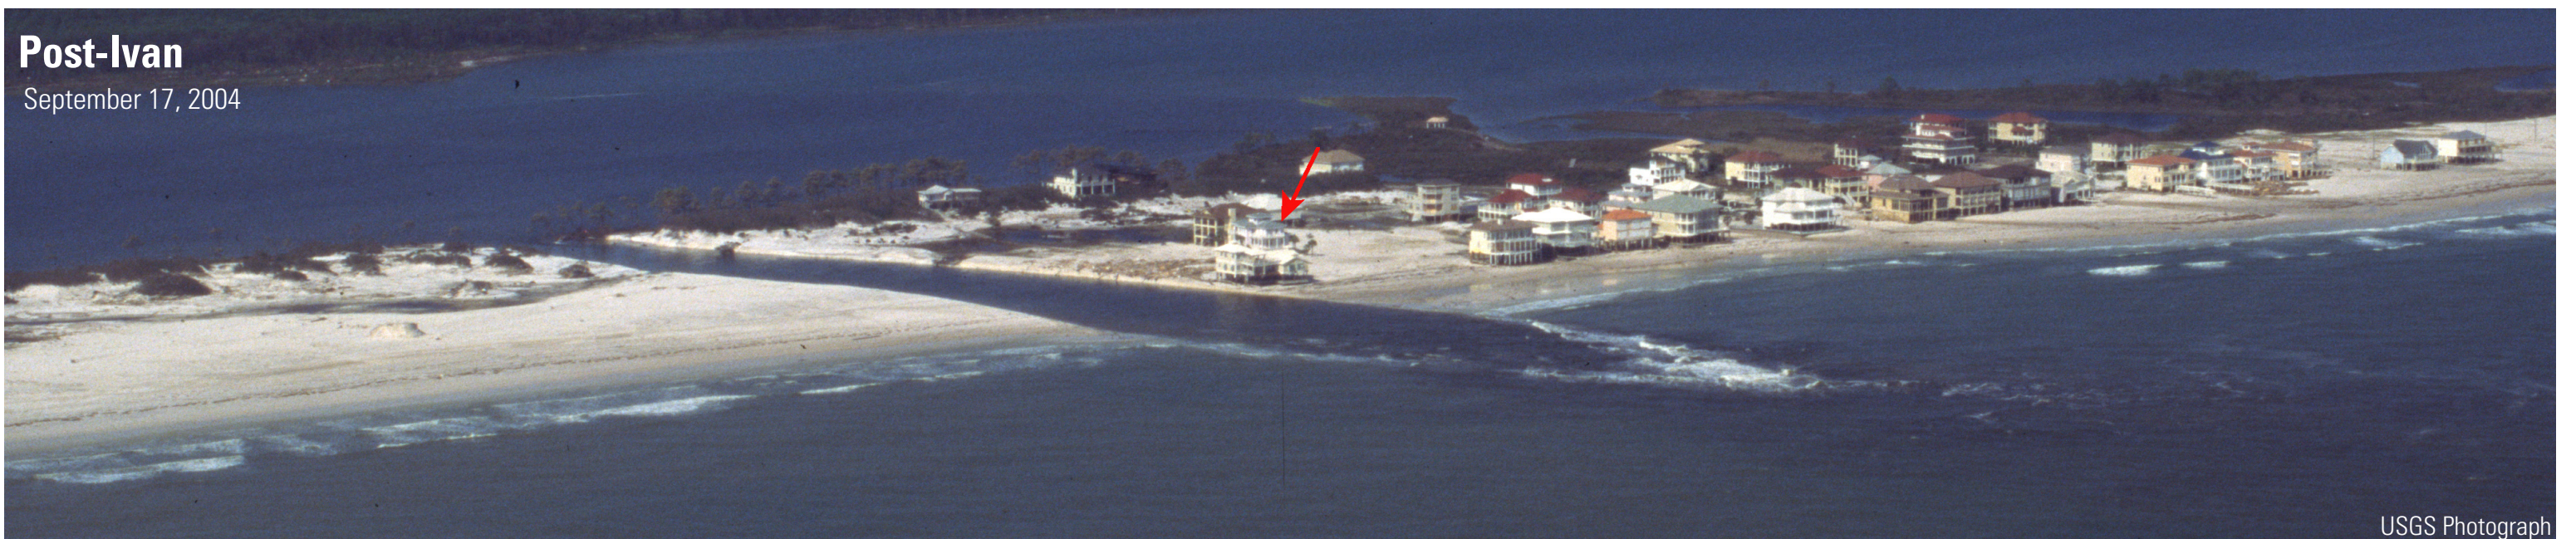
**Figure 3.** Pine Beach, Alabama. Top and Center: Topography/bathymetry measured with lidar before and after the impact of Hurricane Ivan showing a new breach that severed the island. (Note the new houses that were built between the surveys. Houses appear in the topography as rectangular mounds. Their warmer colors indicate higher elevations.) Bottom image: A USGS aerial photograph shows the new breach following landfall. (Arrows in all images point to the same features.)

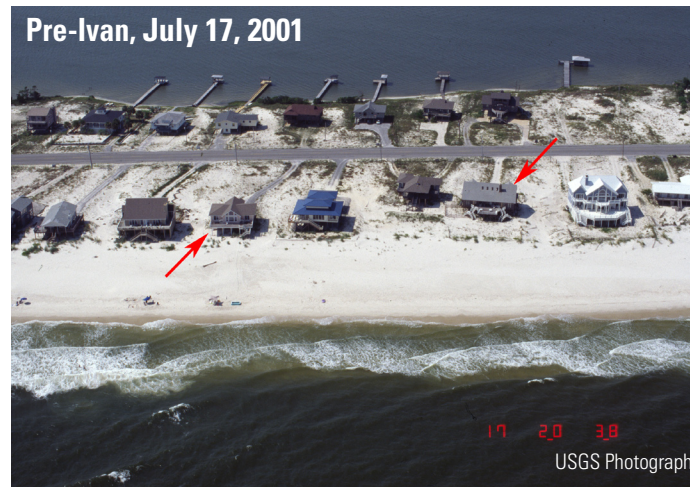
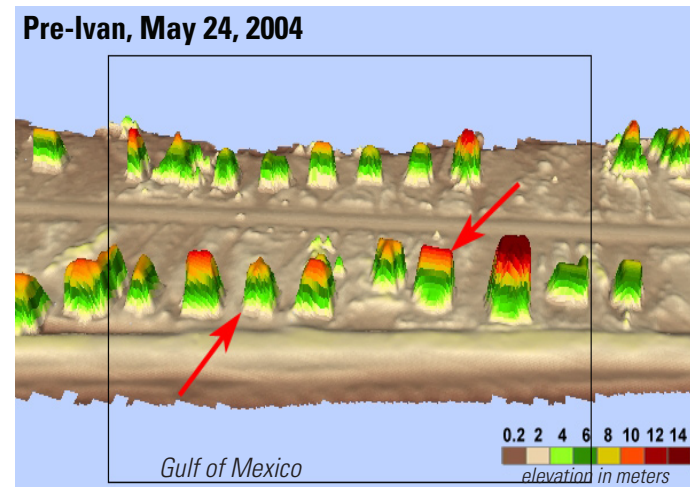
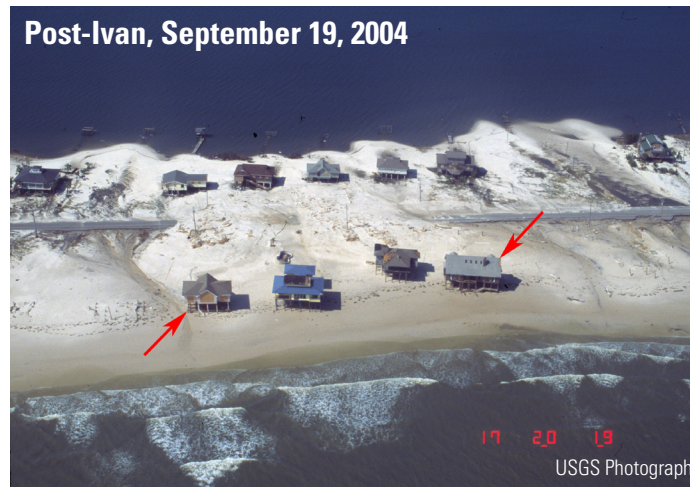
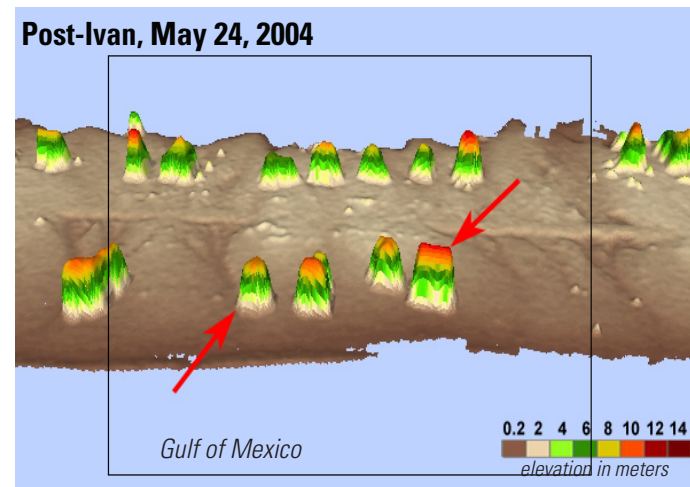
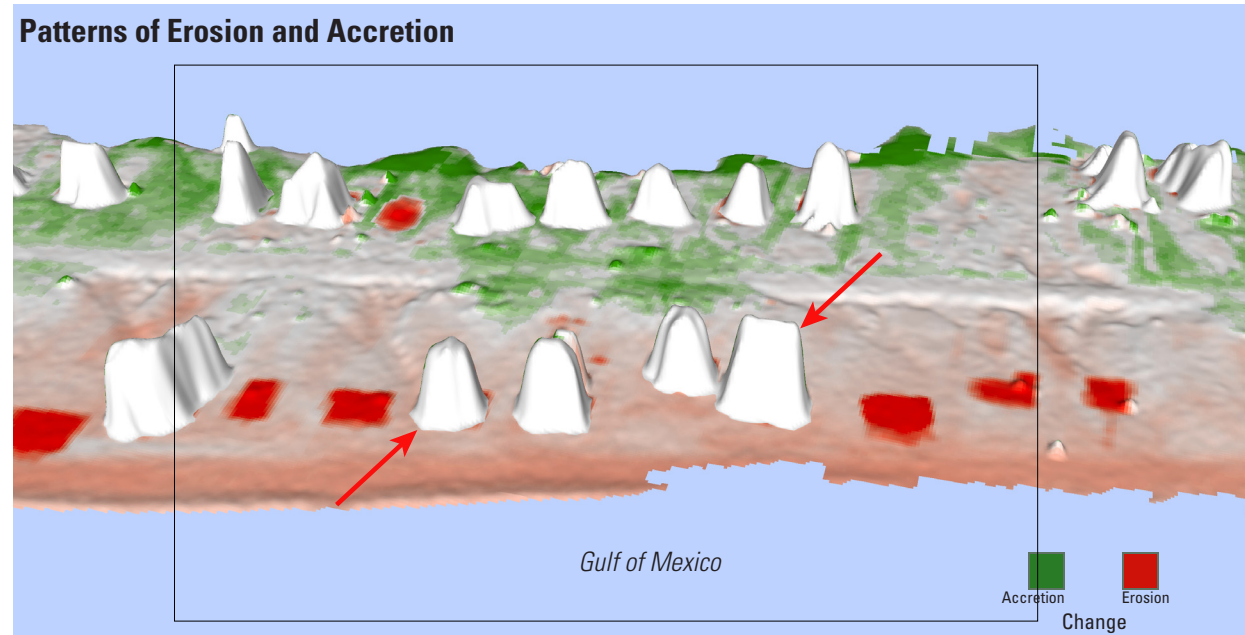
**Figure 4.** Gulf Shores, Alabama. Upper left: USGS before and after aerial photographs showing the loss of houses during Ivan. Upper right: Before and after laser mapping (lidar) topography of the same area shown in the photos (warmer colors represent higher elevations, for example, houses). Bottom center: Vertical elevation change (erosion and accretion) that occurred as a result of the storm. The red rectangles indicate houses that were completely destroyed and swept from the island into the back bay. (Arrows in all images point to the same features.)
