PROGRAM INFORMATION BULLETIN NO. P09-01

SUBJECT: Potential Safety Hazard on J. H. Fletcher & Co. Roof Bolting Machines
with Independent Left and Right Tram Levers

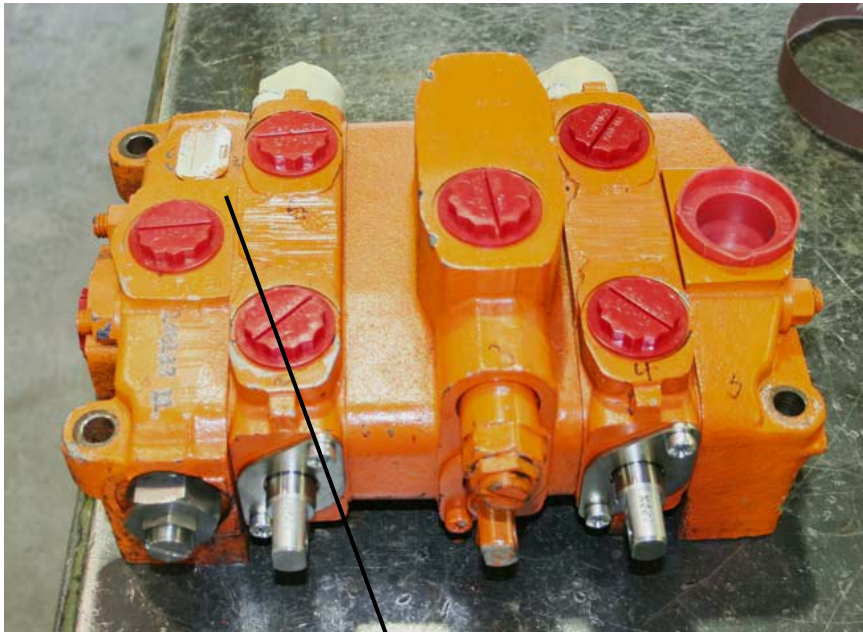
Figure 1 (Tram Control Valve)

- 1: The part number on the tram control valve will be 148133-11 instead of 148133-00. Reference Figure 1 and Figure 2 below.
- 2: The date code in the serial number will be later than the population of suspect tram control valves (H0608-XXXX or later). Reference Figure 1 and Figure 2 below.

Will be "11"

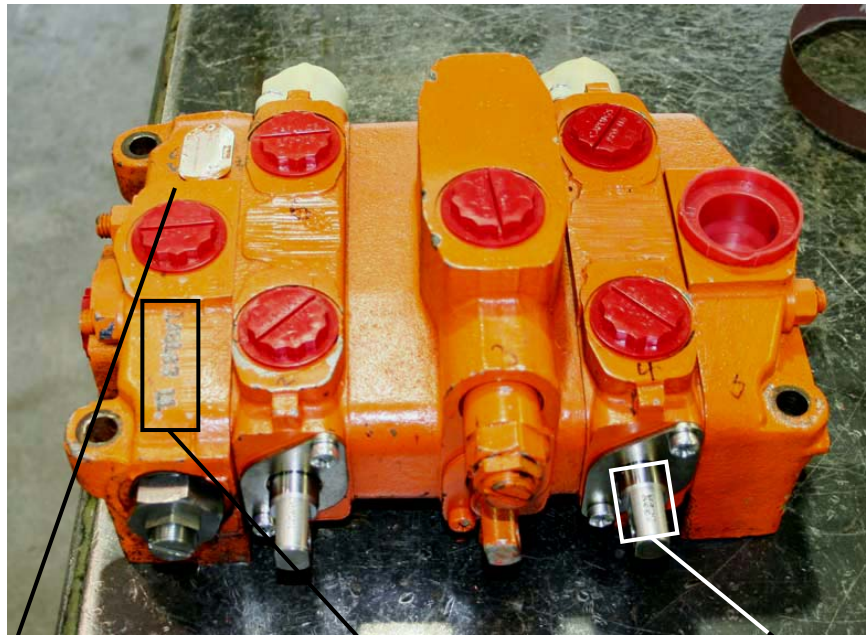
Figure 3
(Tram Control Valve)

- 1: The new part number "148133-11" will be stenciled on the tram control valve body. Reference Figure 3 and Figure 5 below.

- 2: If the original tram control valve tag is present, "11" will be stamped over the "00" at the end of the part number. Reference Figure 3 and Figure 4 below.
- 3: The new spools are stamped with "159X" on the handle end of the spool. Reference Figure 3 and Figure 6 below.
