PROGRAM INFORMATION BULLETIN NO. P08-14

SUBJECT: Potential Hazard from Recalled Electrical Disconnect Switches

MSHA is issuing this PIB to inform the mining industry of a recall of potentially defective electrical disconnect switches manufactured in Finland by Ensto Control Oy, distributed by Ensto in the United States (US) to US manufacturers and distributors, and sold under other manufacturers' labels. The defective switches were identified as certain models for the Ensto Control Origin toggle and rotary switches.

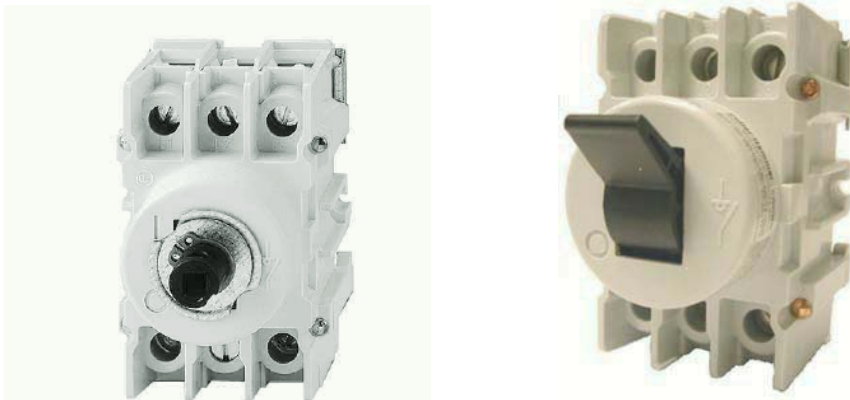
As shown below, the affected switches may be rotary or toggle configuration and have current ratings from 60 to 125 amperes. The switches are typically used in motor disconnect applications (such as HVAC units) and in electric distribution and control panel applications.

**MSHA has been informed that only those switches manufactured during weeks 1 through 50 of 2007 are potentially defective and must be replaced.**

MSHA has not been able to determine whether any of these defective switches are being used in the mining industry. The defect in the disconnect switch could cause one pole to remain energized when the switch is in the **OFF** position. This potential hazard could expose miners performing repair or maintenance work to energized circuits when the indicator is in the off position. The switch must be replaced to assure safe operation.

1. If it is determined that the switch was manufactured during weeks 1 through 50 of 2007, the switch should be tested to determine whether it is, in fact, defective.
2. If it is determined the switch is defective, the switch must be removed from service immediately to assure safe operation.
3. If the switch was manufactured within the recall dates but not defective, the switch can remain in service until replaced as soon as possible. This switch will need to be marked to indicate the potential defect and appropriate safety procedures should be

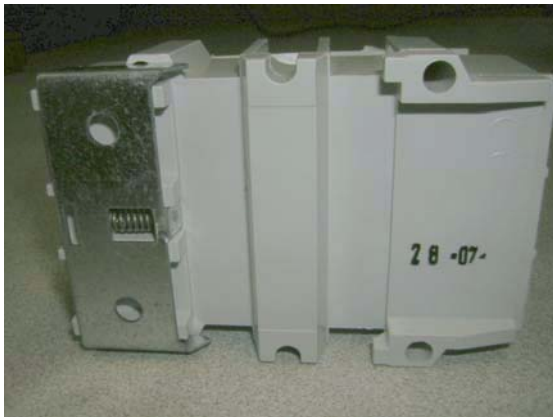
Week - Year

Step 4: If the disconnect switch is installed in an enclosure, open cover and remove the switch. The date code is listed on the back of the switch at the bottom.

Step 5: If date code falls between Week 1 and Week 50 of 2007 (01 07 and 50 07) then the unit must be replaced as specified under Corrective Action. If the date does not fall in the stated time period, reinsert the switch. The unit can be operated normally and the circuit re-energized.

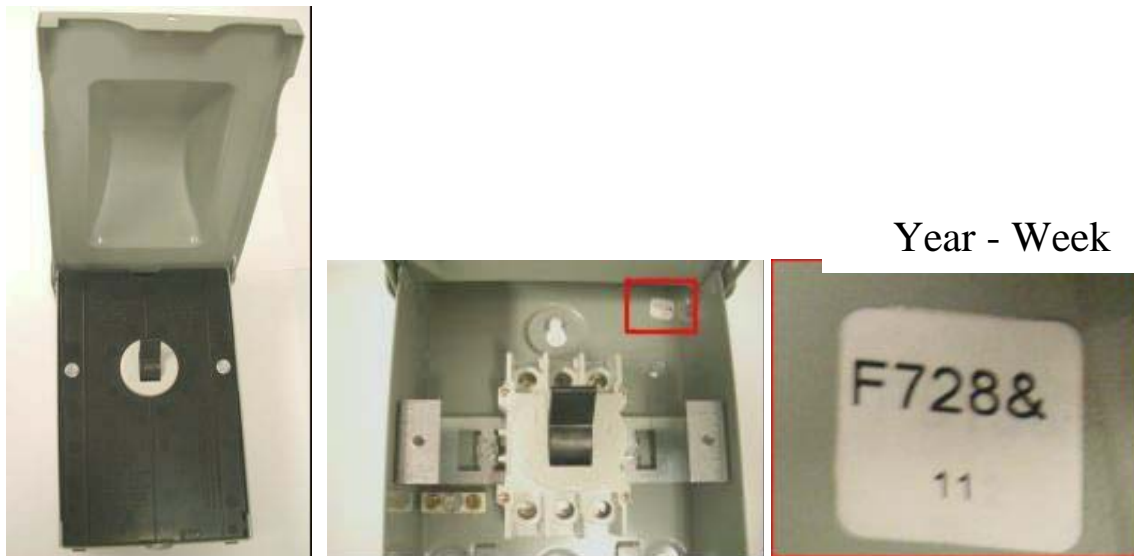
If the switch is enclosed in an Air Conditioning (A/C) Type Disconnect Enclosure manufactured by Eaton, the date is listed on the upper right corner inside the enclosure. To determine the date code of the A/C disconnect switch the operator should use the recommended procedures below:

Step 4: Locate the date code listed on the upper right corner inside the case.

Step 6: Remove the switch using the din rail release tab mechanism located on the line side of the switch. Inspect the date code located on the back of the switch as outlined previously. If the date code falls between Week 1 and Week 50 of 2007, the switch must be replaced as specified under Corrective Action. If the date does not fall in the stated time period, reinsert the switch and cover plate. The unit can be operated normally and the circuit re-energized.
