Effectiveness of Straw Bale Dams for Erosion Control in the Oakland Hills Following the Fire of 1991

Laurel M. Collins¹ and Christopher E. Johnston²

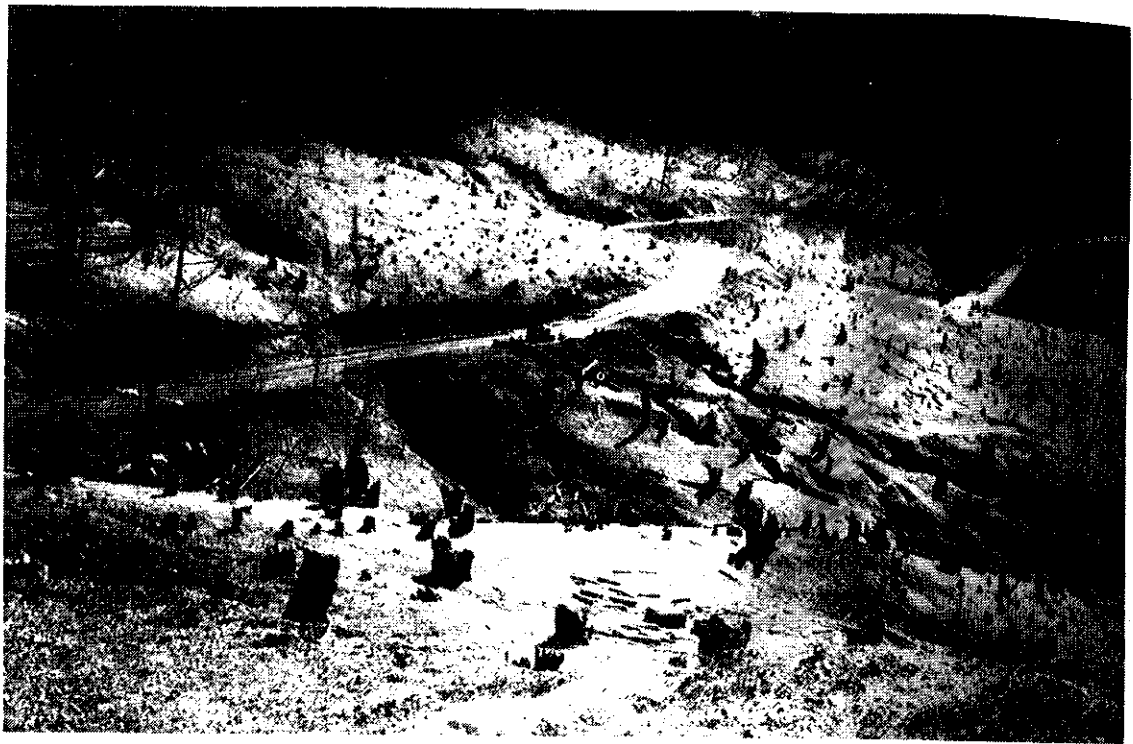
Figure 3. Central portion of the NOSC site. Note erosion associated with the dirt road, which was not protected with erosion control measures, even though most of the watershed was aerial seeded, seeded with hydromulch (mixed with soil sealant) and straw bales were added to all the gullies and landslides.

The analysis for NOSC suggests that a high proportion of sediment is also associated with the bales, but that the dirt road was also a major contributor. Although dirt roads are known to be major sources of sediment, erosion control measures were never applied to the one in NOSC. If we make similar assumptions for a sediment budget in NOSC, then a possible 2% accounts for hillside soil erosion (Table 1b). A minimum of 20% accounts for combined sediment generated by gully, fan, and abutment trench spoils. This leaves a remaining 78%, some of which must be attributed to natural erosion of gully walls. Since cross sections were not established in NOSC, we do not have an estimate of gully dimensions or amount of wall

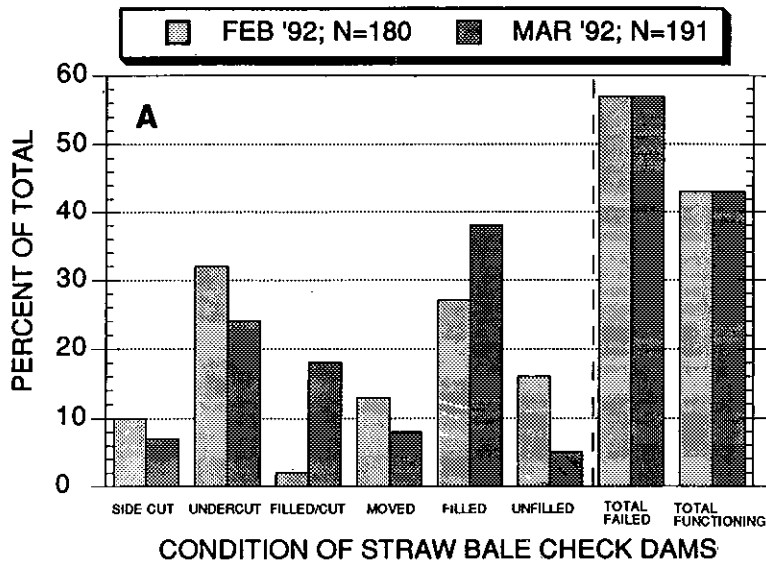
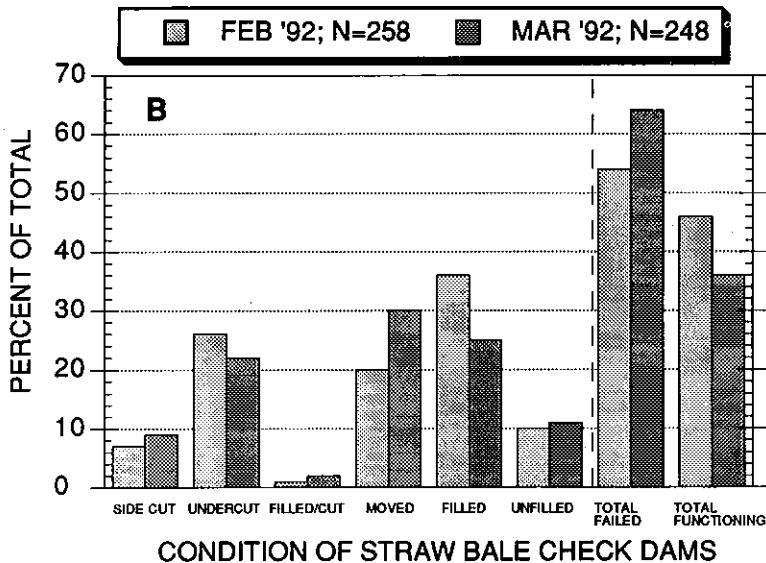
The results of the check dam analysis are shown in Figure 5a and b. By the third month after the bales were installed only 43% of the straw bale dams in CCRP and 46% in the NOSC were functioning to reduce the

erosion potential. About 60% (330 mm) of the total rainfall (since the bale installation) had already occurred. After 4.5 months (end of March) a respective 43% and 37% were functioning. The reason the number of functioning dams in CCRP did not change may have been due to the plugging of holes and repairing of dams by labor crews after the February storms. Repairs on other straw bale dams within gullies were not consistently observed in NOSC. Crews from the California Conservation Corps (CCC) inspected some of the bales in the gullies of NOSC in early February (David

Figure 5a and b. Percentage of functioning and non-functioning straw bale check dams in the watersheds.

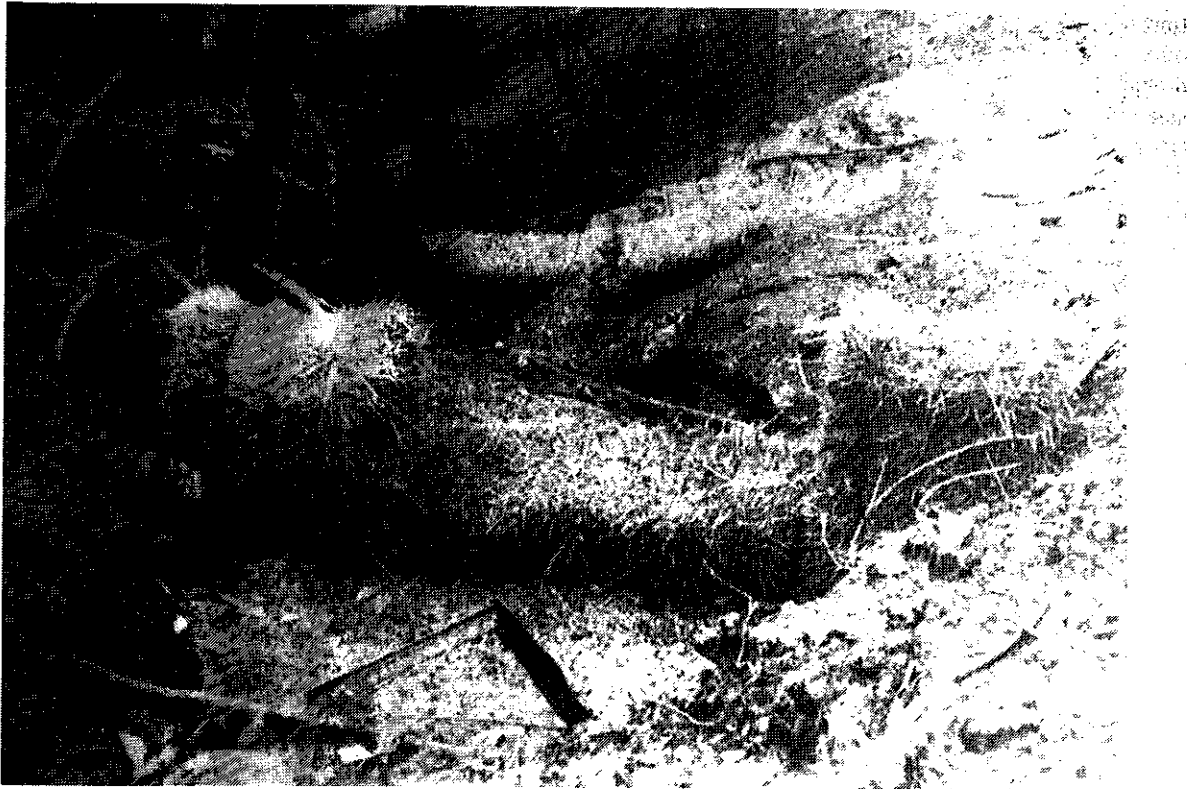
Figure 7. Check dam with two edge bales placed on end.
