Map 14  
**RADIAL ROADS - VEGETATION**  
**LINCOLN MEMORIAL CIRCLE &**  
**RADIAL ROADS**  
 CULTURAL LANDSCAPE REPORT  
 LINCOLN MEMORIAL GROUNDS  
 PREPARED BY: M. JOSEPH DATE: OCTOBER 1996 FEB. 1997

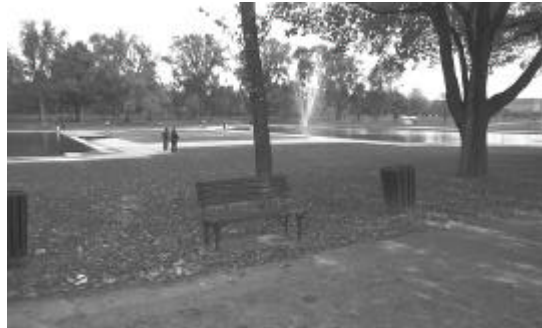
*Figure 54 – Cast iron frame benches and tulip trash receptacles used today along elm walks, November 11, 1996. LINC 11-12.*

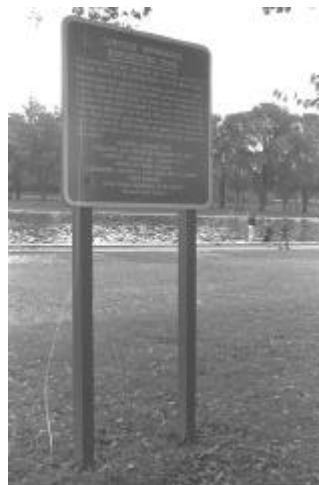
**Signs.** In the Reflecting Pool area, the park has placed four large interpretive signs (two on each side) that describe the Reflecting Pool. The large metal signs (white lettering on brown background) block the view of the feature they are describing and are out of scale with the surrounding landscape. New interpretive signs are proposed for this area and will be a low-profile, tamper-resistant type, wayside.

**Figure 56 - Oversized interpretive signs by the Reflecting Pool, November 11, 1996. LINC 11-16.**

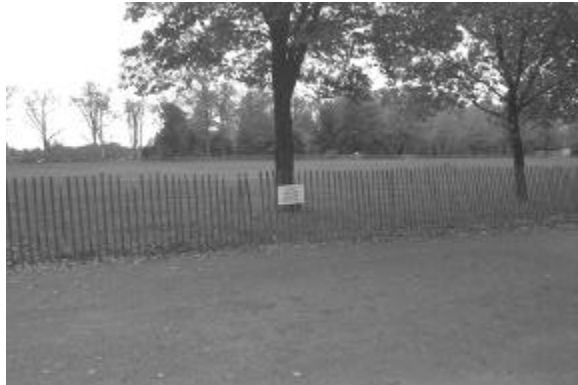
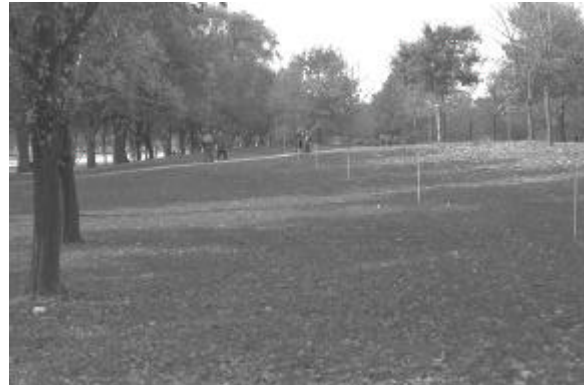
*Figures 57 & 58 - Temporary snowfencing installed along pedestrian corridors to protect grass areas. Stake and rope installed on the flood berm to mark secure area for landing pad, November 11, 1996. LINC 11-11 & LINC 11-14.*

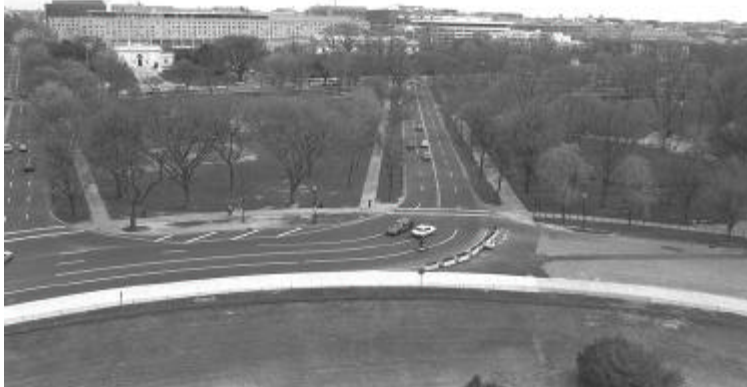
**Figure 61 - Remnant concentric row of elms around Lincoln Circle, between 23rd Street NW and Bacon Drive, March 1996. LINC 6-27.**

Unlike the radial roads, the original planting pattern around the outer circle is almost entirely lost. Only a few remnant elms remain to suggest the old design. While the quadruple band on the eastern part of the circle is evident between 23<sup>rd</sup> Street NW and Bacon Drive and 23<sup>rd</sup> Street SW and French Drive, the areas between the two drives and the Reflecting Pool no longer show any evidence of the old tree pattern. In these two areas, the distinctive landscape plans for Constitution Gardens and Korean War Veterans Memorial have encroached upon the old concentric design for the elms. Here newer plantings of native understory trees are clustered beneath a mixed

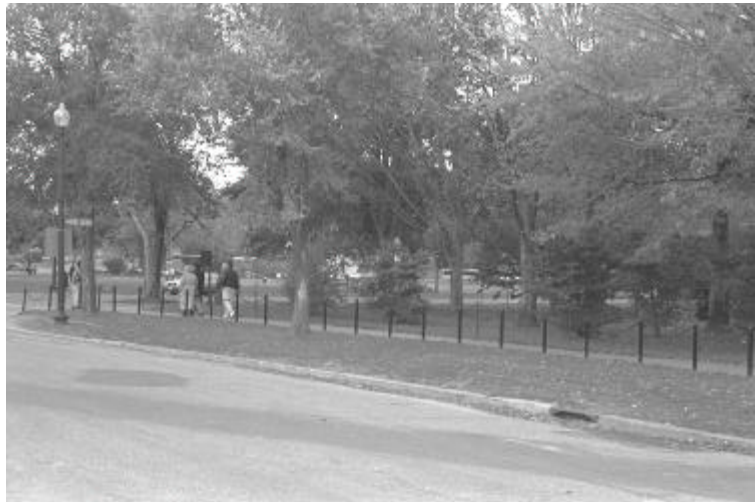
**Figure 62 - Inappropriate trees and shrubs, planted under canopy of American elms, November 11, 1996. LINC 11-27.**

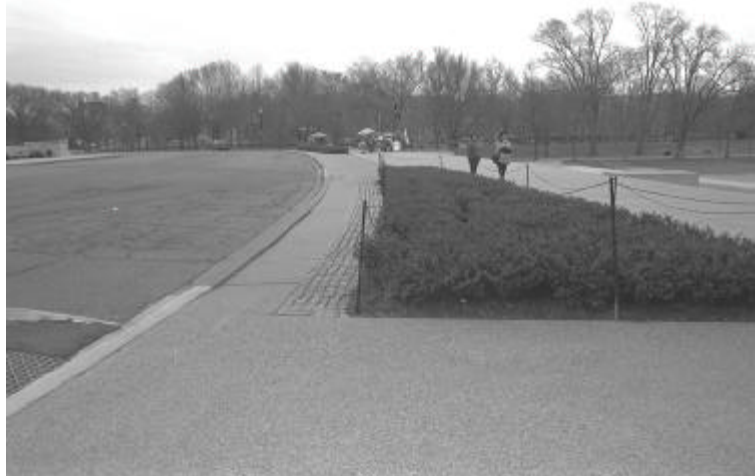
The only significant alteration to the original landscape plan occurred in 1953 when the outer edge of the circular roadway near the sidewalk above the Reflecting Pool was changed. Here a rectangular curb cut was eliminated, the circle was made continuous, and a pair of planting beds were installed on the north and south side of the sidewalk in the areas formerly shaped by the old squared-off curb. The park appears to have planted dwarf boxwood in the beds, which were replaced in 1977 with a little leaf holly, also known as inkberry (*Ilex glabra*.) At subsequent intervals, the park replaced the inkberry with Japanese hollies (*Ilex crenata*.) which occupy the planting bed today.

**Figure 63 - Shrub planting at top of Reflecting Pool steps, December 1996. LINC 17-35.**

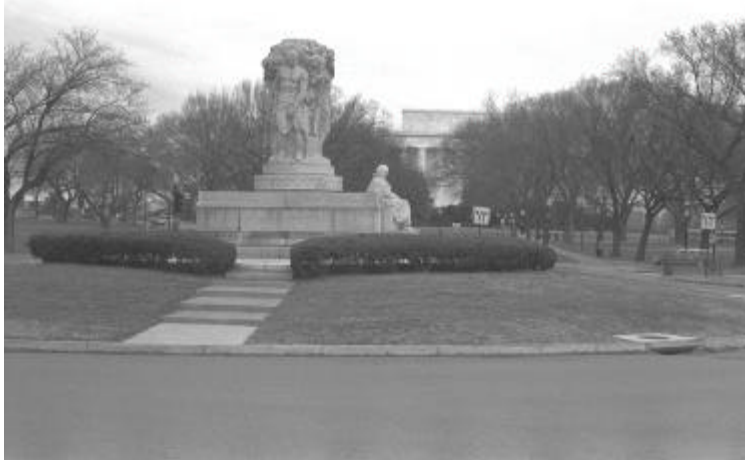
Around the Ericsson Memorial, the planting plan was changed substantially. Japanese holly replaced the original junipers, which once encircled the granite platform. Four walks, which radiated from the granite platform, also were lined with junipers, but these shrubs were also removed and now the walks are surrounded by grass. These changes have further downplayed the connection of the Ericsson Memorial to the Lincoln Memorial landscape.

**Figure 64 – Replacement shrubs around Ericsson Memorial changes the character of the original planting, February 1997. LINC 18-8.**

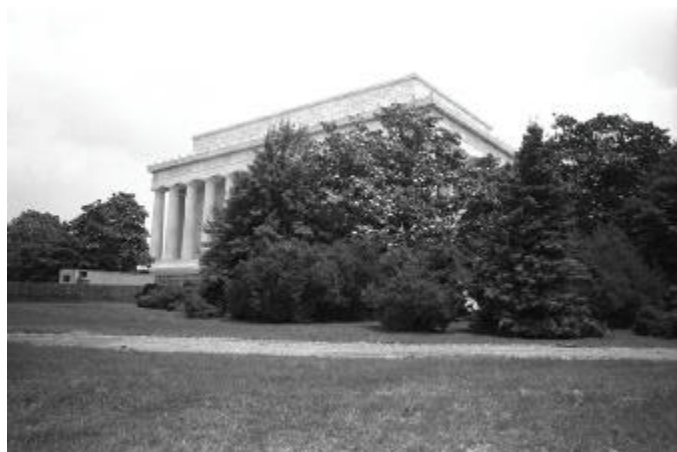
The trees and shrubs surrounding the memorial currently exhibit different degrees of health and reflect a range of growing conditions. Along the front or east side, the plantings have suffered greatly from the effects of repeated construction activity and preparation for large-scale public events that have occurred in this area over time. The 1995-96 construction on the approachway has caused further damage to the foundation plantings. The lack of routine maintenance and regular pruning has also caused some of the plantings to appear ragged or

Figure 68- Existing west side foundation plantings, July 23, 1996. LINC 10-17.

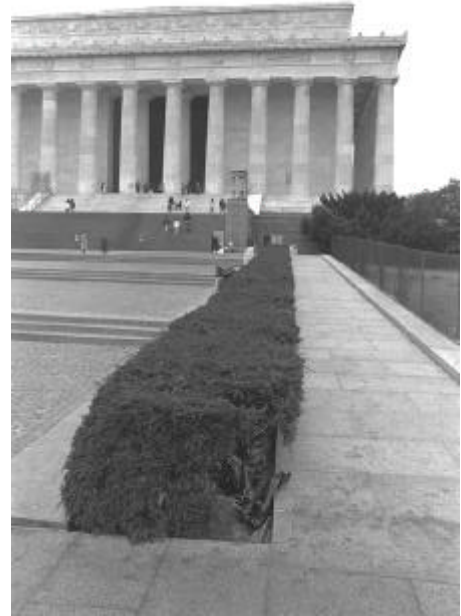
overgrown. When the park revised the original plans by replacing the boxwood hedges with yews in 1945, they altered the character of the entry planting, yet retained some of the historic integrity by keeping a band of green hedge growing on both sides of the approachway. However, the addition of an American holly and the Japanese hollies to the front side and massings of yews to screen floodlights have further compromised the character of the planting design. Because replacement plantings have deviated from the original design, the landscape on the front side retains a lower degree of integrity. On the sides and rear of the memorial, the integrity of the plantings is mostly intact, although some boxwood planted near the magnolias and close to the raised terrace have been shaded out and are unhealthy, or have died. At the midpoint of the north and south sides, two thick masses of *Taxus cuspidata* ‘Nana’ provide the horticultural transition between the character of the two different planting areas. Even though these yews were planted to replace the original mugo pines, the design intent of keeping a lower growing conifer mass in this area is still evident. In other areas overgrown plant material, like some American hollies that were planted on either side of the horizontal-growing yew mass on the north face of the memorial, are encroaching upon the designed opening above the raised terrace. See Map 15 and Map 16 *Lincoln Circle - Vegetation* for the graphic representation of the front and back plantings.

*Figure 69 - Existing yew hedge along approachway and accessible ramp, January 3, 1997. LINC 16-21.*
