# Final TAKE

Incident ALERT Message from Performance Surety

**September 11, 2003**  
LANL PS-7, No. 0302

## Worker Receives Electrical Shock After Contact with Welder Cart

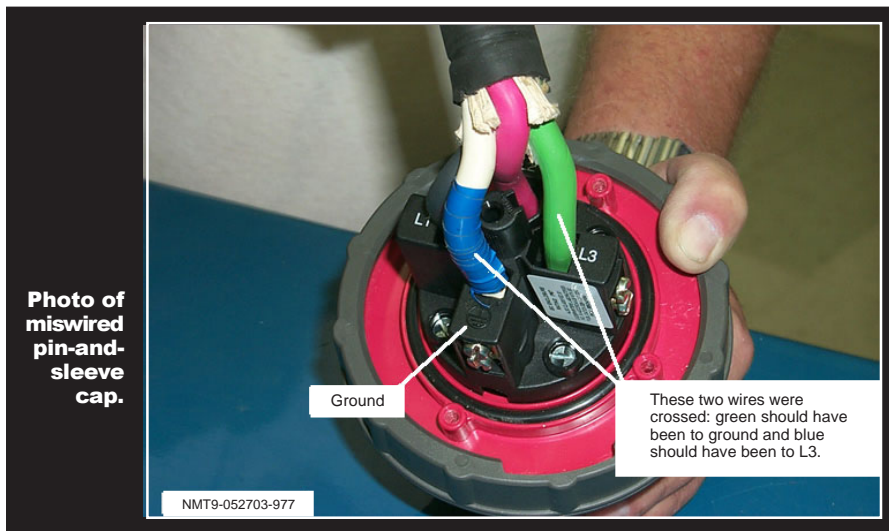
On May 27, 2003, a LANL machinist received an electrical shock when his left upper arm (bicep area) touched the side of a welder cart that had been wired incorrectly during modification by support services subcontractor electricians. The machinist was escorted to Occupational Medicine (HSR-2) for evaluation. The on-call physician determined that there were no abnormal heart rhythms as a result of this incident, however the machinist was suffering from a headache and prolonged numbness in his left arm. The machinist was released back to work with no restrictions, but asked to return for follow-up medical evaluations. A week later, the machinist reported that the headache had dissipated and all feeling in his arm had returned.

interrupted by his partner with a request for assistance. The electrician believes he made the wiring error when he returned to complete the wiring of the cap. On May 13, the disconnect switch was received and two other electricians were tasked with installing the switch and terminating the wires to the switch. The two electricians were not aware that the cap on the welder had been changed. They completed the work, then tested the voltage from the disconnect switch and receptacle and found that the voltage checked at 480 volts. The electricians did not perform a post-maintenance check of the plug wiring, and neither LANL nor subcontractor procedures required this post-maintenance testing. At this point, the disconnect switch was left in the “on” position, the welder was plugged into the wall-mounted pin-and-sleeve receptacle, and the welder was in the “off” position. The accident happened on May 27 when the machinist came into contact with the welder. A LANL electrical technician subsequently determined that the ground and one of the power leads within the welder plug had been reversed during welder modification.

**DIRECT CAUSE:** Investigators determined that the direct cause of the accident was inattention to detail on the part of the electrician who reversed the wiring. However, several factors contributed to this cause: The electrician was assigned too many tasks, he was assisting his co-worker with other job tasks, and he was installing additional components needed to complete the job because the work scope had changed.

**ROOT CAUSE:** Accident investigators cited failure to develop acceptance criteria as the root cause of the accident. In addition, the LANL Facility Management Work Control Laboratory Implementation Requirements (LIR 230-03-01) and Graded Approach for Facility Work (LIR 230-01-02) did not provide clear guidance and expectations for planning purposes with respect to assigning management levels and planning information that should be reflected in the work package.

- **The subcontractor implemented a new procedure for electrical work packages that requires verification and testing by craft employees and independent verification by a qualified person.**

- **The Laboratory is in the process of re-engineering its work-control and change-control processes, and is developing a post-maintenance/modification procedure. The end product will be a uniform Laboratory work management program that will be incorporated in the LANL Work Management Program Manual.**
