Mesa Verde National Park

Mesa Verde Fuel Treatments Reduce Impacts of Long Mesa Fire

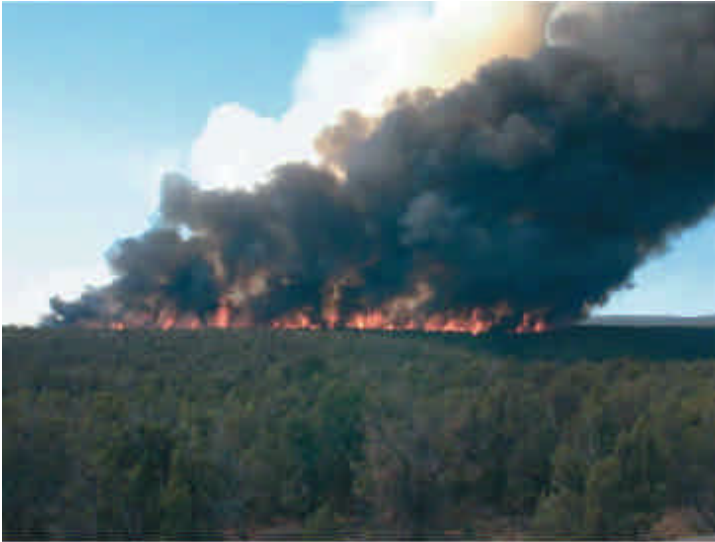
The Long Mesa Fire moving through the piñon-juniper forest towards the Mesa Verde National Park headquarters and housing areas on the afternoon of July 29. This photo was taken from the water tank, the first structure to be impacted by the fire.

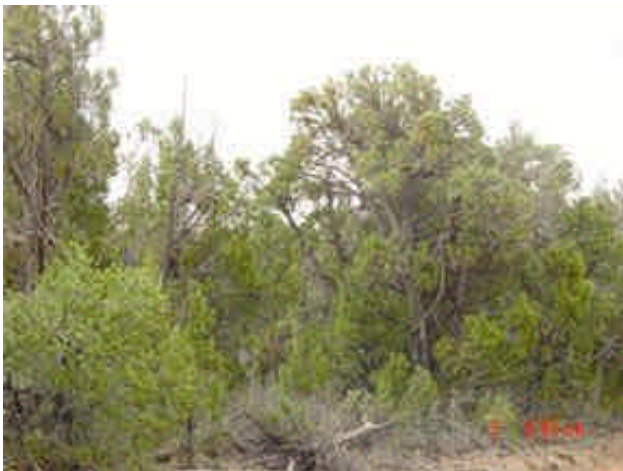
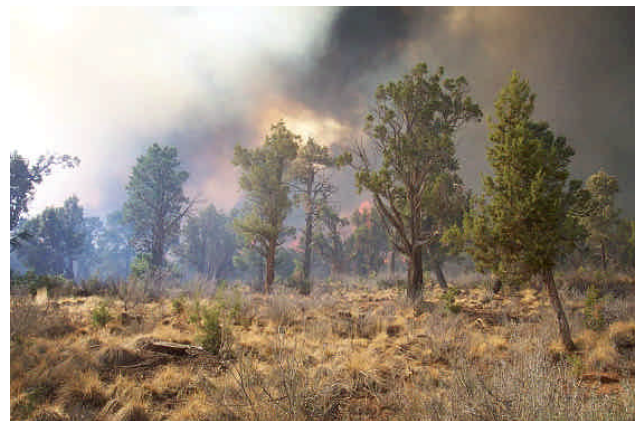
The piñon-juniper forest on Chapin Mesa, before (left) and after (right) thinning through fuels reduction projects.

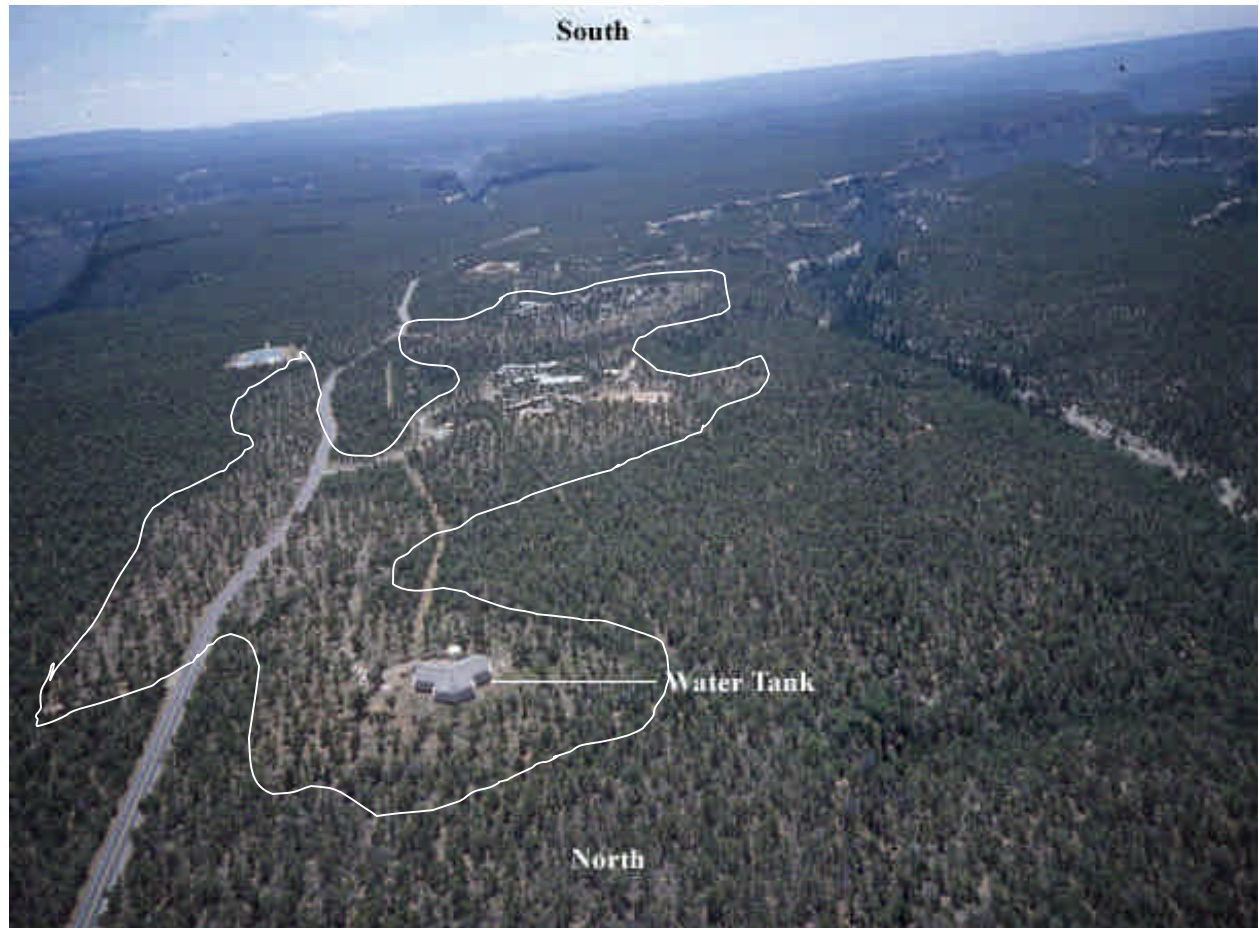
Aerial view before the fire shows thinning in place around the water tank, Research Center, main road, and housing area

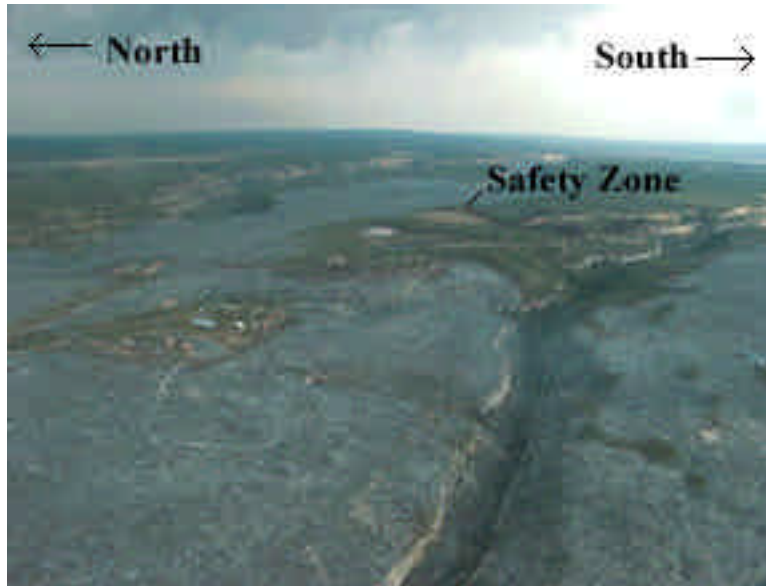
Looking south down Chapin Mesa, the Fire Management Office and Research Center are in the front, the housing area is next, and the Headquarters extends on the finger to the top right corner of the photo. This clearly shows the fire broke into two fronts as it hit the fuel treatments around the buildings and on the road. Note the canyon between the Research Center and the housing area.

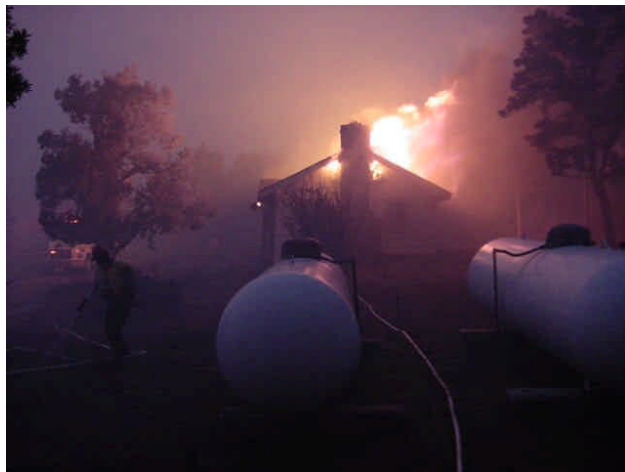
An unoccupied house is lost to embers as firefighters work to save others. The attic vent is on the other side of the house. This house also fronted a small draw coming up from the side canyon, which may have exposed it to more embers than the other structures. The hose in the center has a sprinkler between the two propane tanks.

Two structures were consumed. The radiant heat did not start other fires in nearby houses because of the preventive measures taken and the actions of the firefighters.

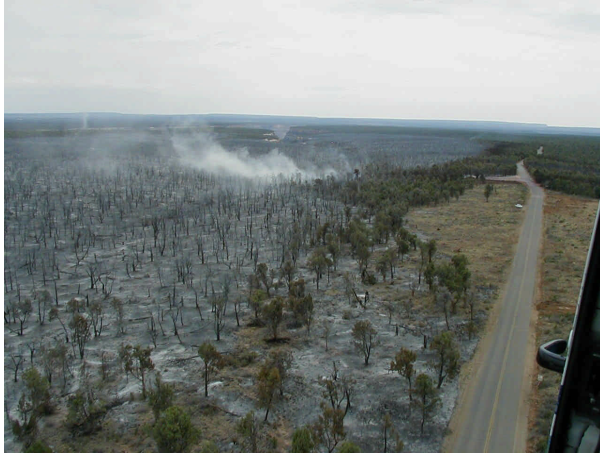
Fuel treatments along the main road and a 12-acre safety zone helped protect Headquarters and Spruce Tree House. Fire did burn through the fuel treatments in places, but it did not cross the road.

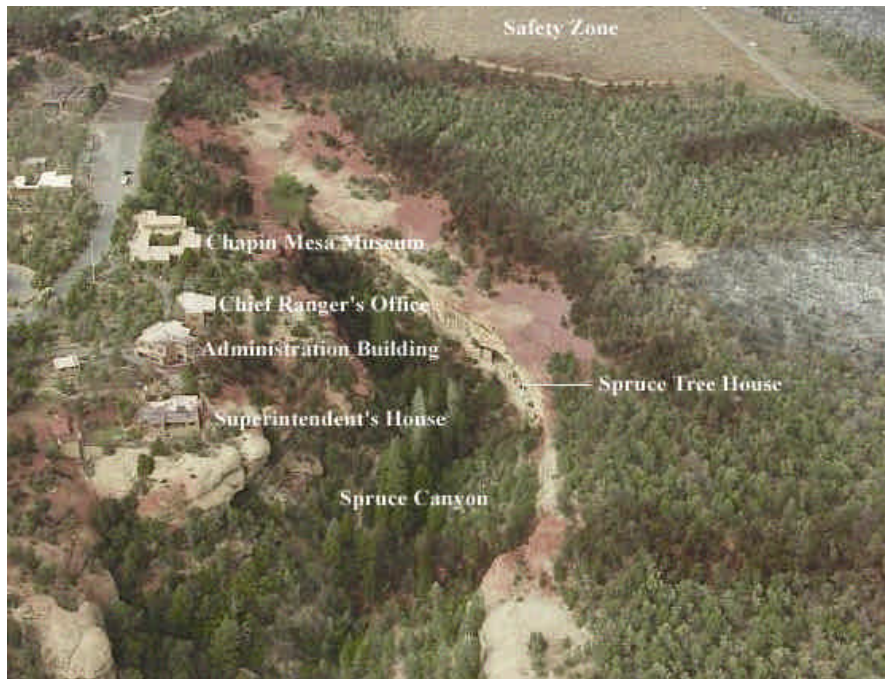
Retardant drops are evident around the main visitor area and Spruce Tree House. The safety zone is at the top of the photo.
