# Sierra Chemical Co. High Explosives Accident

Mustang, Nevada January 7, 1998

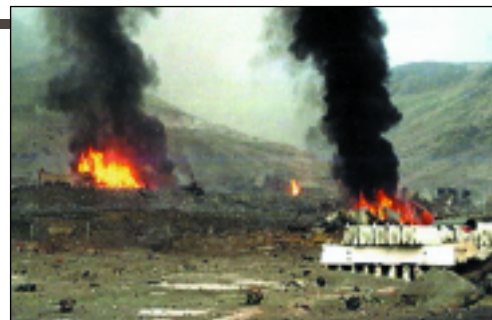
Sierra Chemical facility burns after massive explosions.
